Attoyac Bayou Recreational Use Attainability Analysis

**Attoyac Bayou
Recreational Use Attainability Analysis**

**Texas State Soil and Water Conservation Board
Project # 09-10**

October 2012

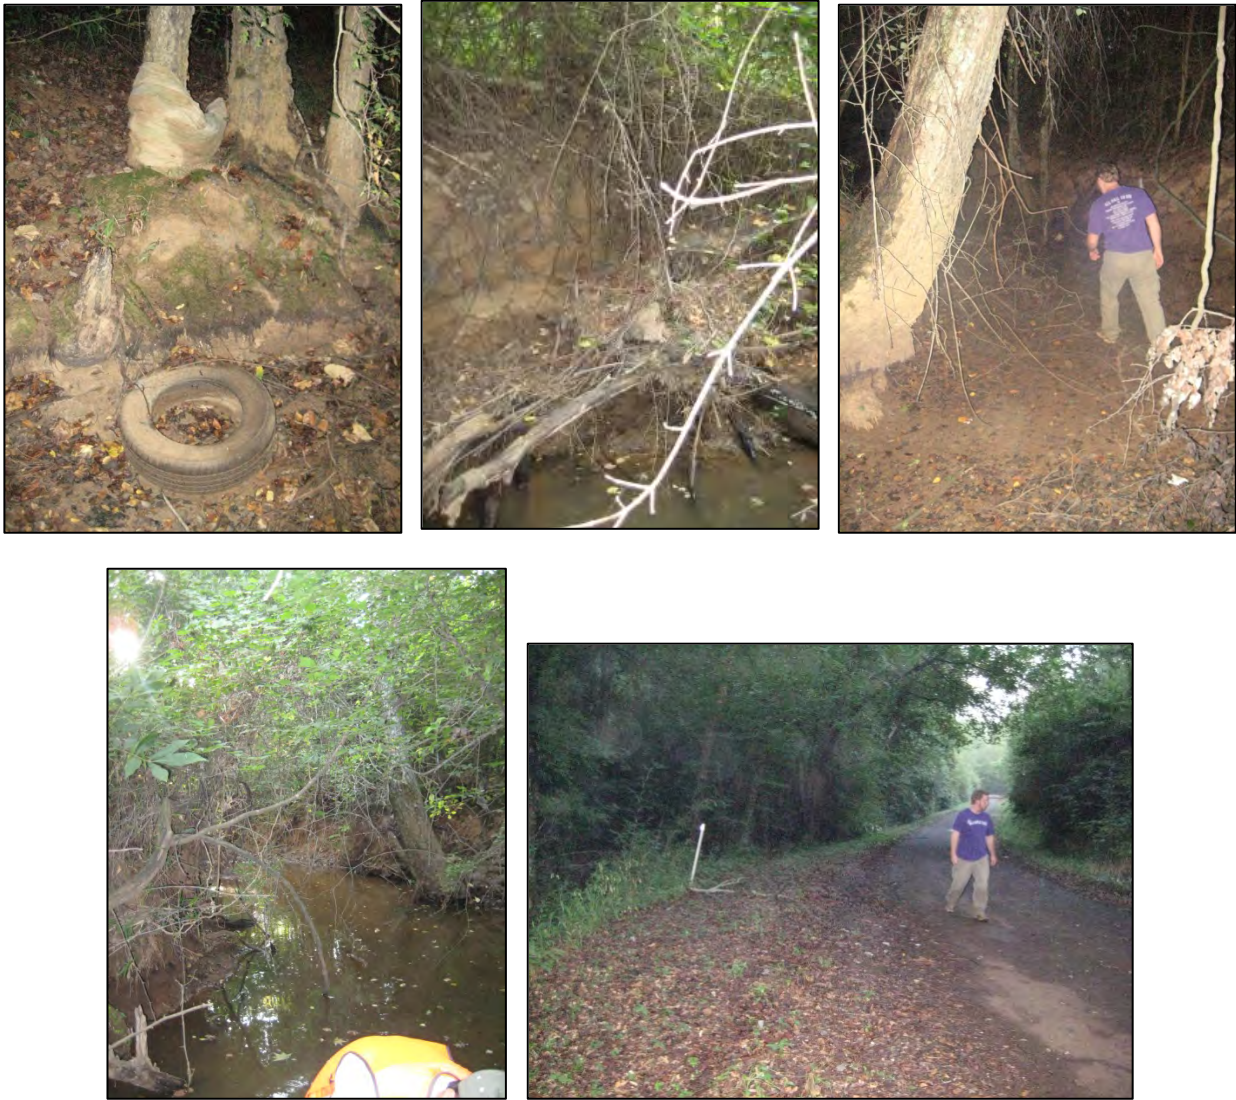
Photogroup 4-3 Attoyac 3 depicting bank access and general bank appearance. All individuals featured are SFASU and CES staff. Top left: Large channel litter against left bank, August 2012; Top center: 150-m transect, left bank, July 2012; Top right: 30-m transect, downstream, August 2012; Bottom left: 150-m transect, upstream, July 2012; Bottom right: Stream access point from CR 3181.

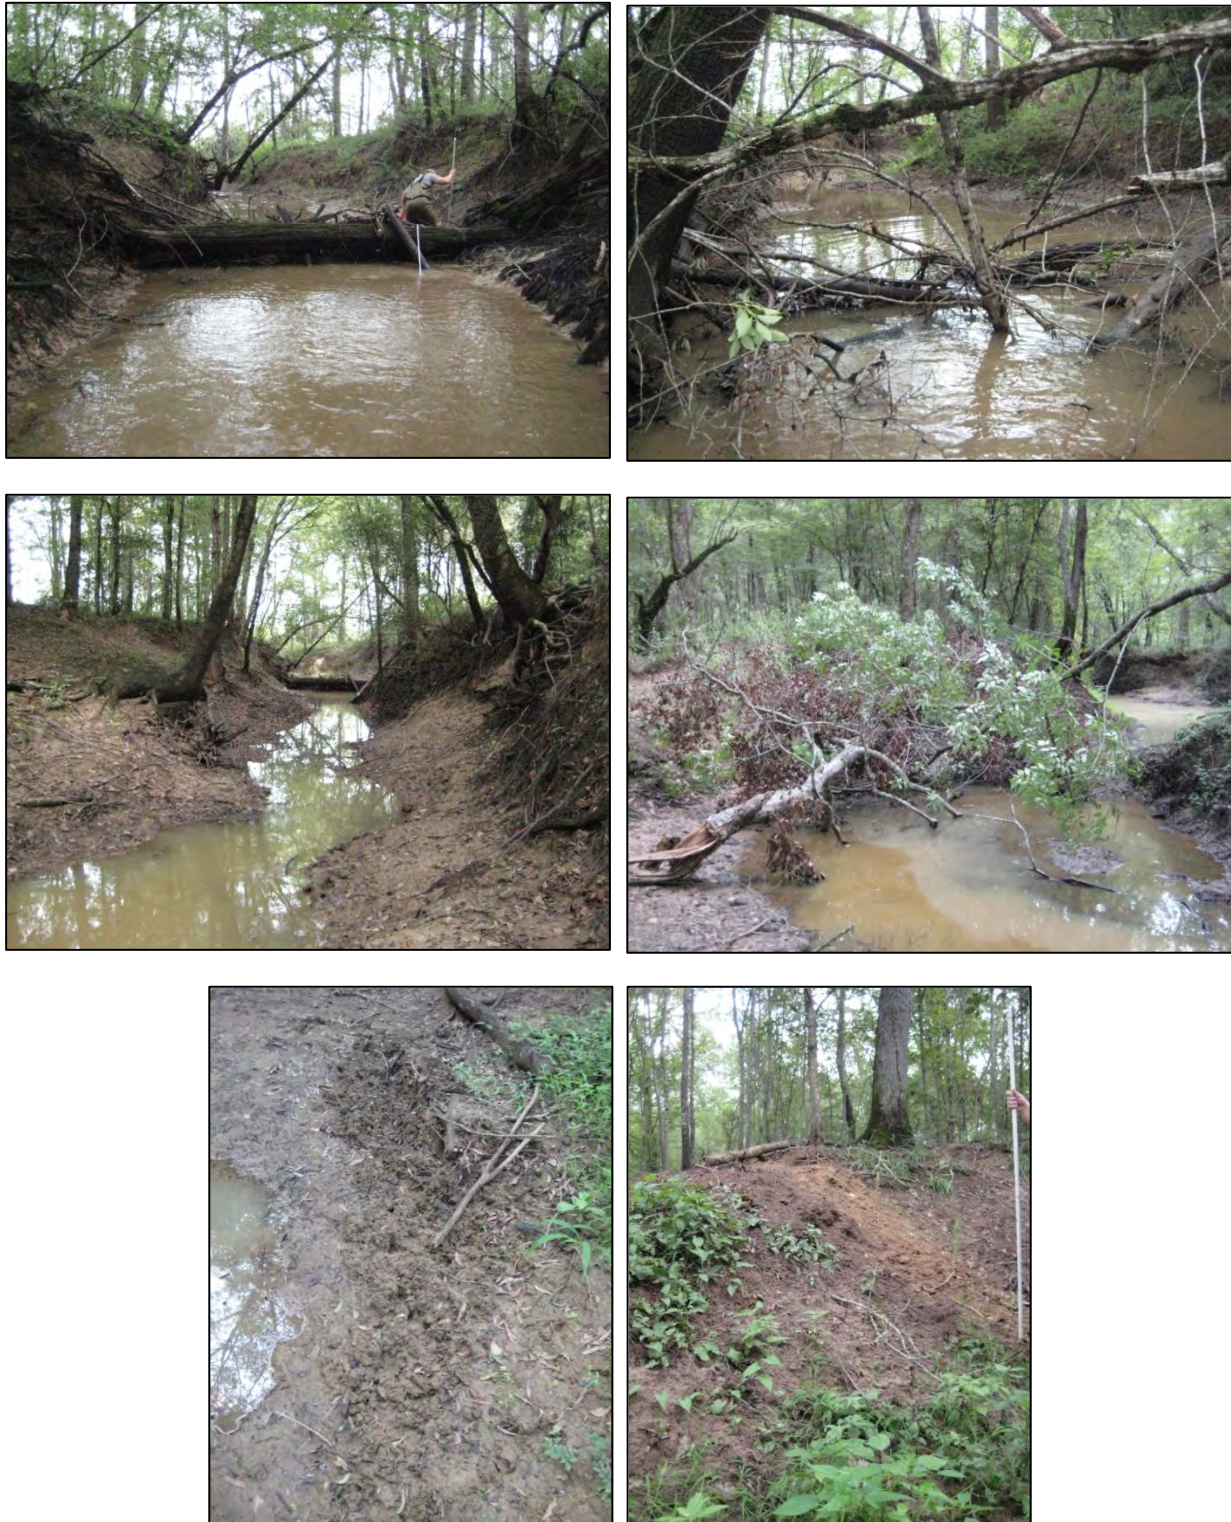
Photogroup 4-12 Attoyac 13 depicting water surface appearance and potential sources of contamination. Top left: Large woody debris, July 2012; Top right: 300-m, upstream, July 2012; Middle left: 300-m, upstream, August 2012; Middle right: Woody debris, August 2012; Bottom left: Feral hog use, August 2012; Bottom right: Feral hog use, August 2012.

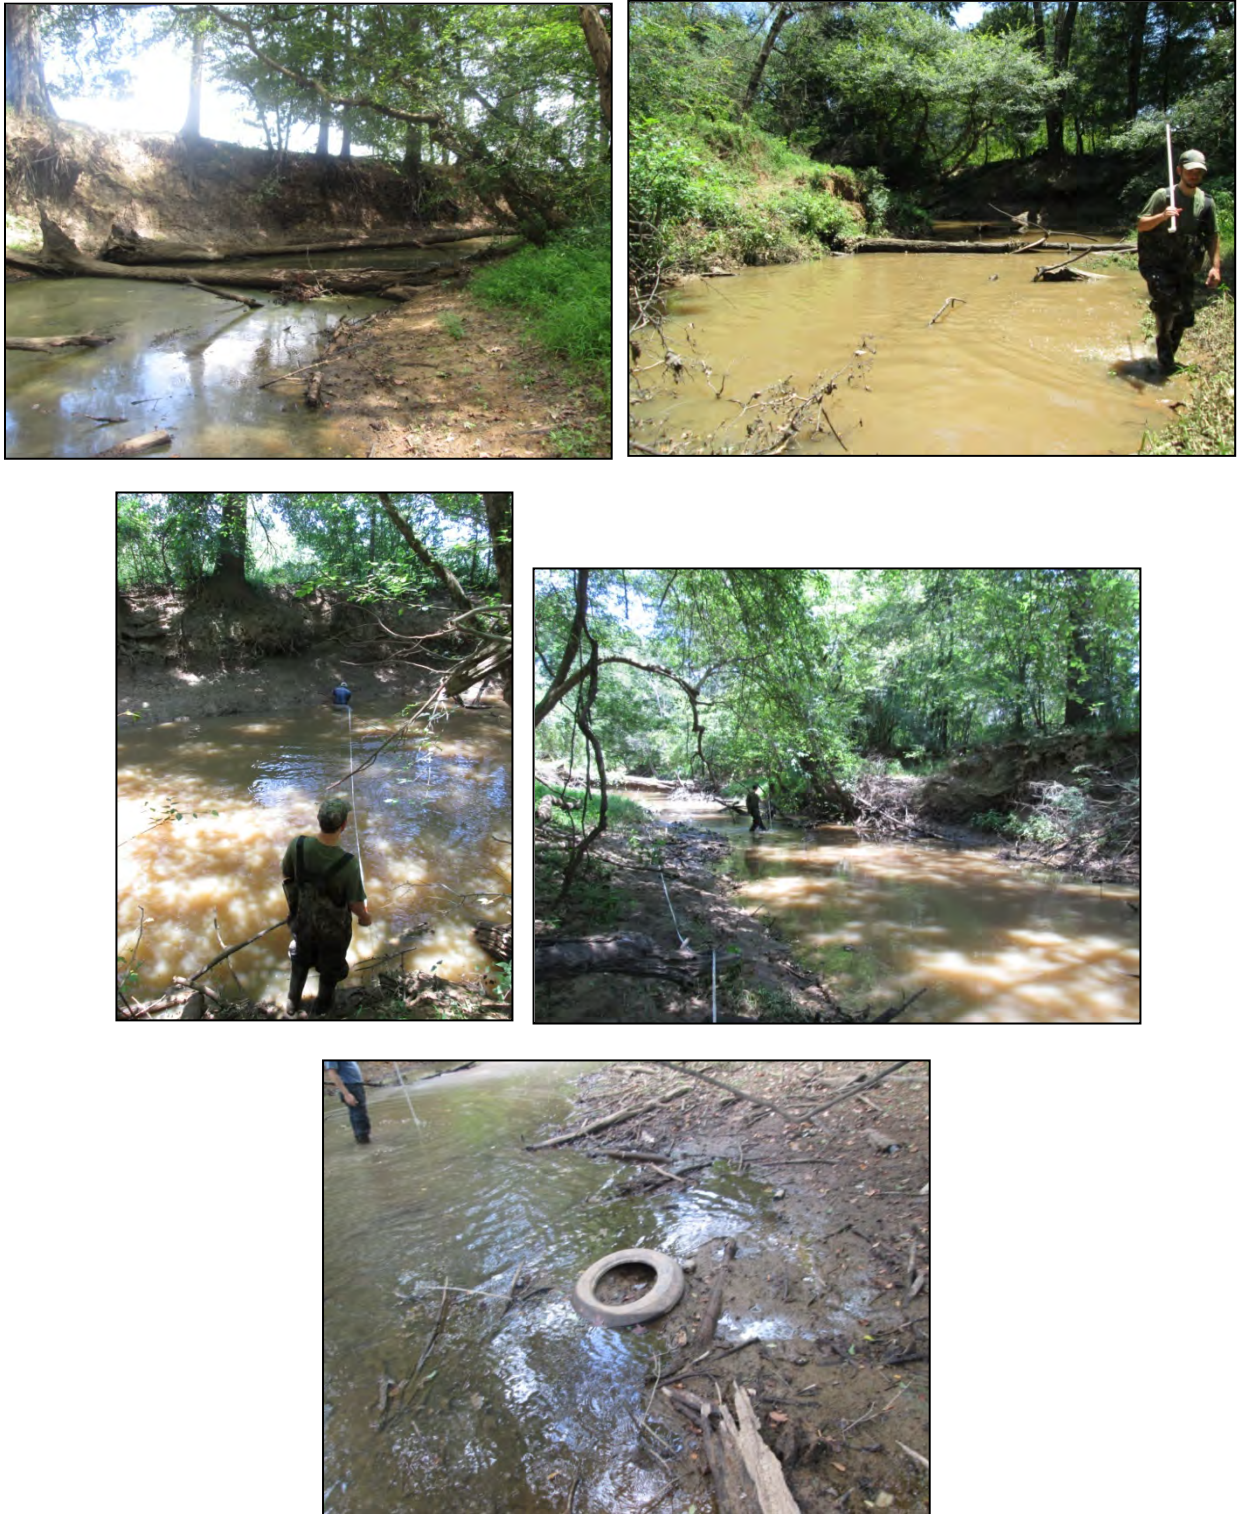
Photogroup 4-14 Attoyac 15 depicting water surface characteristics. All individuals featured are SFASU and CES staff. Top left: 300-m transect, upstream, August 2012; Top right: 300-m, downstream, July 2012; Middle left: Stream width measurement, July 2012; Middle right: 150-m transect, upstream, July 2012; Bottom: Channel litter (tire), August 2012.

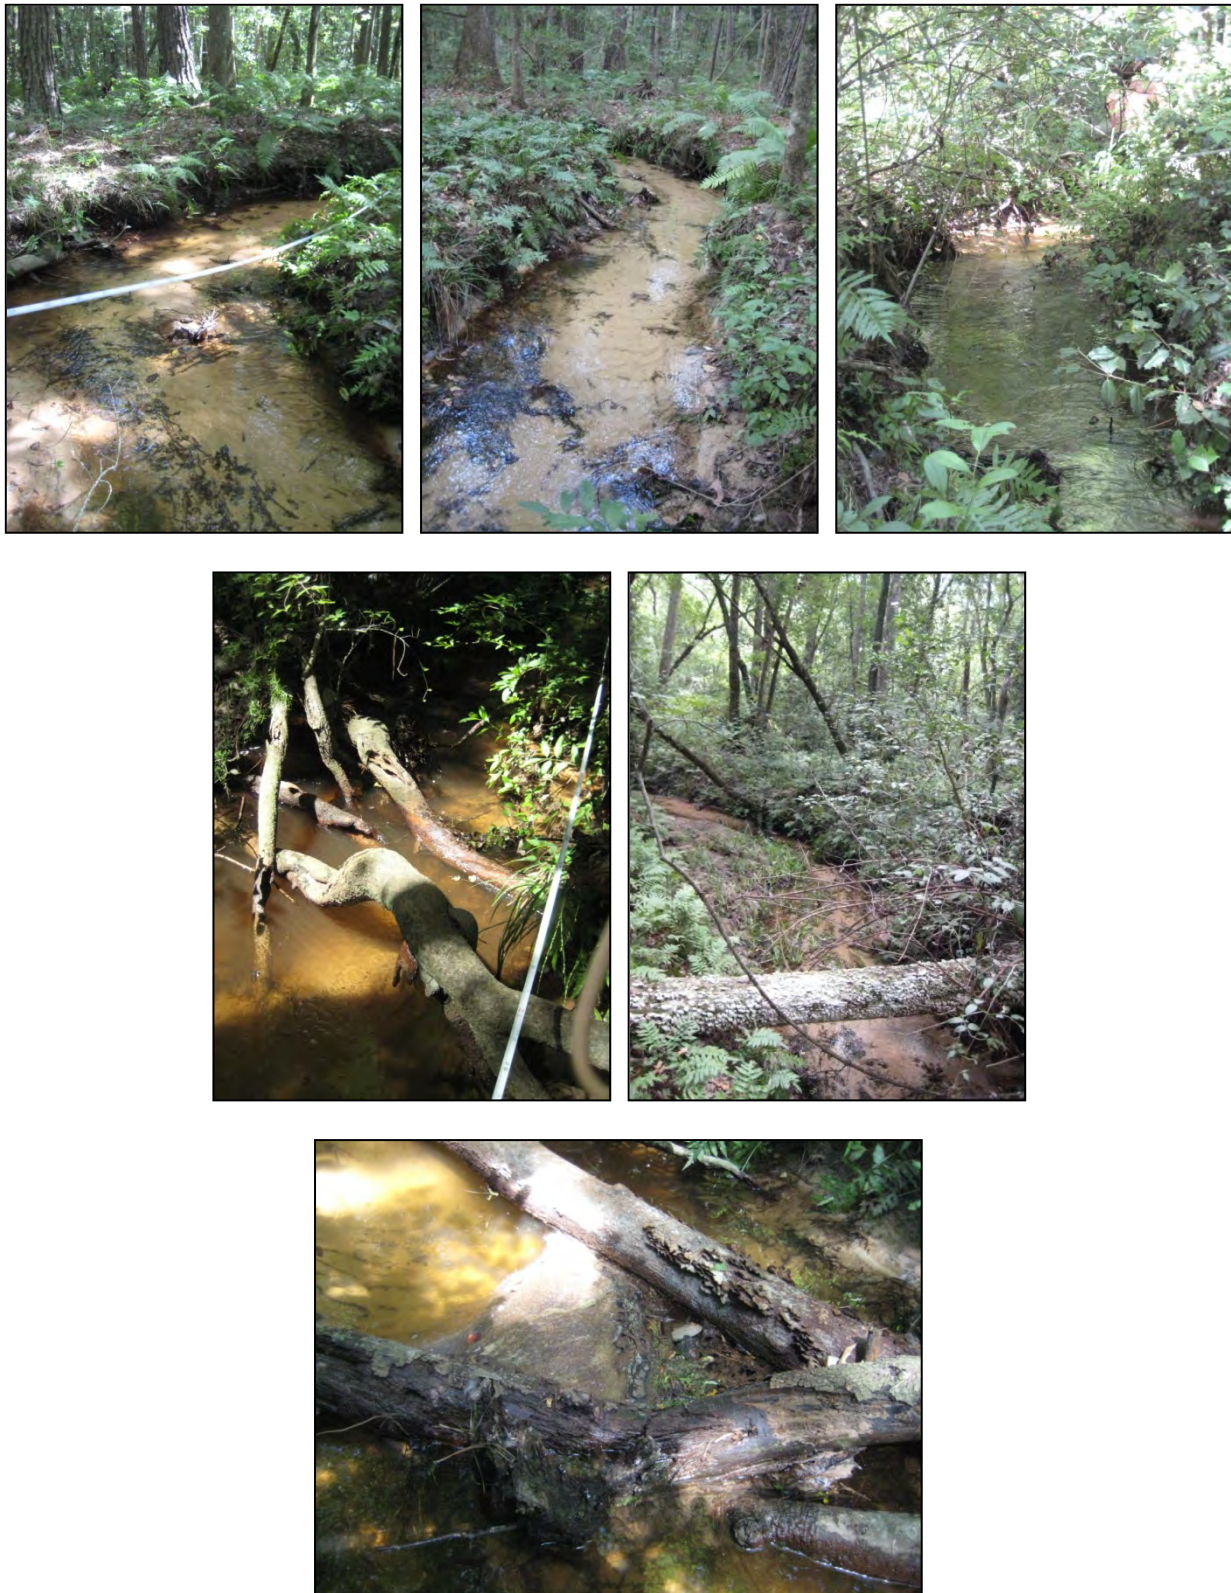
Photogroup 4-23 Naconiche 1 depicting water surface characteristics. Top left: 300-m transect, downstream, July 2012; Top center: 300-m transect, upstream, August 2012; Top right: Dense bank vegetation, August 2012; Middle left: Woody debris across channel, August 2012; Middle right: 150-m transect, downstream, August 2012; Bottom: Woody debris with foam, July 2012.

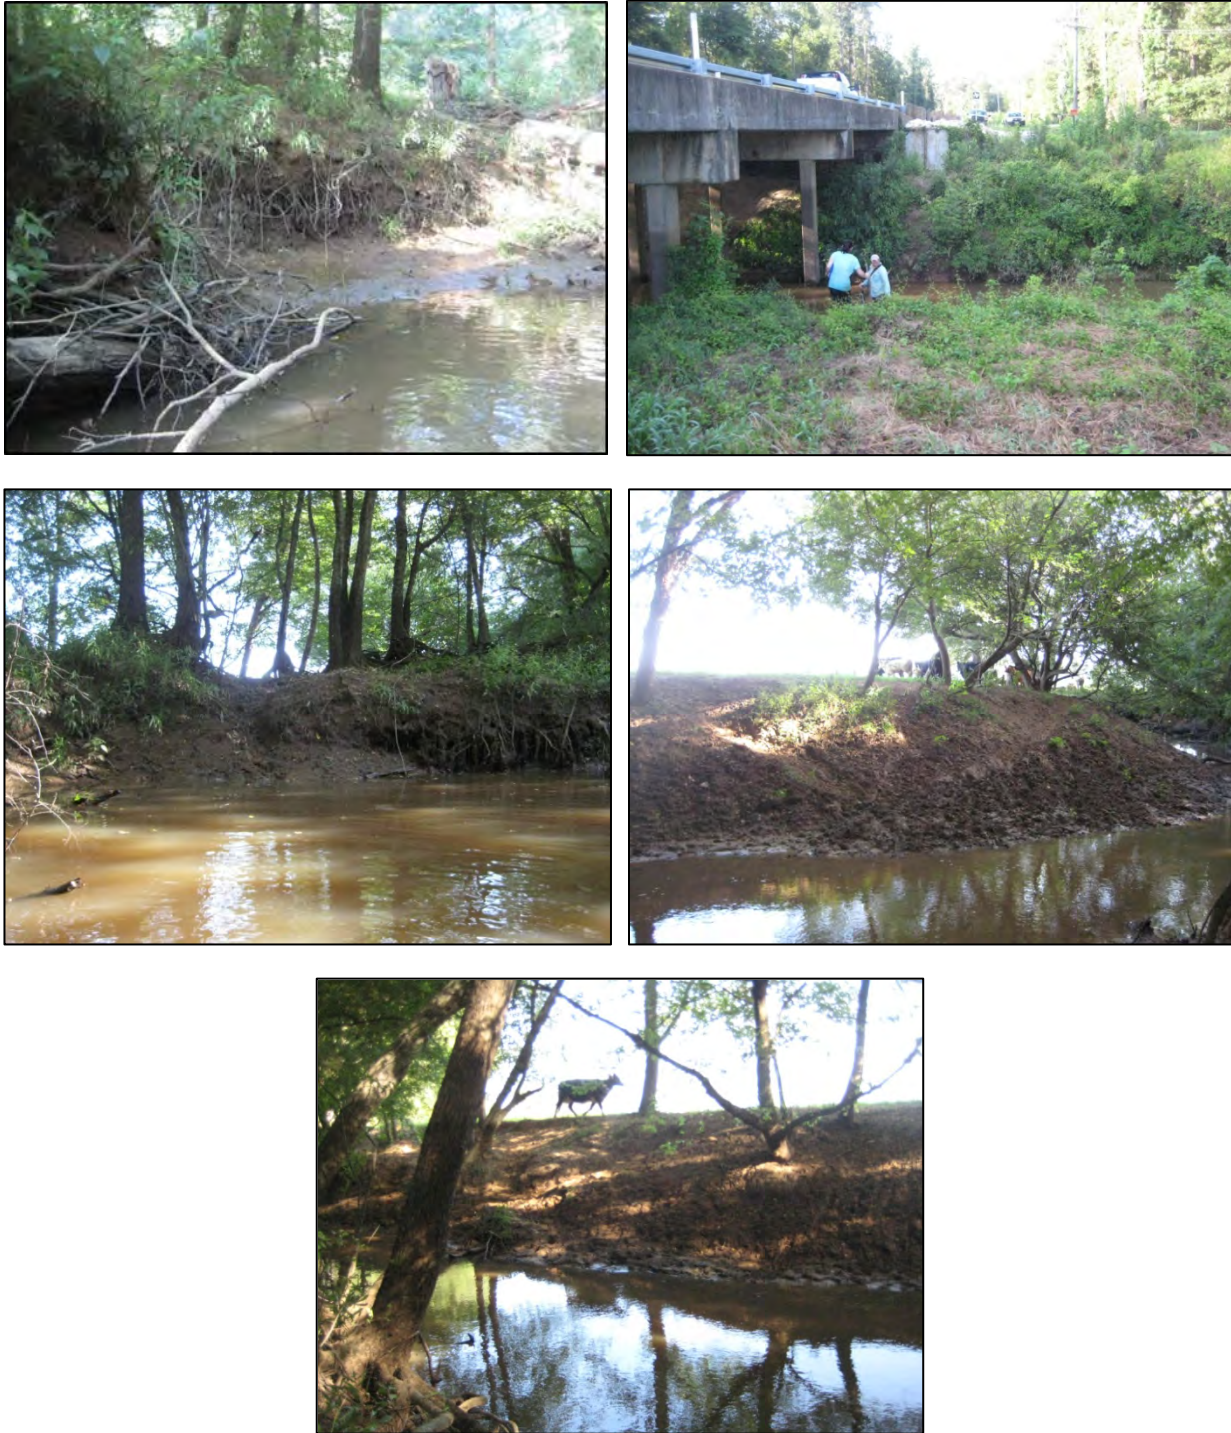
Photogroup 4-30 Naconiche 11 depicting bank access and general bank appearance with livestock access. All individuals featured are SFASU and CES staff. Top left: 30-m transect, left bank, July 2012; Top right: 0-m transect, FM 95 crossing/access point, July 2012; Middle left: 300-m transect, left bank, July 2012; Middle right: Livestock and livestock bank use, July 2012; Bottom: Livestock use, July 2012.

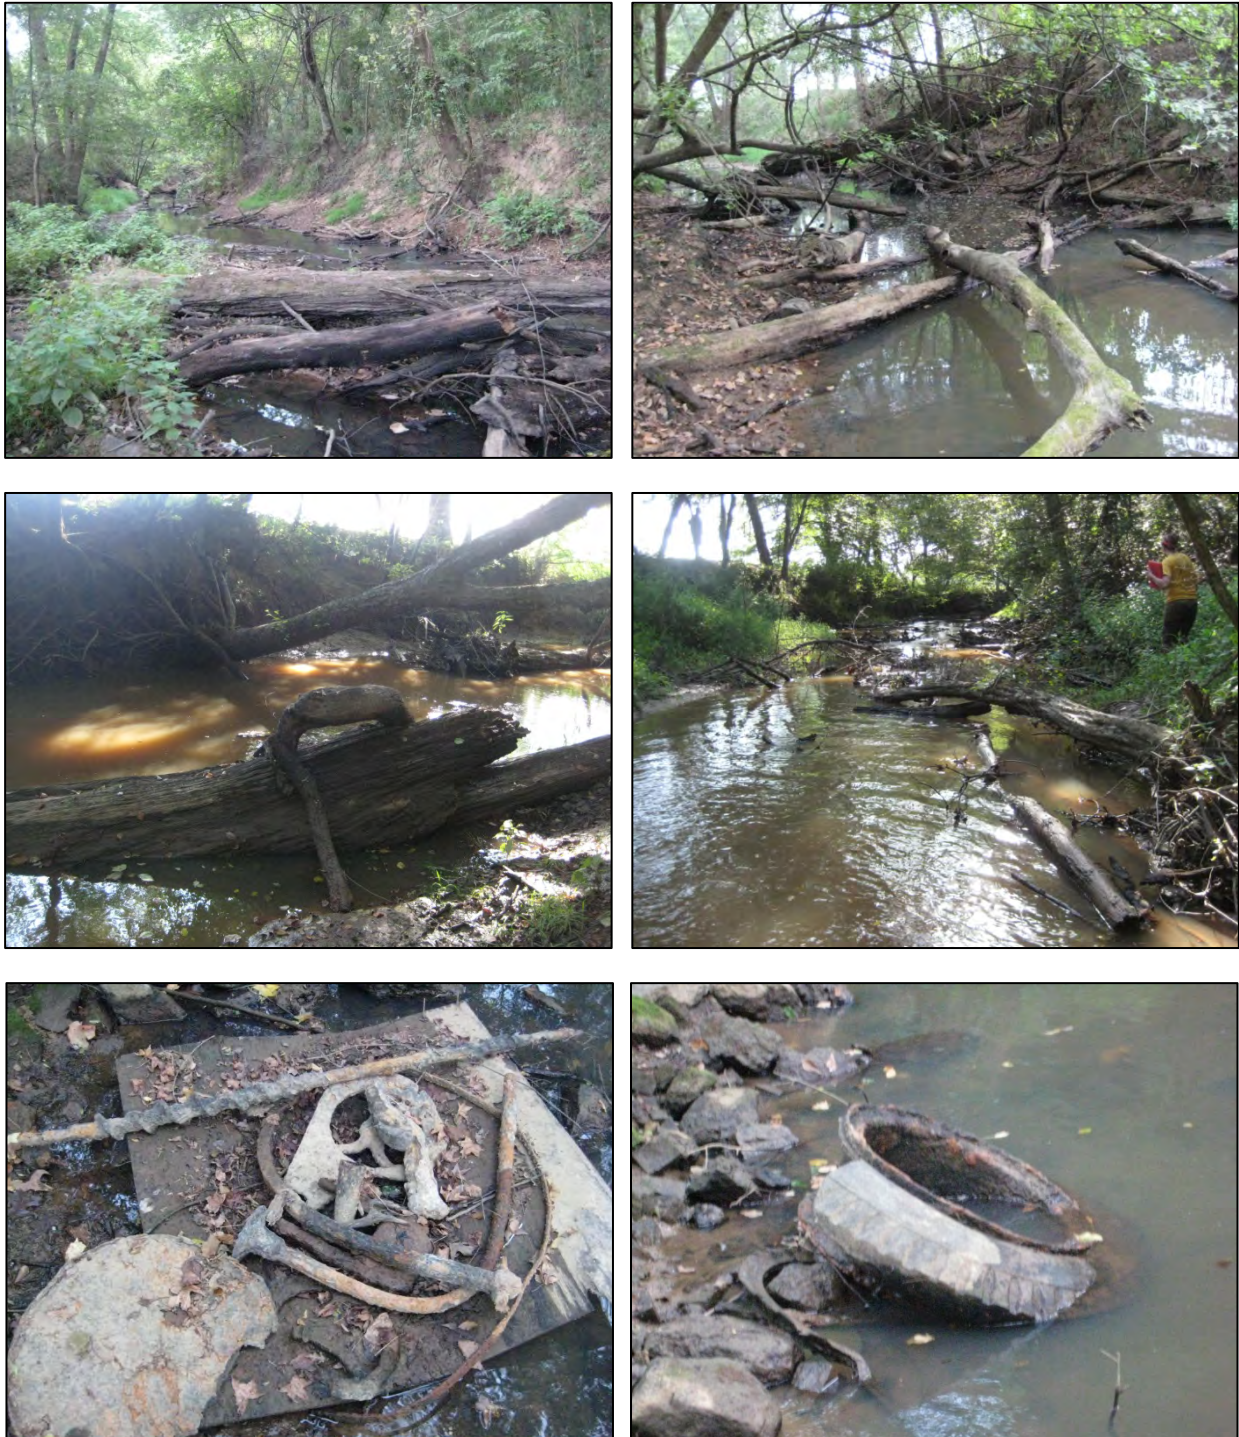
Photogroup 4-30 Naconiche 11 depicting water surface characteristics. All individuals featured are SFASU and CES staff. Top left: 150-m transect, downstream, August 2012; Top right: Large woody debris across/within channel, August 2012; Middle left: Large woody debris, July 2012; Middle right: Large woody debris, July 2012; Bottom left: Large channel litter (various metal objects), August 2012; Bottom right: Large channel litter (tire with metal rim), August 2012.

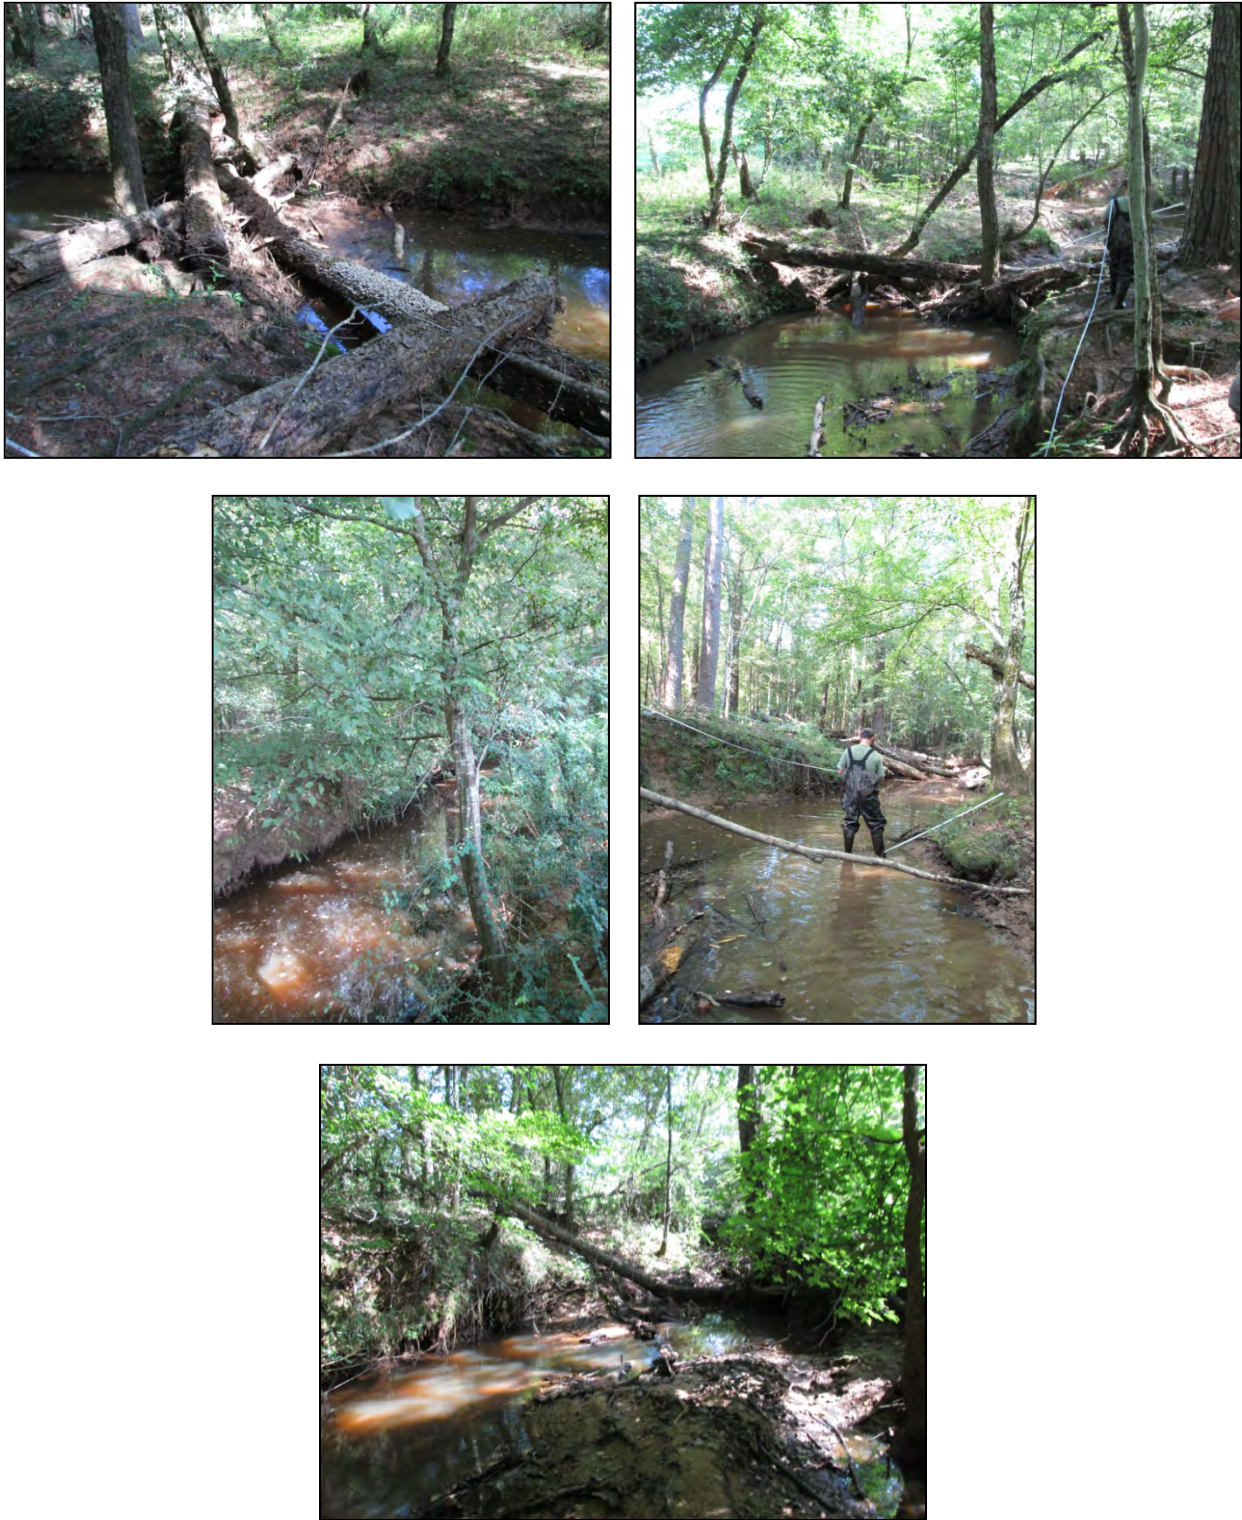
Photogroup 4-32 Terrapin 2 depicting water surface characteristics. All individuals featured are SFASU and CES staff. Top left: Logjam with foam, July 2012; Top right: Logjam within channel, July 2012; Middle left: 150-m transect, upstream, August 2012; Middle right: 150-m transect, downstream, July 2012; Bottom: 300-m transect, upstream, July 2012.

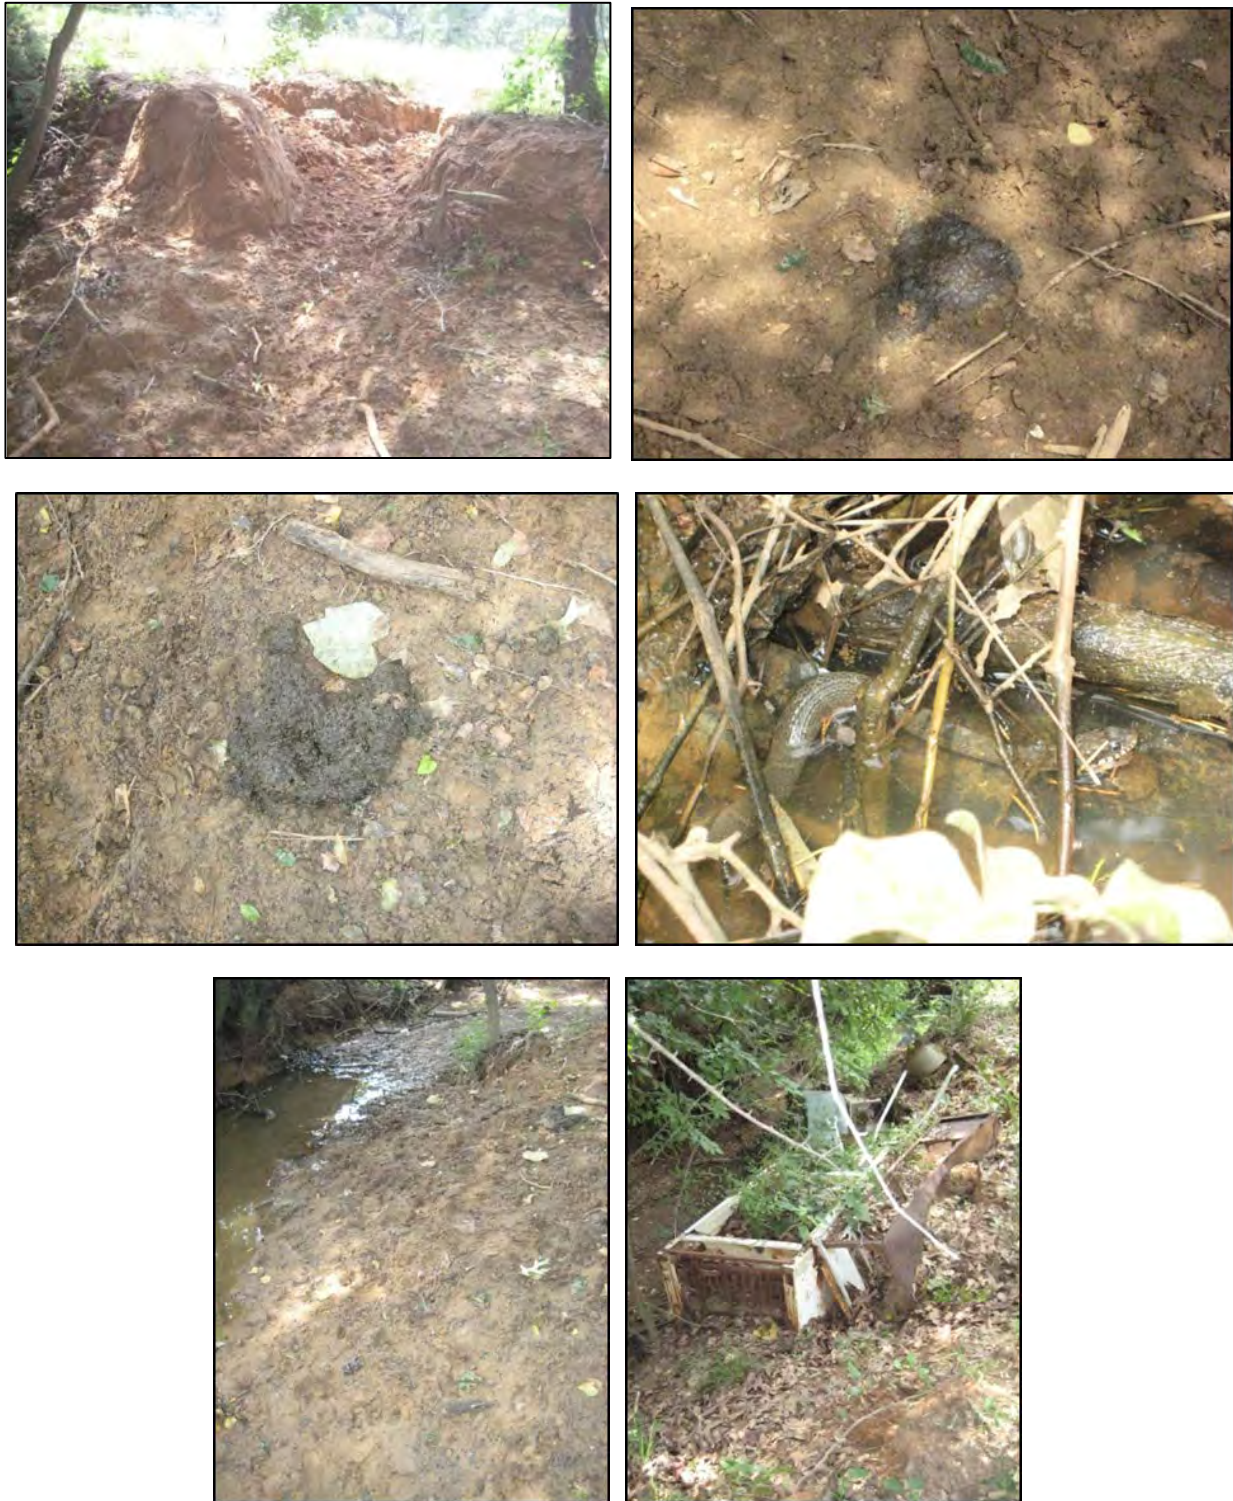
Photogroup 4-35 Waffelow 1 depicting water surface characteristics and potential sources of contamination. Top left: Livestock access point, July 2012; Top right: Livestock fecal in portion of dry stream channel, July 2012; Middle left: Livestock fecal on bank, July 2012; Middle right: Water snake at CR 1878 access point, July 2012; Bottom left: Livestock bank use, July 2012; Bottom right: Large bank litter (refrigerator), July 2012.

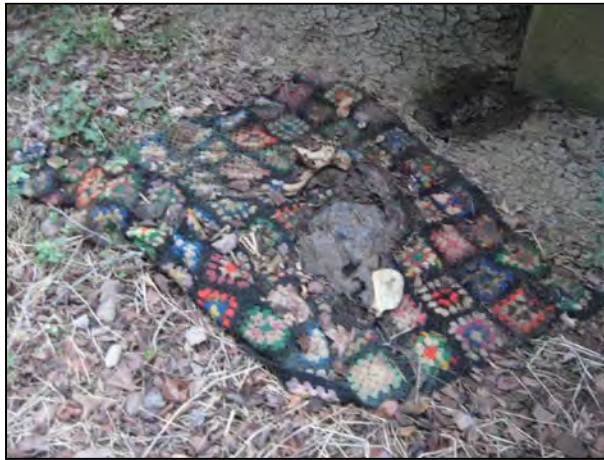
Photogroup 5-1 Attoyac 4 depicting crocheted afghan with unidentified animal carcass lying along the stream bank next to FM 1971 bridge crossing.
