# **Evaluation of canal lining projects in the Lower Rio Grande Valley of Texas**

Texas Water Resources Institute TR-465 September 2014

### **2013 Rating and Analysis**

September 1, 2014

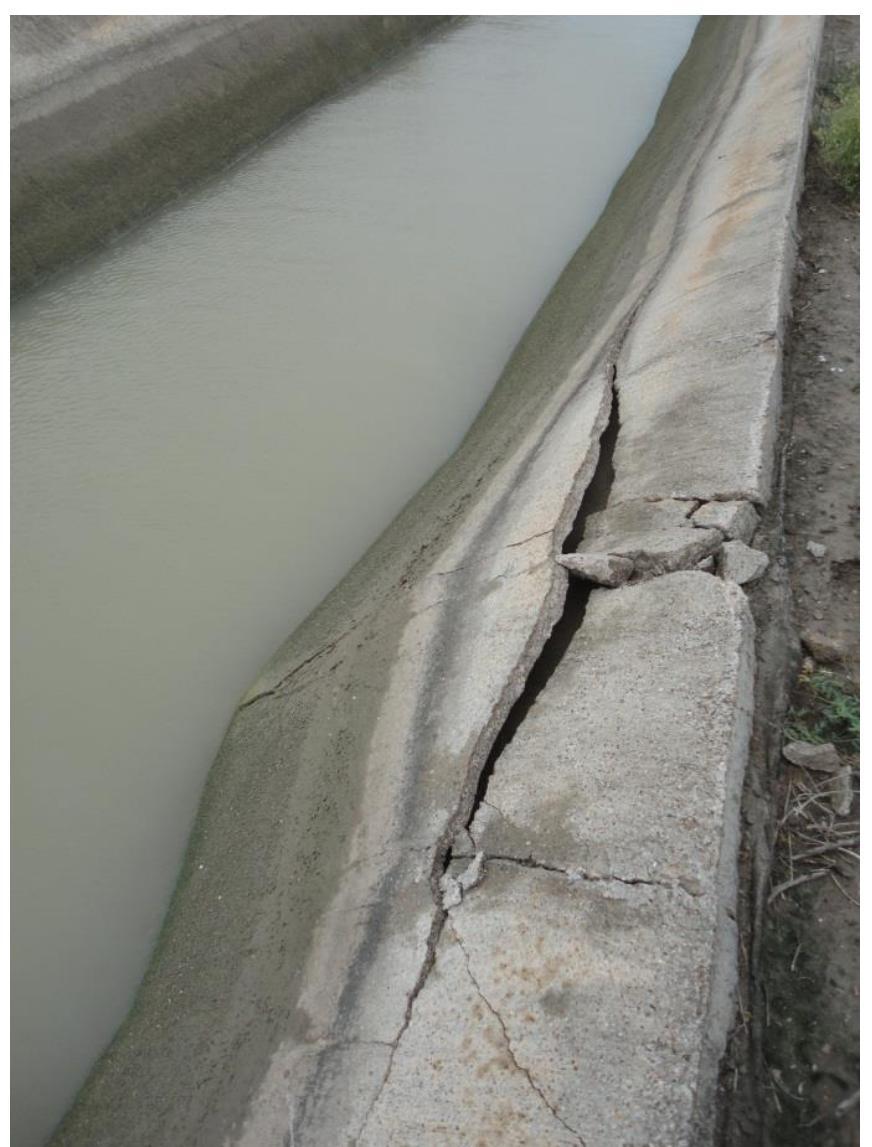
All six (6) projects are still in Good or Excellent condition after 5 to 10 years and have required little maintenance. No difference in performance was observed between the two types of synthetic liners used under the shotcrete. Water infiltrating behind the liner where not properly anchored has resulted in buckles (Fig. 10). Most buckles were found in the eastern section of Project No.5. Although we did not find any evidence of damages on the synthetic liner underneath buckles, more data should be collect on this regard. Other observed damages are erosion under the synthetic liner caused by insufficient free-board, and horizontal cracks found especially close to work zones. Figure 11 shows horizontal cracking likely caused by the heavy machines working next to the southern bank of project No. 5.

Figure 10. A buckle on the shotcrete protective barrier overlaid on polyester (Project No.5)

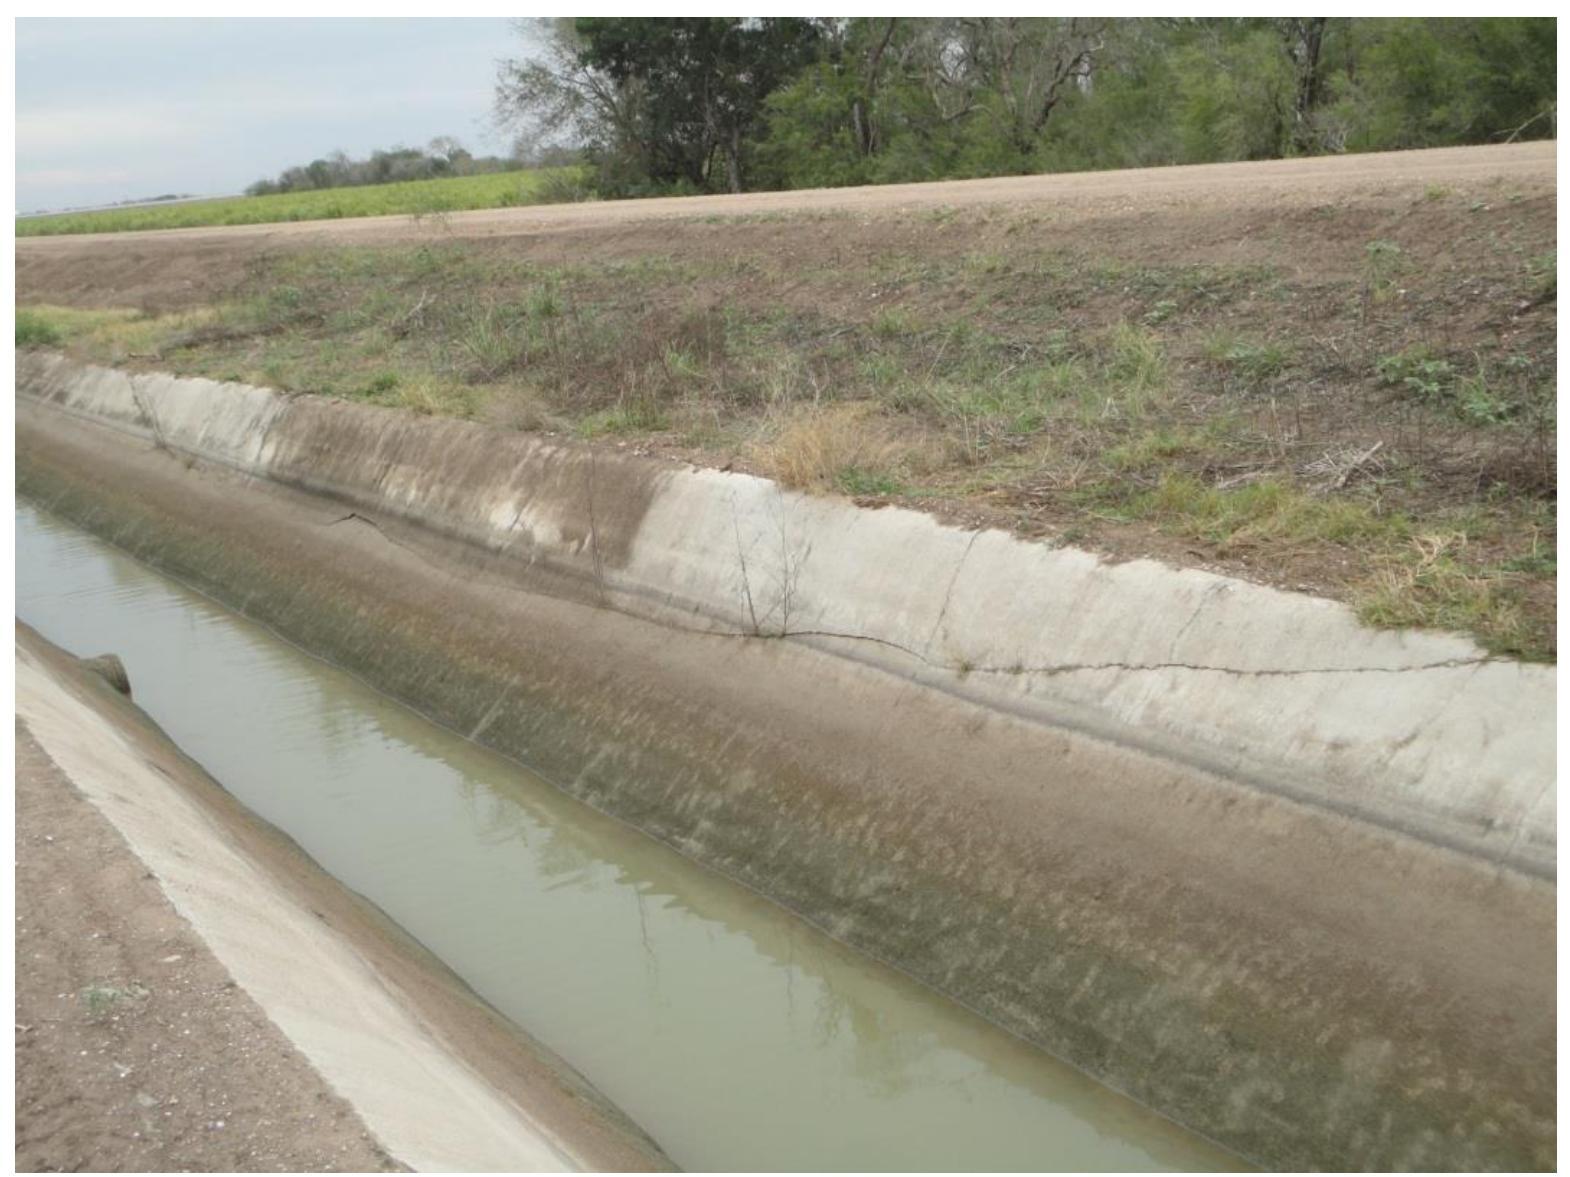
Figure 11. Horizontal hairline crack on the shotcrete protective barrier, likely caused by heavy machines working next to the southern bank of Project No. 5

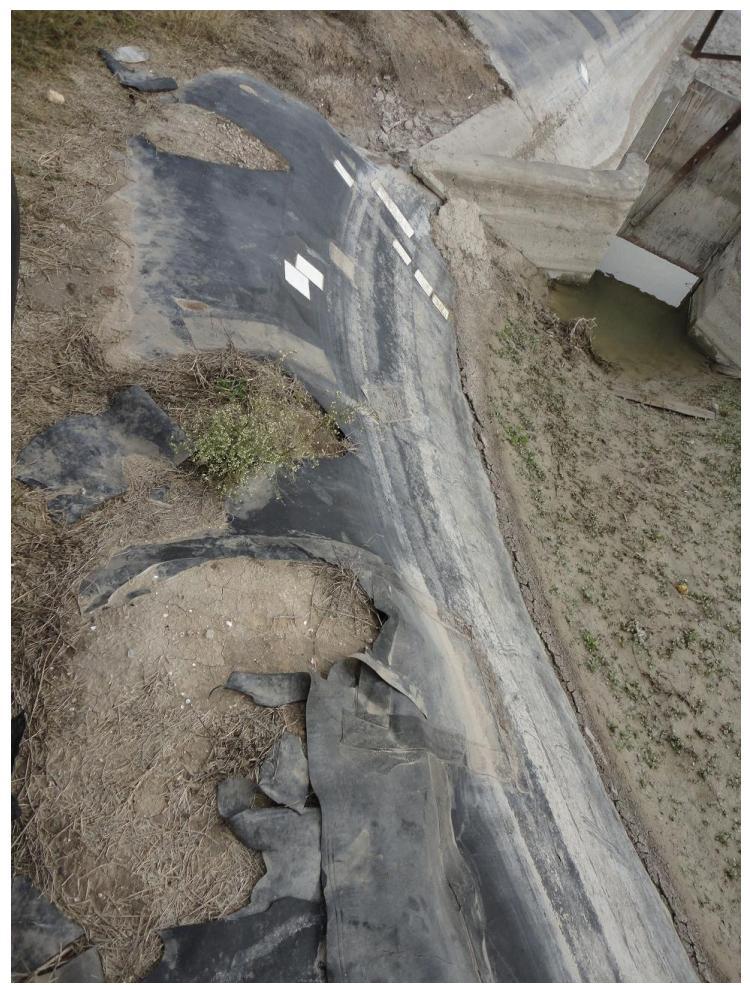
Figure 12. Damage on the anchor likely caused by district mowers.

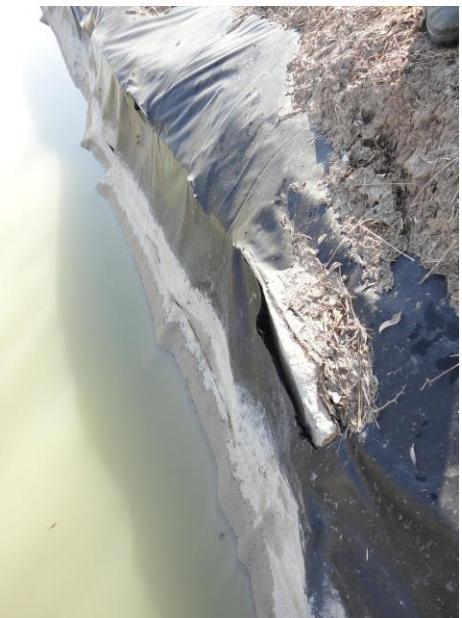
The two polypropylene projects are rated as *Excellent* and *Serious Problems*. Project No.4 is in *Excellent* condition after ten (10) years, with no visual problems, except for the last few linear feet where the concrete canal section has collapsed. Project No.9 (9-years old) was rated as *Serious Problems* due to extensive damage caused by collapsing wall, very sharp-edged canal concrete sections, and vandalism (Fig. 13 and 14). Damaged parts of this project were removed, and the rest is still in good conditions (Fig. 15)

Figure 13. Collapsing and very sharp-edged canal concrete sections (Project No. 9)

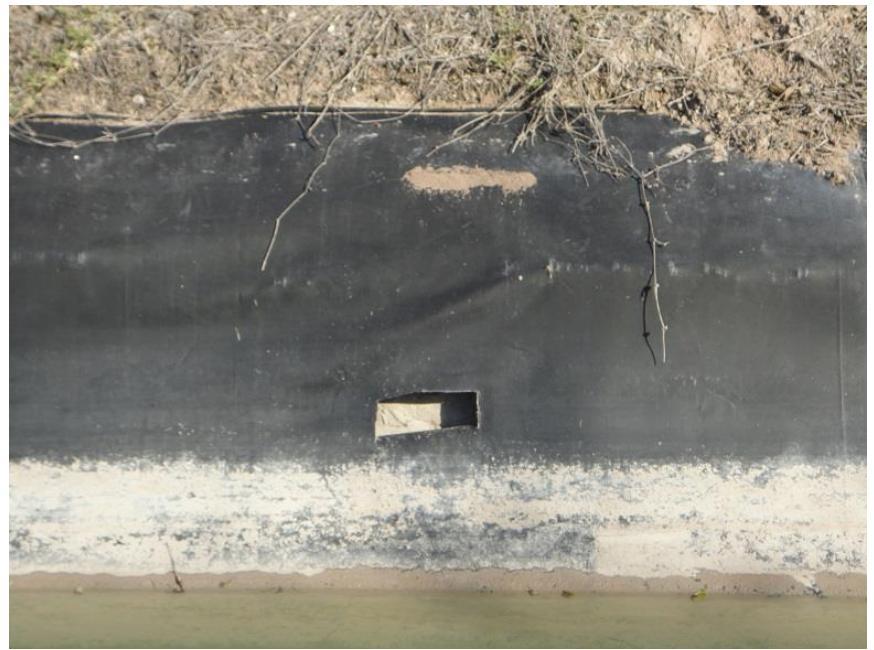
Figure 14. Damage caused by vandalism (Project No. 9)

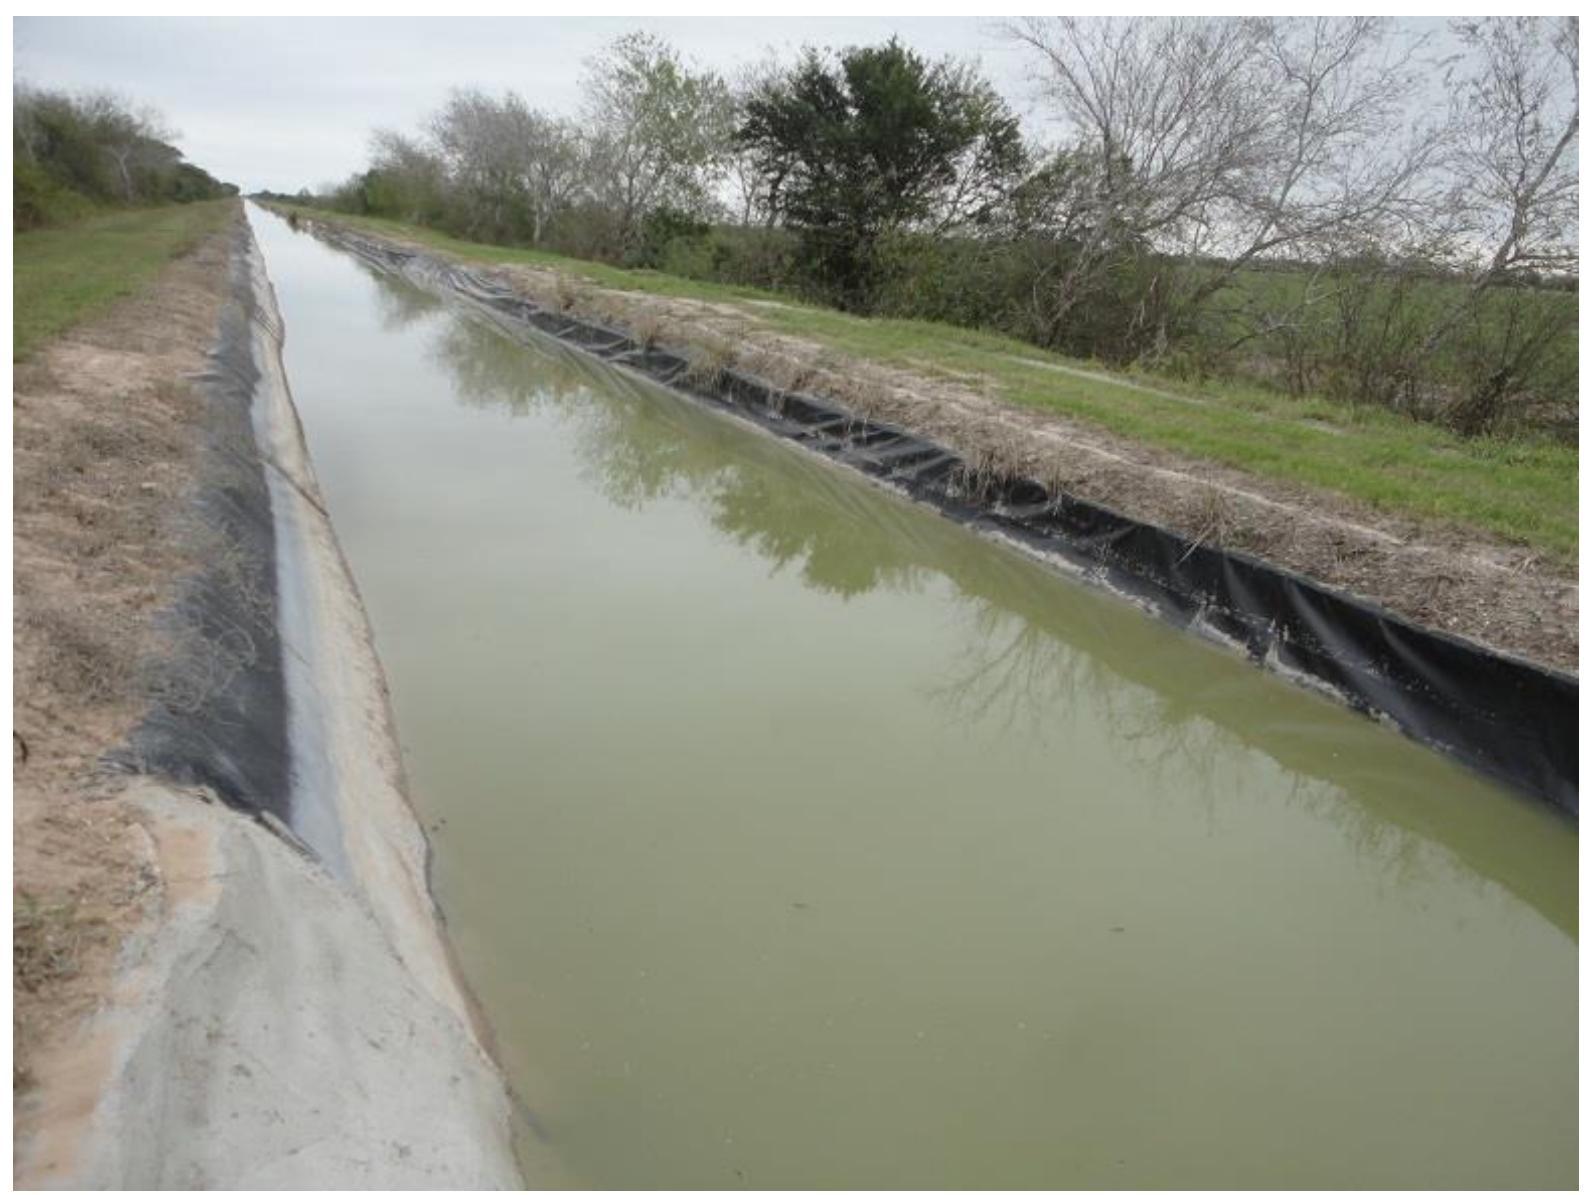
Figure 15. Portion of Project No. 9 in good conditions

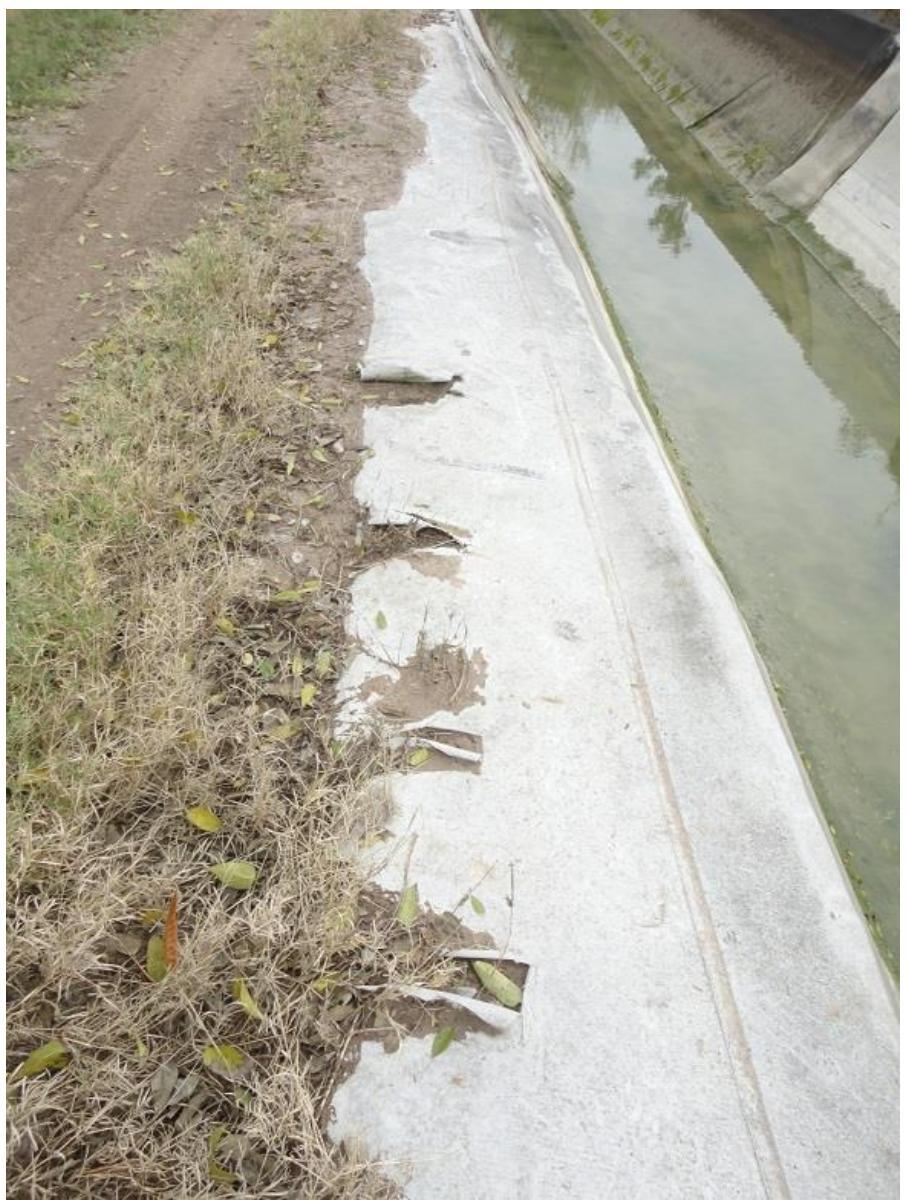
Of the three (3) 15-years old PVC Alloy projects, one was rated *Good* (No. 22), one *Fair* (No.16) and one *Serious Problems* (No.24). This material has shrinking problems but is pretty resistant, and tears do not expand easily (Fig. 16). Performance was therefore overall good, excluding Project No.24 were extensive damage has occurred due to nearby road construction activity. We noticed some new scattered natural degradation of the material, which should probably be repaired and monitored to prevent more serious damage.

Figure 16. Damage caused by maintenance (Project No. 22)

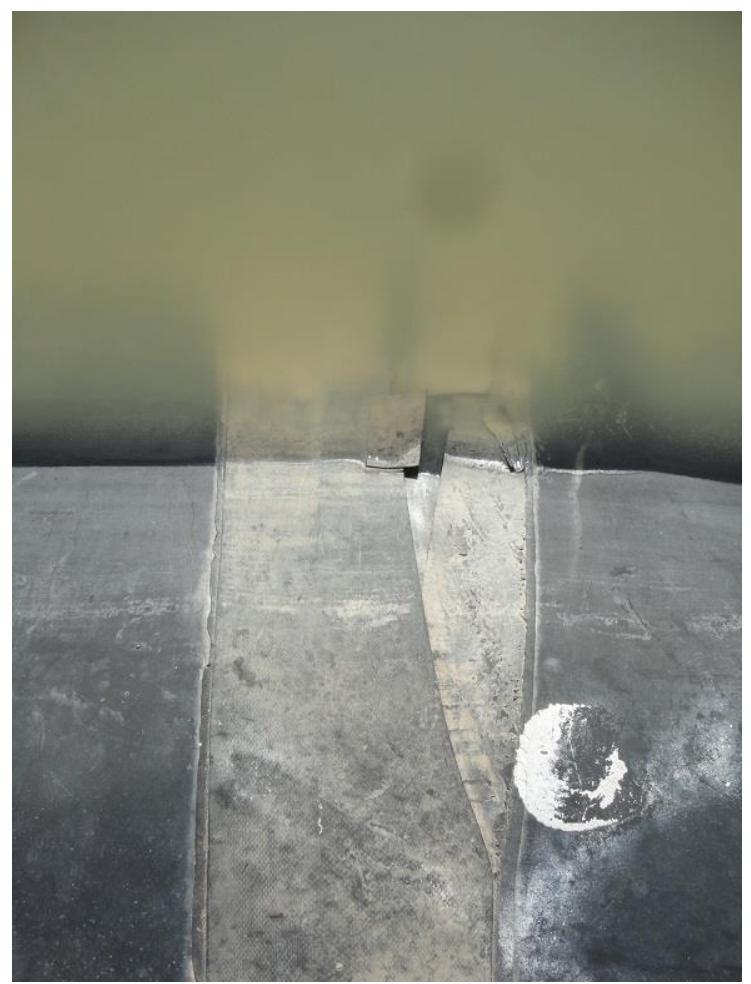
Figure 17. Shrinking of the rubber causing a seam to open (Project No. 7)

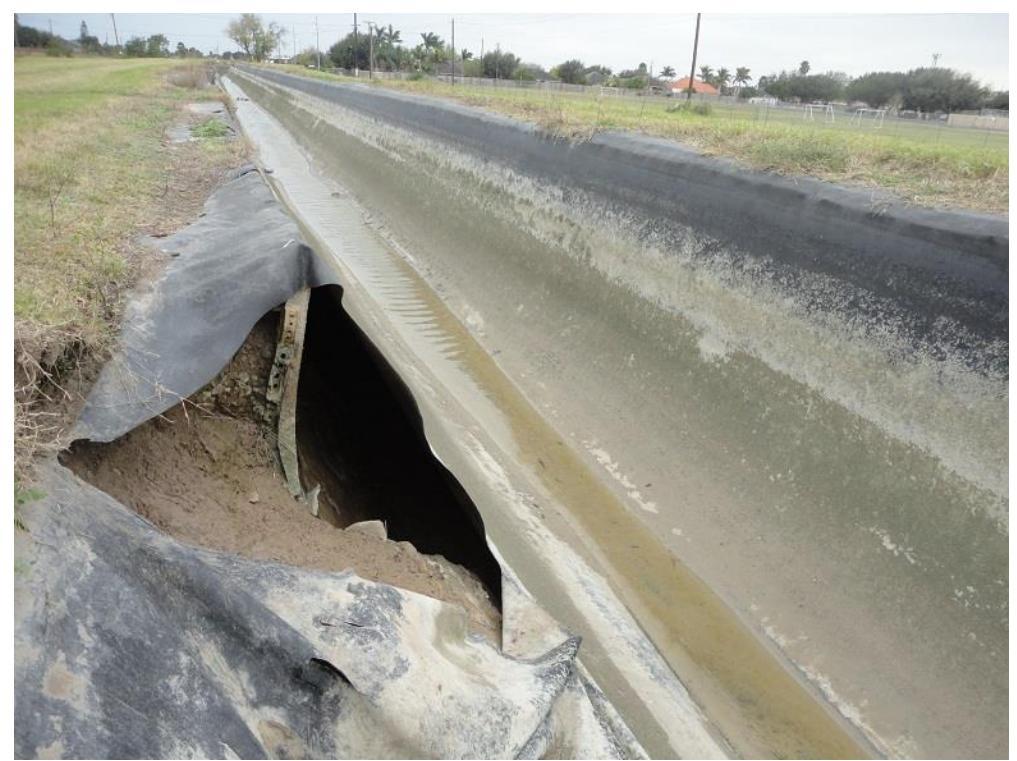
Figure 18. Large spacing between liner and canal sides due to shrinking of rubber, visible through a large cut (Project No. 13)

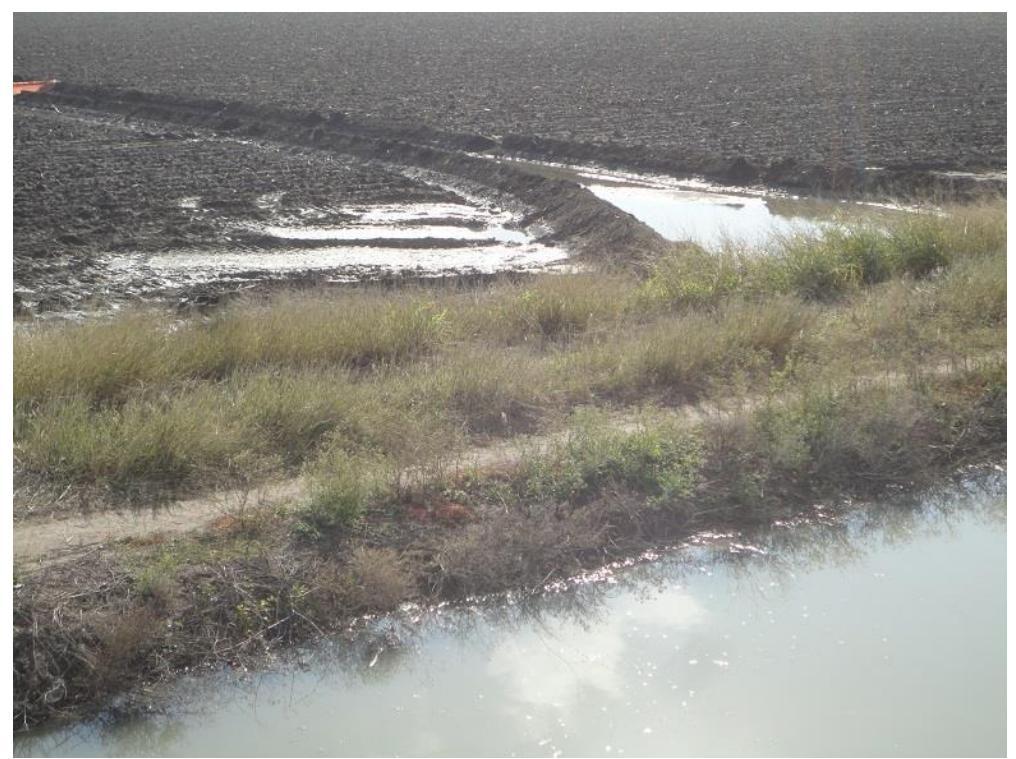
Figure 19. Water level above anchor (Project No. 7)

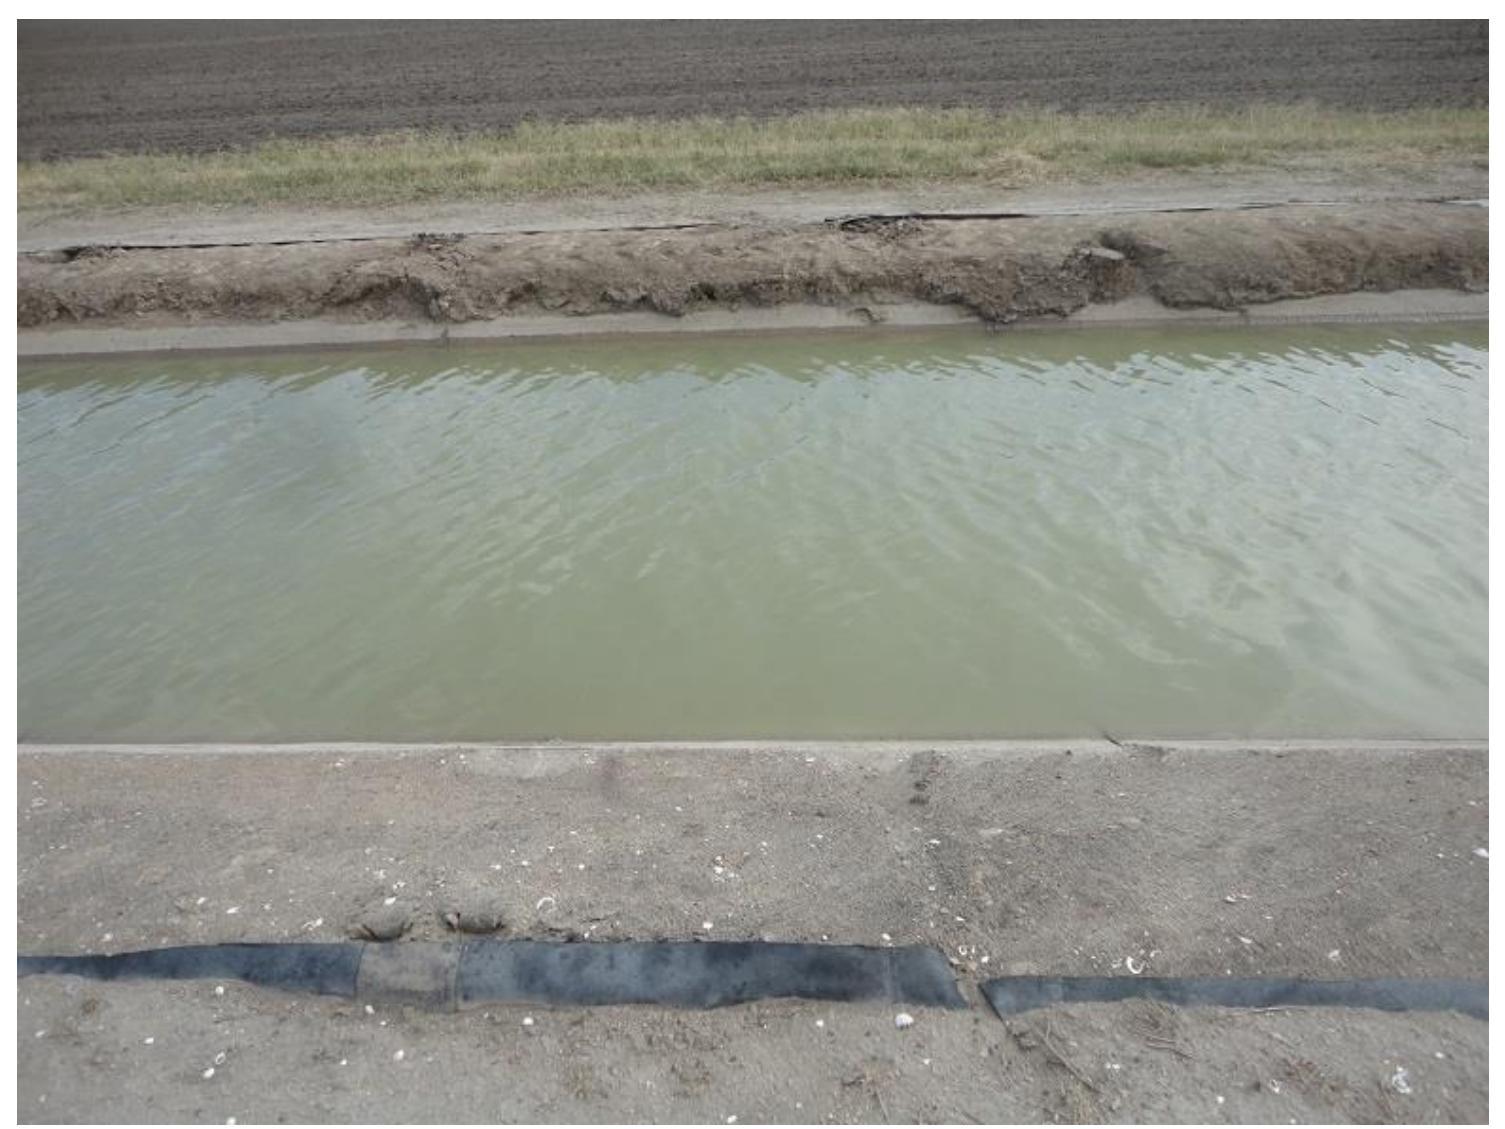
Figure 20. Uneven material underneath the liner in the anchor of a removed section (Project No. 7)

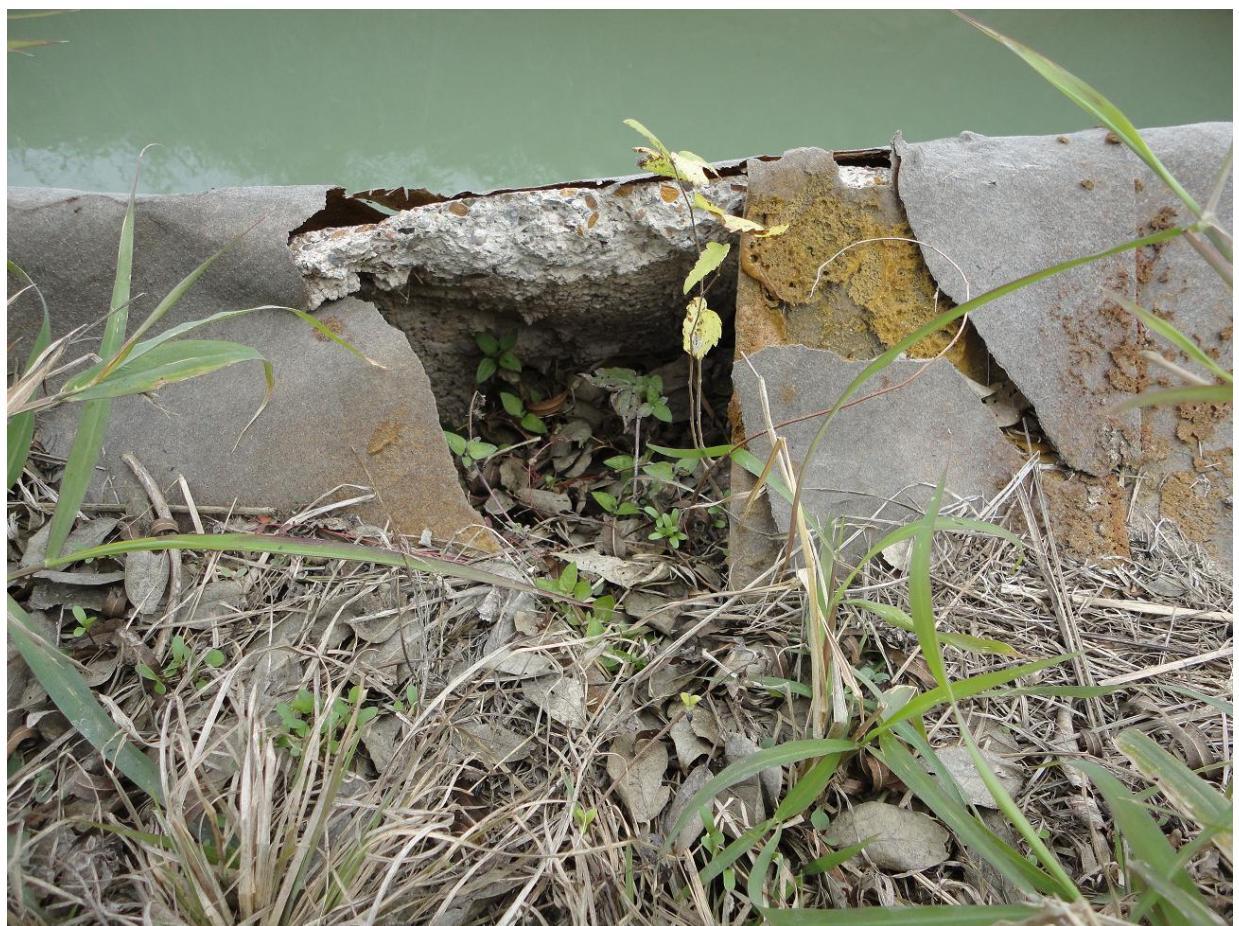
We found many cuts and holes, and large portions collapsed because of sharp edges of anchor, farm and district traffic, and inconsistency of product thickness (Fig. 21 and 22). In some segments the top layer of the material has only peeled off, or damage is limited to the anchor, with a minor effect on performance (Fig. 23).

Figure 21. Damage caused by the sharp edge of concrete underneath the liner

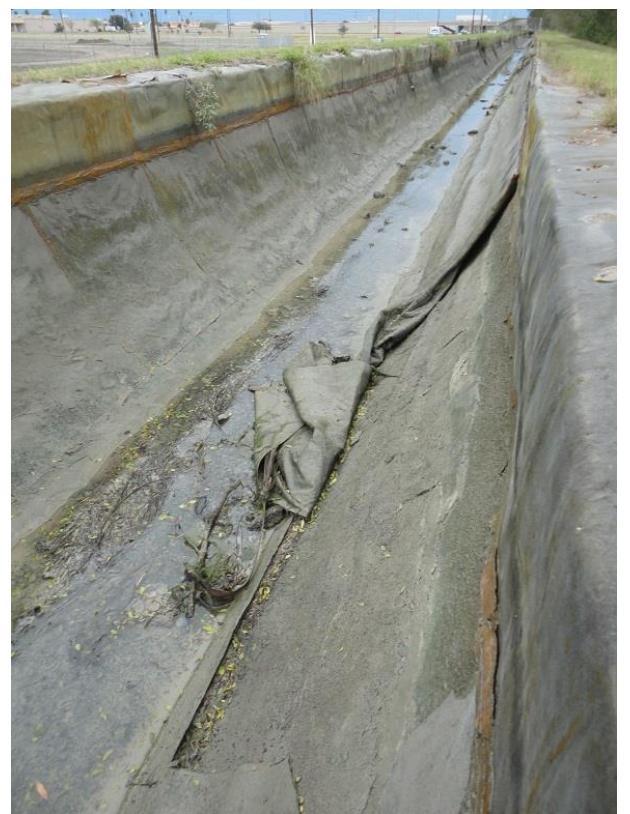
Figure 22. Polyurethane liner hanging off the canal side

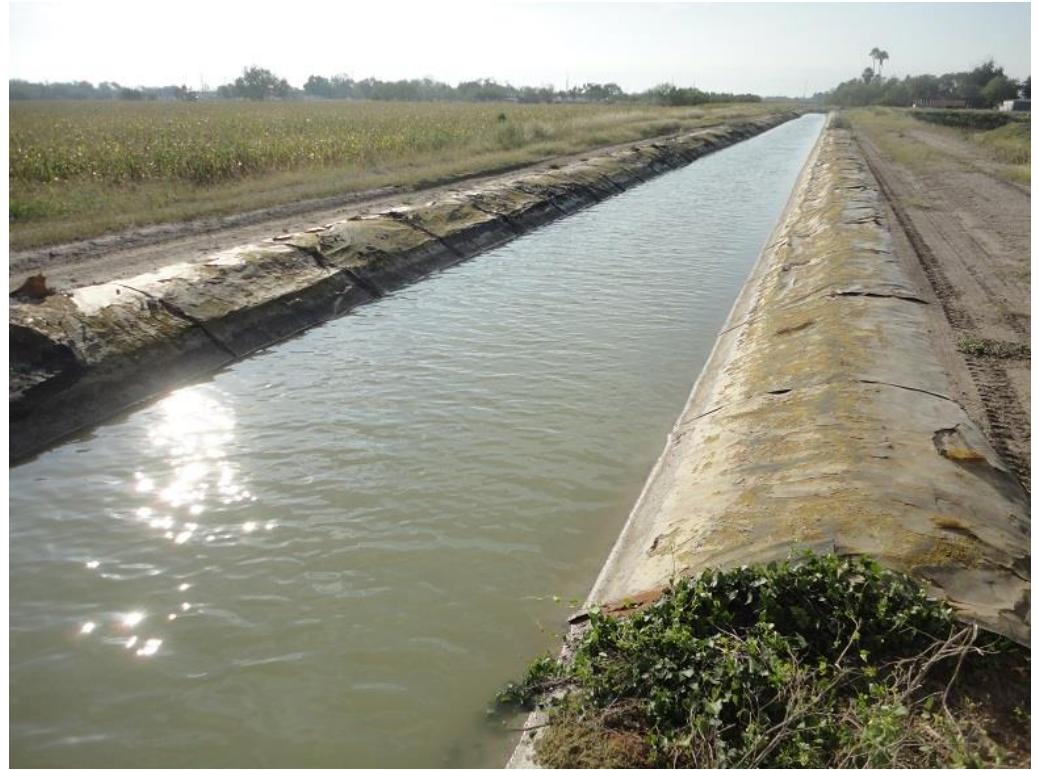
Figure 23. Polyurethane liner peeling off in the anchor

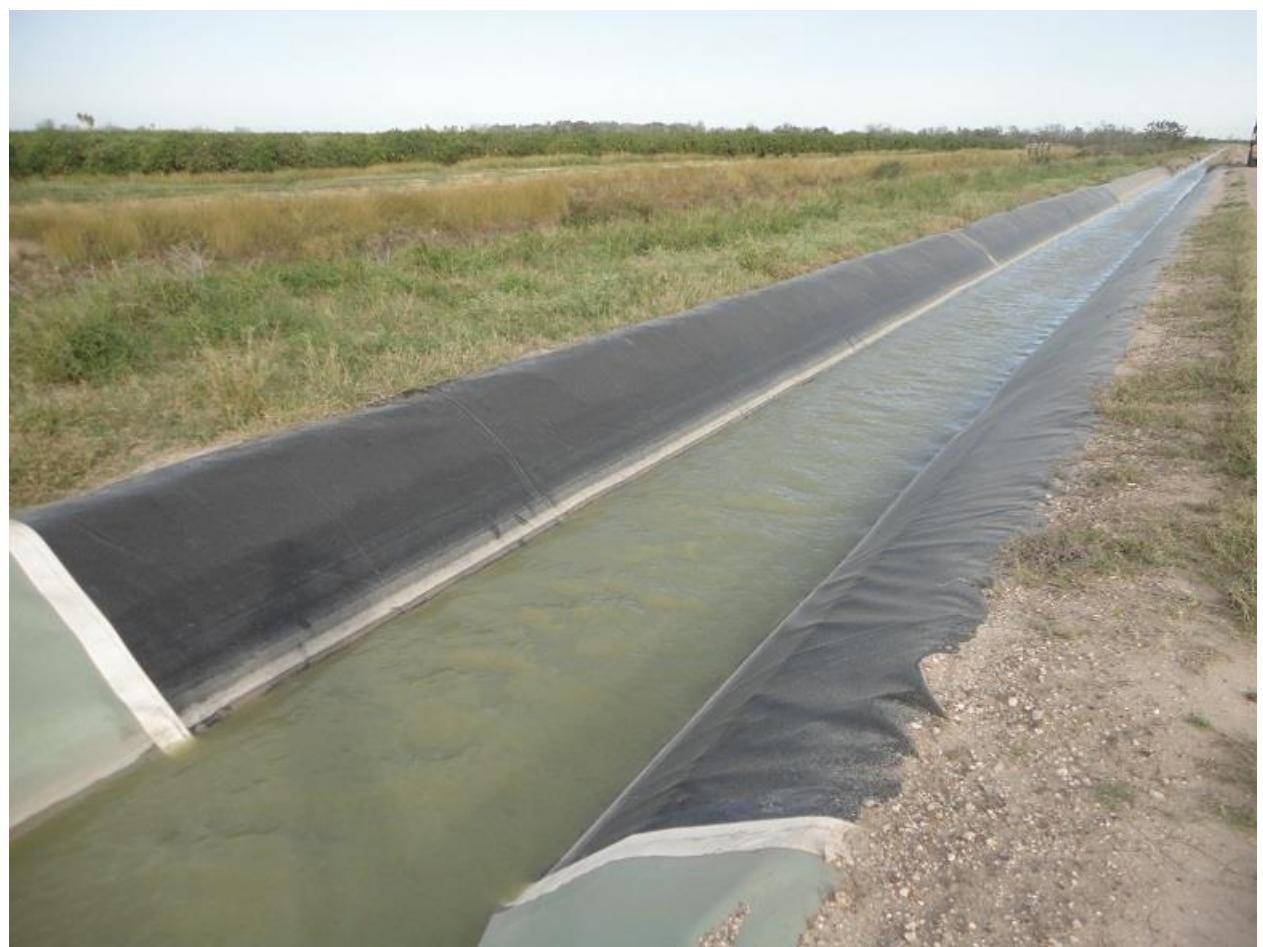
All three projects that were donated by Firestone Inc. to improve their rubber products poor performances have been rated *Excellent* (Fig. 24). Out of all tested products, this is the only one that has shown no decline in average performances at the fifth  $(5^{th})$  year of testing. The material underneath looks even and smooth, there is no significant shrinking, and vandalism is not a problem in this area.

Figure 24. Reinforced FPP-R in excellent condition after 5 years

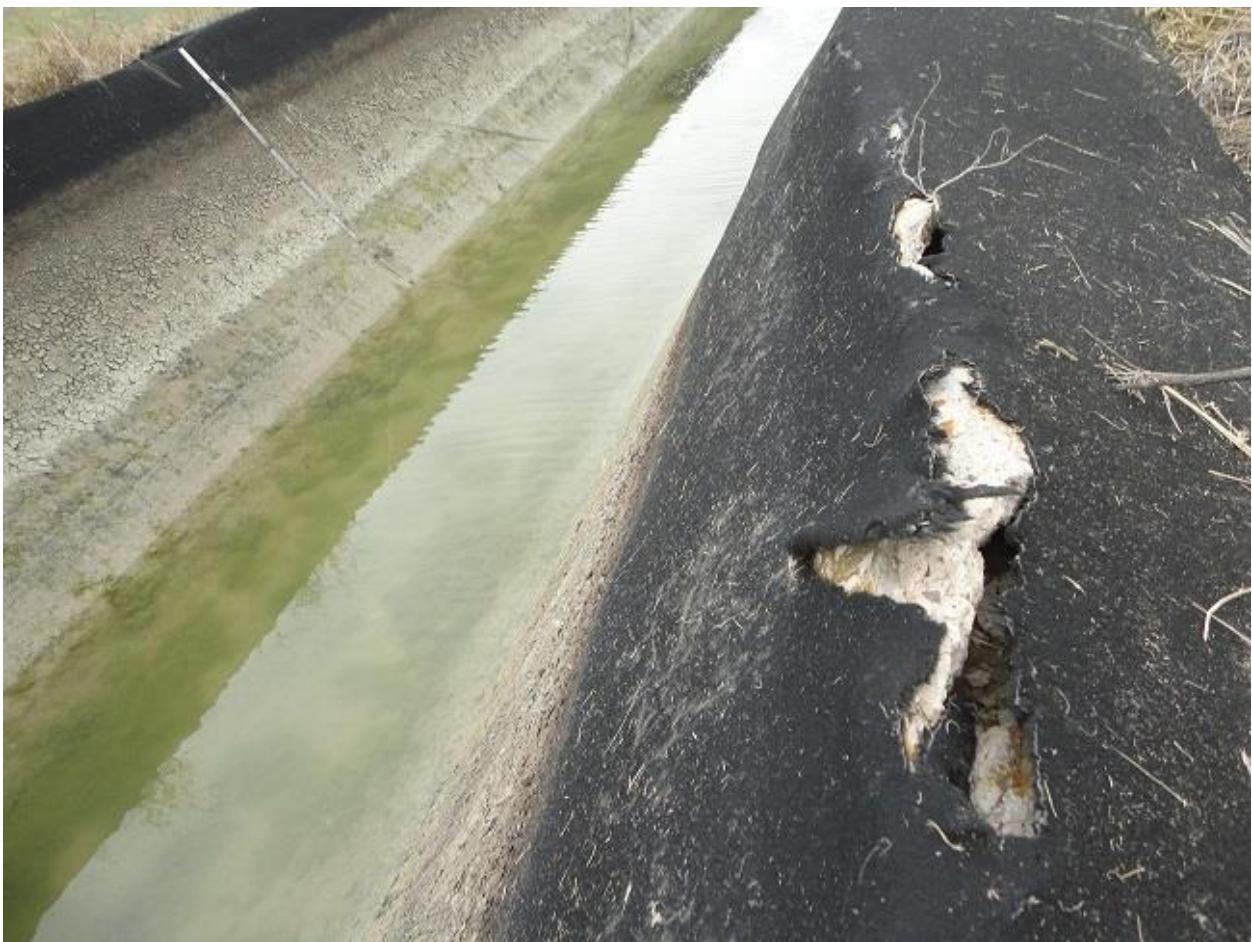
In 2012 HCID1 installed a new material (Multi-layer Polyethylene) in place of some Polyurethane and EPDM Rubber projects that were removed. The main advantage of this material is that is difficult to tear after cut, and therefore is less affected by vandalism, and that is easy to install. Ratings in 2013 ranged from *Good* to *Excellent*. Some damage was found on the anchor, which was caused by sharp edges of the concrete underneath the liner, and district mowers (Fig. 25). Additionally, some little holes might have been caused by ants. No damage has extended to the canal wetted area.

Figure 25. Multi-layer Polyethylene cut due to sharp and collapsing anchor
