Basin Approach to Address Bacterial Impairments in Basins 15, 16, and 17

Texas Water Resources Institute TR-462
August 2014

Year One Report

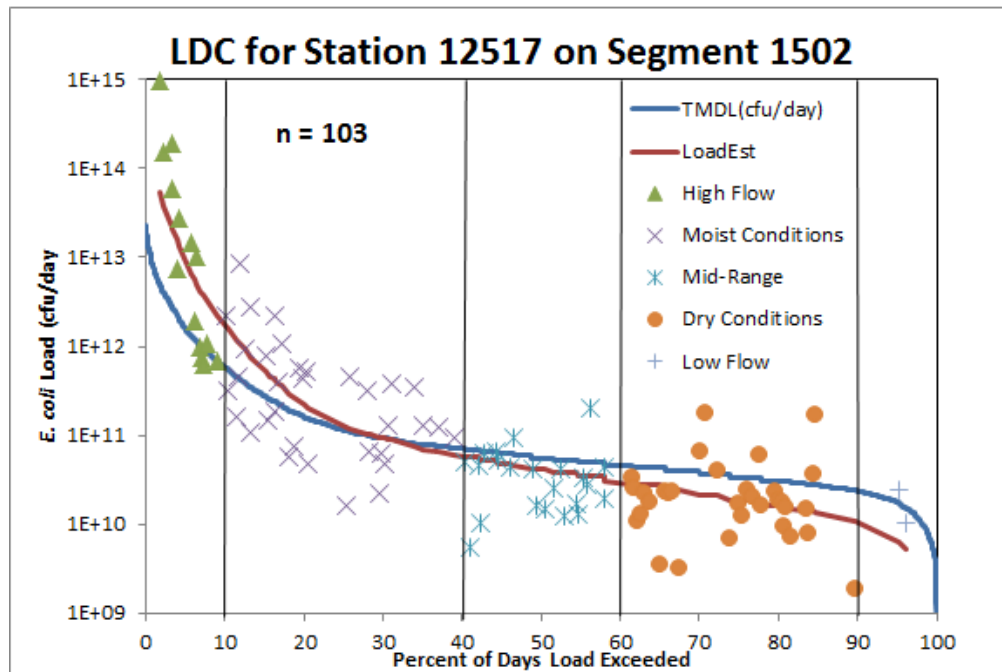
Figure 6. LDC for Station 12517 using all available *E. coli* data (1999 – 2013)

Station 12517 on Tres Palacios Creek at FM 456 had the most extensive data record available for developing LDCs; however, it is not located within an impaired portion of the creek. In total, 103 *E. coli* data points existed that also had stream flow rates associated with them. Additionally, USGS gage 08162600 is also located at this site. Daily mean flow values were acquired from the past 15 years and used to develop the LDC. The inclusion of this USGS data produces an extremely accurate record of flow and estimation of the TMDL for this site. The LDC revealed that the bulk of *E. coli* loadings occurring above the allowable level occurred during high flows and moist conditions suggesting that nonpoint source pollution and/or sediment resuspension within the channel are the primary pollutant sources. Under mid-range, dry and low flow conditions, *E. coli* loads are typically within allowable levels suggesting that point sources and direct depositions to the water body are not overly problematic. That said, exceedances do exist within all flow categories.

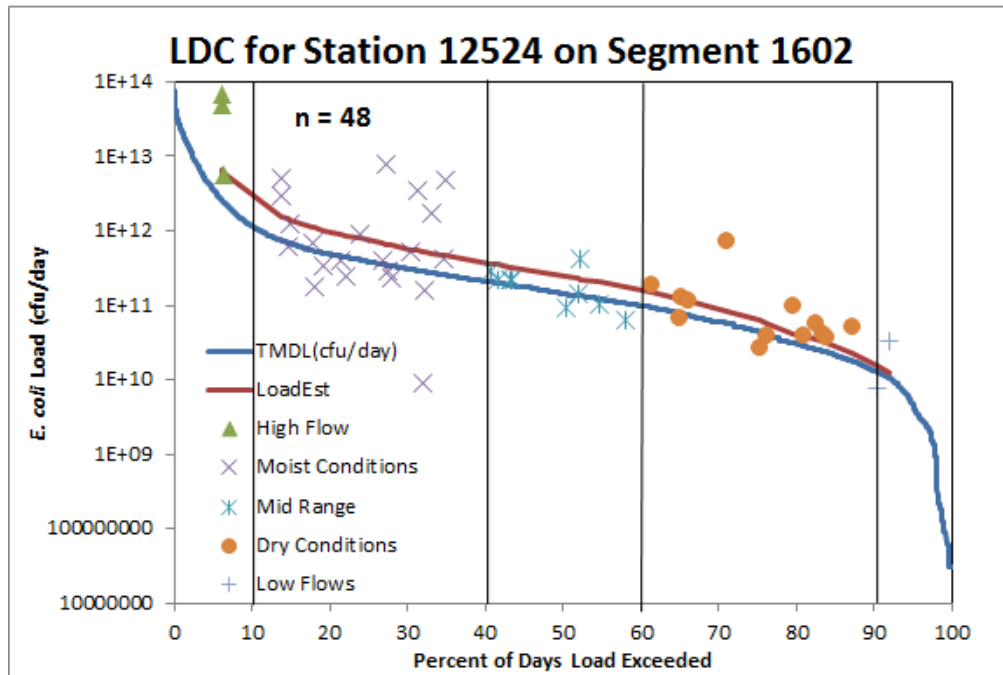
Figure 7. LDC for Station 12524 using all available *E. coli* data (2001 – 2013)

Station 12524 on the Lavaca River at US 59 had a total of 48 *E. coli* data points with associated stream flow data. USGS gage 08164000 is also located at this site and produced a total of 5,714 daily mean flow values were acquired and used to develop the LDC thus yielding an accurate flow record and approximation of the TMDL for this site. The LDC revealed that the *E. coli* loadings were approximately evenly distributed above the allowable level during all flow conditions. This suggests that nonpoint source pollution and/or sediment resuspension within the channel as well as point sources and direct depositions to the water body are all contributors to the overall pollutant load at this site.

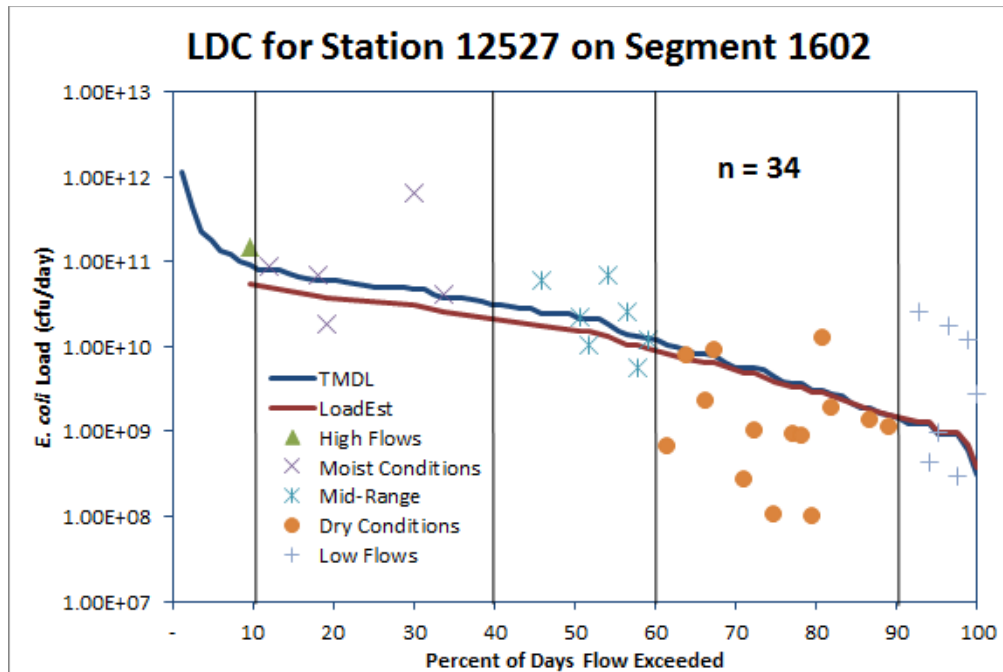
Figure 9. LDC for Station 12527 using all available *E. coli* data (2004 – 2013)

Station 12527 on the Lavaca River at US 77 had 34 *E. coli* data points with associated stream flow data available. An additional 49 stream flow readings were also available and were used to enhance the FDC. Under high, moist and mid-range flow conditions, the LDC illustrated that *E. coli* loadings were distributed almost evenly around the allowable level. The load regression calculated for these flow categories is lower than the allowable load suggesting no needed *E. coli* reduction to meet applicable standards; however, the

plotted data indicate that the actual load may be closer to the TMDL line plotted below. Therefore, nonpoint source pollution and/or sediment resuspension within the channel can be considered somewhat problematic under these flow conditions. During dry conditions, measured *E. coli* loads are largely within allowable levels except for loads measured under low flows are the opposite. This suggests that point sources and/or direct *E. coli* deposition could be problematic at this site. The quantity of data available at this site is quite limited though, especially under higher flow conditions, thus decreasing confidence in these results.
