Basin Approach to Address Bacterial Impairments in the Navasota River Watershed

Texas Water Resources Institute TR-476
May 2015

Year One Report

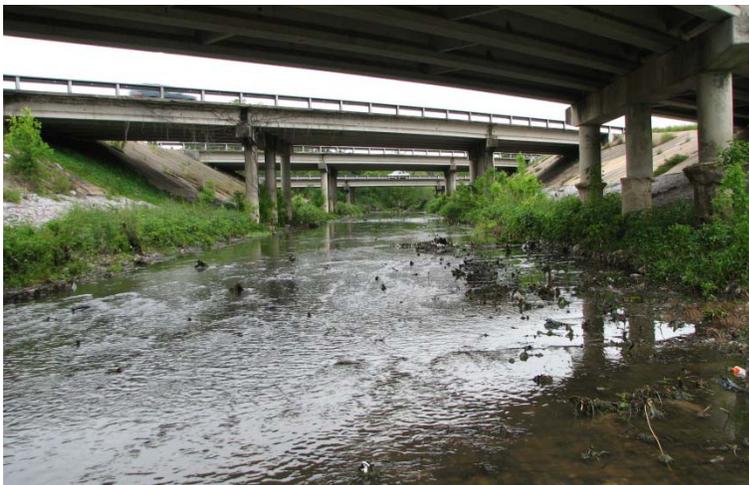
Burton Creek (1209L), downstream of the Burton Creek Wastewater Treatment Plant. This urban stream now maintains flow year-round due to inputs from the plant.

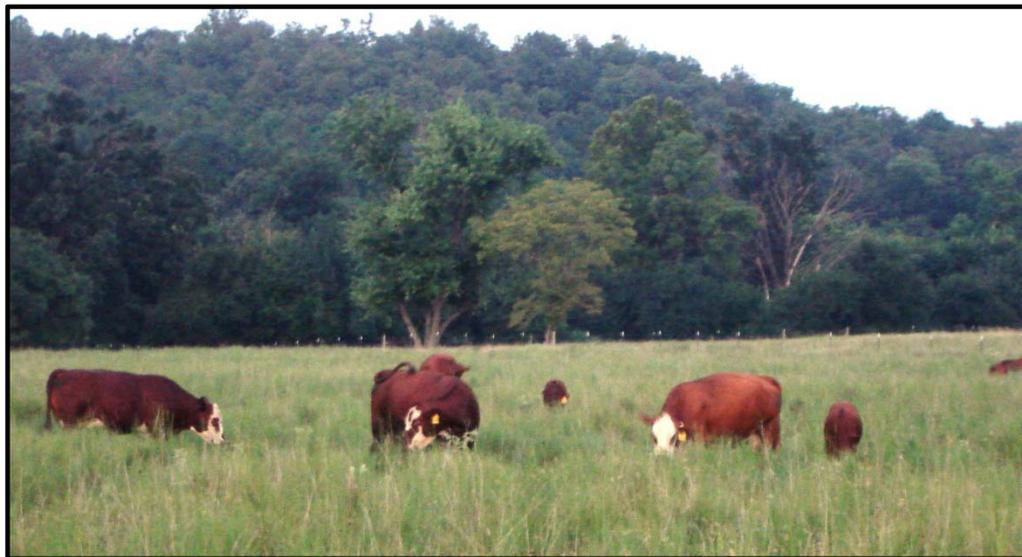
Prescribed grazing planned through WQMPs include utilizing proper stocking rates, cross fencing and a rotational grazing strategy to maximize forage production, improve cattle weight gain, and reduce input cost. The prescribed grazing also improves onsite water holding capacity and reduces the amount of runoff leaving the property.

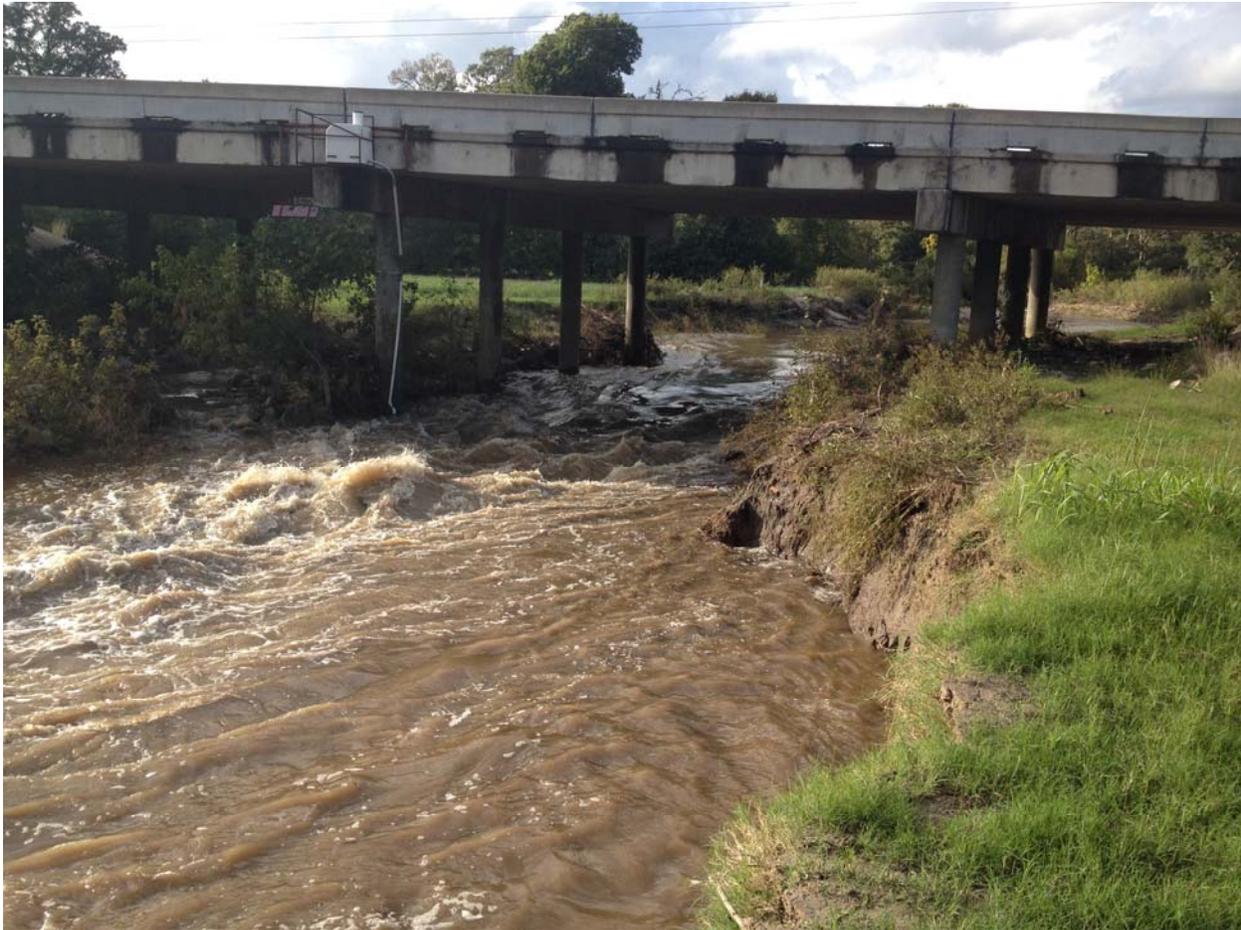
High flow event on Carters Creek at WM D. Fitch Pkwy (Station 21259) in October 2013. Events such as this have caused severe erosion at this site as is evidenced by the near vertical creek bank on the right side of the photo.
