Carters Creek Total Maximum Daily Load Implementation Project

Watershed Source Survey and GIS Mapping: Task 3

Texas Water Resources Institute TR-484
January 2016

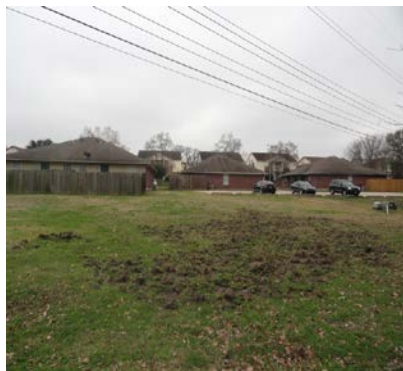
Feral hog rooting near neighborhood and creek

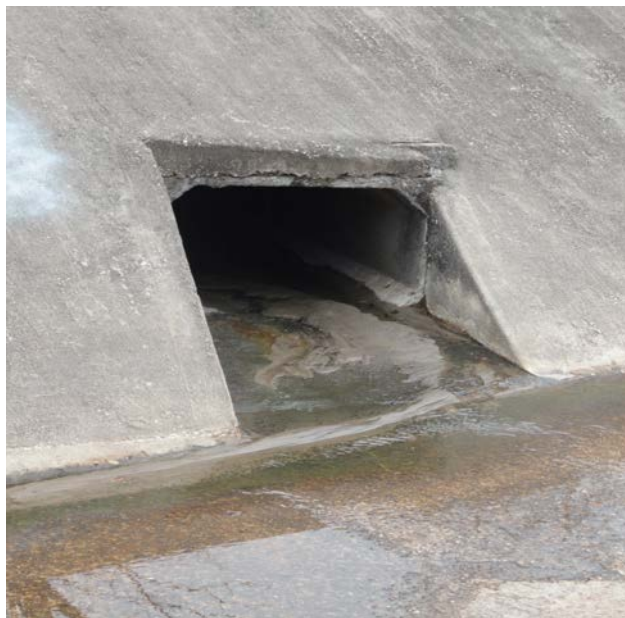
Stormwater inherently contains elevated *E. coli* concentrations; however, storm drains can also contribute water to stream between runoff events. Excess landscape irrigation or illicit connections can occur and provide a relatively consistent source of water to stormwater infrastructure. In some cases, wastewater entering stormwater infrastructure has been identified as primary contributors of *E. coli* to receiving waters between storm events (Sercu et al. 2009; Ekklesia et al. 2015). Stormwater infrastructure also retains sediment known to harbor *E. coli*. Pipes that protect sediment from sunlight and decrease drying can promote prolonged *E. coli* survival and regrowth in sediment in some cases (Smith et al., 2008; Pachepsky et al. 2011). As a result, stormwater infrastructure should be considered as a potential source of *E. coli* contributions to watersheds during wet and dry conditions. Sediment in stormwater outfalls was noted in some locations and could be a potential *E. coli* reservoir in the watershed.

Sediment in Storm Drain Outlet

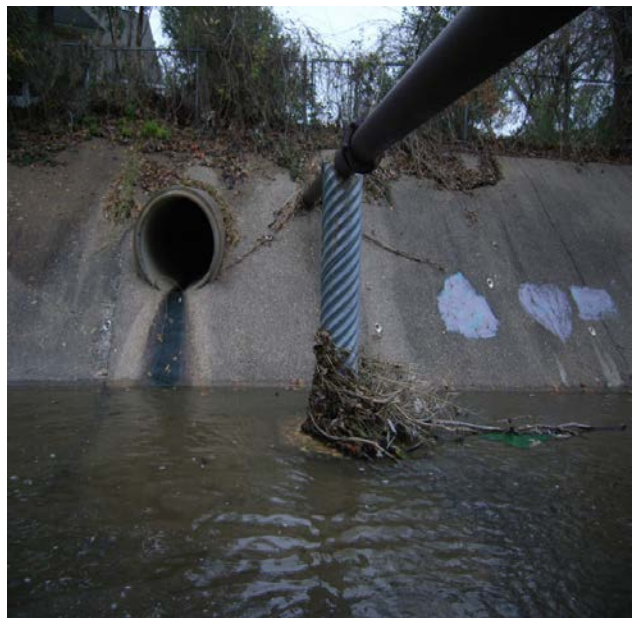
Storm Drain Outlet and Adjacent Wastewater Line
