# Characterization of Middle Yegua, Davidson and Deer Creeks Watersheds

Texas Water Resources Institute TR-523  
May 2020

Texas Water Resources Institute  
Texas A&M AgriLife  
College Station, TX  
Texas Water Resources Institute Technical Report-523

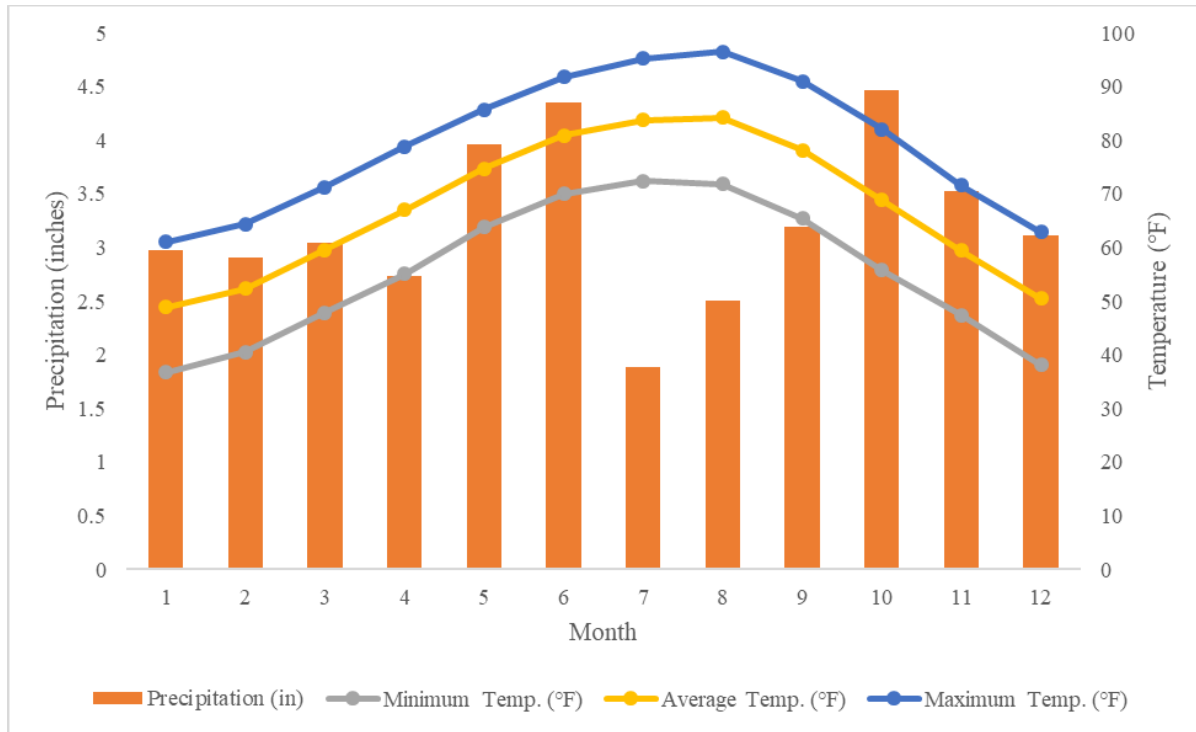
Figure 22. Monthly climate data, including precipitation, normal average, maximum and minimum air temperature, for Somerville Dam, Texas from 1981-2010 (NOAA 2016).

Therefore, the nearby Somerville Dam, Texas USC00418446 weather station (NOAA 2016) was used to determine the approximate precipitation and temperature data for the watershed (Figure 22). Monthly normal air temperature indicates daily mean air temperature was 67.4°F (NOAA 2016). Minimum average daily temperatures reached a low of 36.8°F in January. The maximum average daily temperature reached a peak of 96.5°F in August. Monthly normal precipitation, from the weather station, indicates that the area had a mean annual rainfall from 1981-2010 of 38.7 inches (NOAA 2016). Rainfall normally peaks in October (4.47 inches) with the lowest totals occurring in July (1.89 inches) (NOAA 2016). Average annual precipitation values across the study area from the PRISM Climate Group at Oregon State (2012) indicate average annual rainfall ranges from 36 to 40 inches per year across the watershed, with a clear East to West decreasing gradient (Figure 23).
