Characterizing the Middle Yegua, Davidson Creek and Deer Creek Watersheds Final Report

Texas Water Resources Institute TR-524
May 2020

Prepared for the Texas State Soil and Water Conservation Board
TSSWCB Project #18-52

Middle Yegua Creek, Davidson Creek and Deer Creek are all located in the southern portion of the Brazos River Basin in separate watersheds (Figure 1). Each of the watersheds is evaluated separately throughout the report to reflect the individual characteristics and water quality issues of the water bodies.

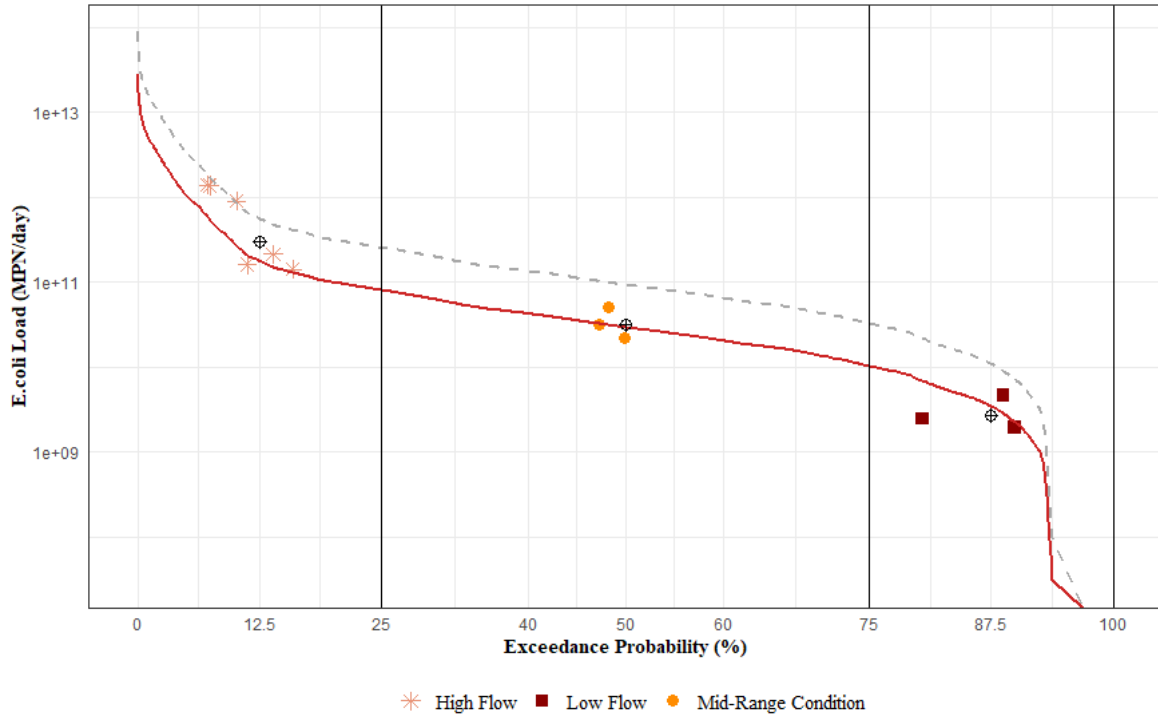
Figure 55. Load duration curve for Middle Yegua Creek Surface Water Quality Monitoring station 11838. The solid red line indicates the allowable load at geometric mean criterion (126 most probable number (MPN)/100 milliliter (mL)) and the gray dashed line is allowable load at single sample criterion (399 MPN/100mL). The black circles indicate the existing geometric mean load in each flow regime (MPN/day).

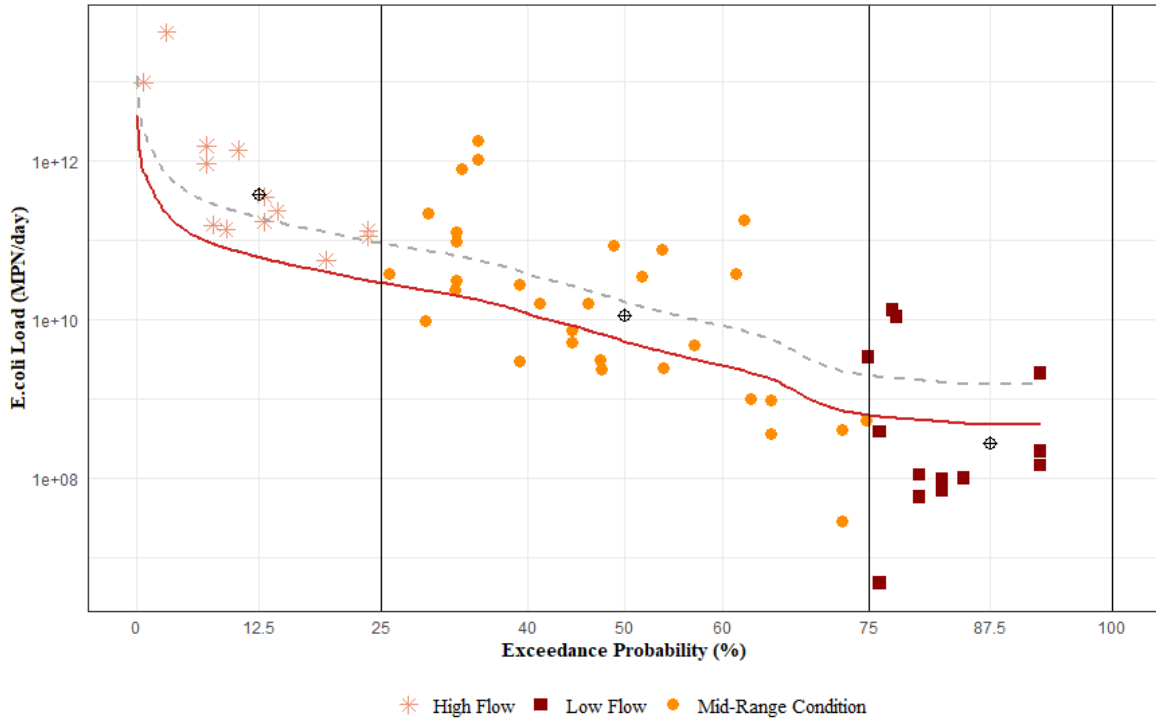
Figure 57. Load duration curve for Deer Creek Surface Water Quality Monitoring stations 11723 and 18644. The solid red line indicates the allowable load at geometric mean criterion (126 most probable number (MPN)/100 milliliter (mL)) and the gray dashed line is allowable load at single sample criterion (399 MPN/100mL). The black circles indicate the existing geometric mean load in each flow regime (MPN/day).
