Mission and Aransas TMDL Effectiveness Monitoring

Texas Water Resources Institute TR-527
August 2020

TCEQ Contract Number 582-18-80208

Texas Water Resources Institute Technical Report-527

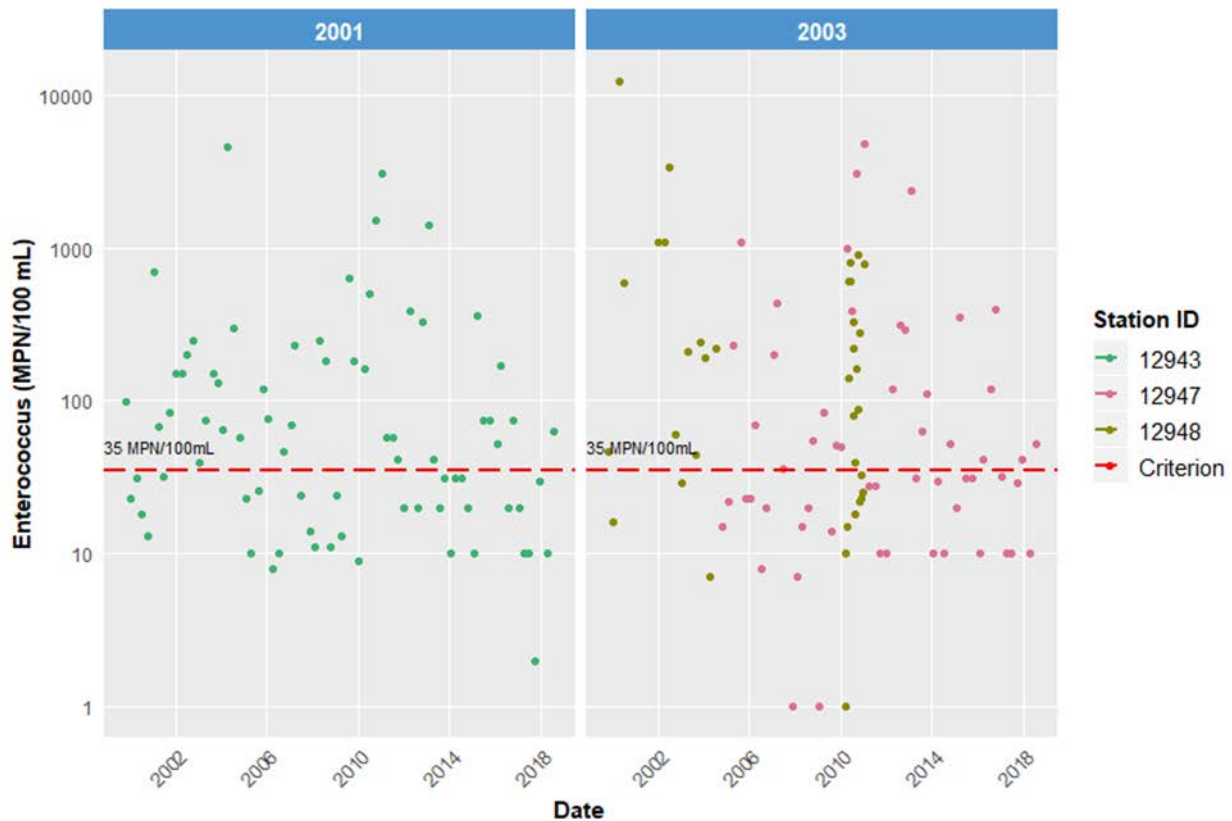
Figure 2. Historical Enterococcus concentrations at impaired tidal Segments 2001 and 2003.

Under the primary contact recreation standards, the geometric mean criterion for bacteria is 35 MPN of *Enterococcus* per 100mL in saltwater. According the 2020 Texas Integrated Report (Table 1; TCEQ 2020), the tidal segments of the Mission and Aransas rivers are impaired. This listing is based on the geometric mean value from bacteria samples collected at stations in each assessment unit (AU) between December 2011 and November 2018 (Figure 2).

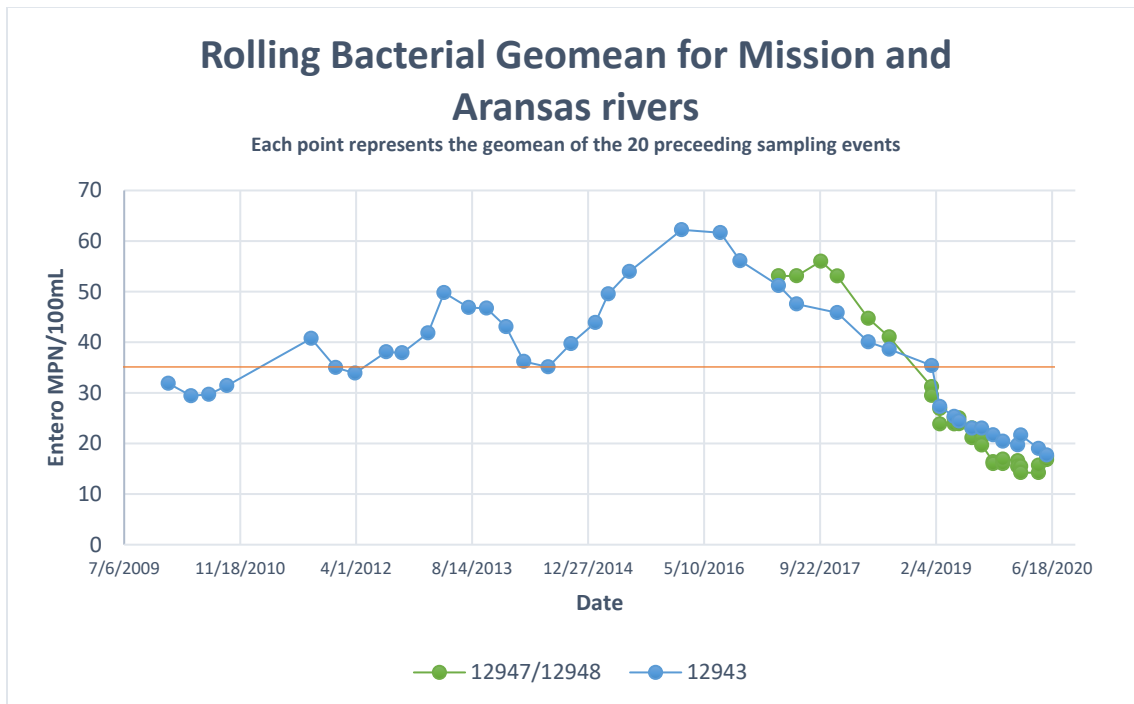
Figure 3. Rolling 20-sample geomean of bacterial loads in the tidal segments of the Mission (12943) and Aransas (12947/12948) rivers. Orange line denotes water quality standard of 35 MPN/100mL. Enterococcus, Entero.

Since May of 2016, there appears to have been a steady decline in observable bacterial loads in the watershed (Figure 3). Using a rolling 20-sample geomean, it is evident that water quality has been consistently below the 35 MPN/100mL contact recreation standard since about February of 2019 (Figure 3), indicating possible effectiveness of TMDL implementation within the watershed.

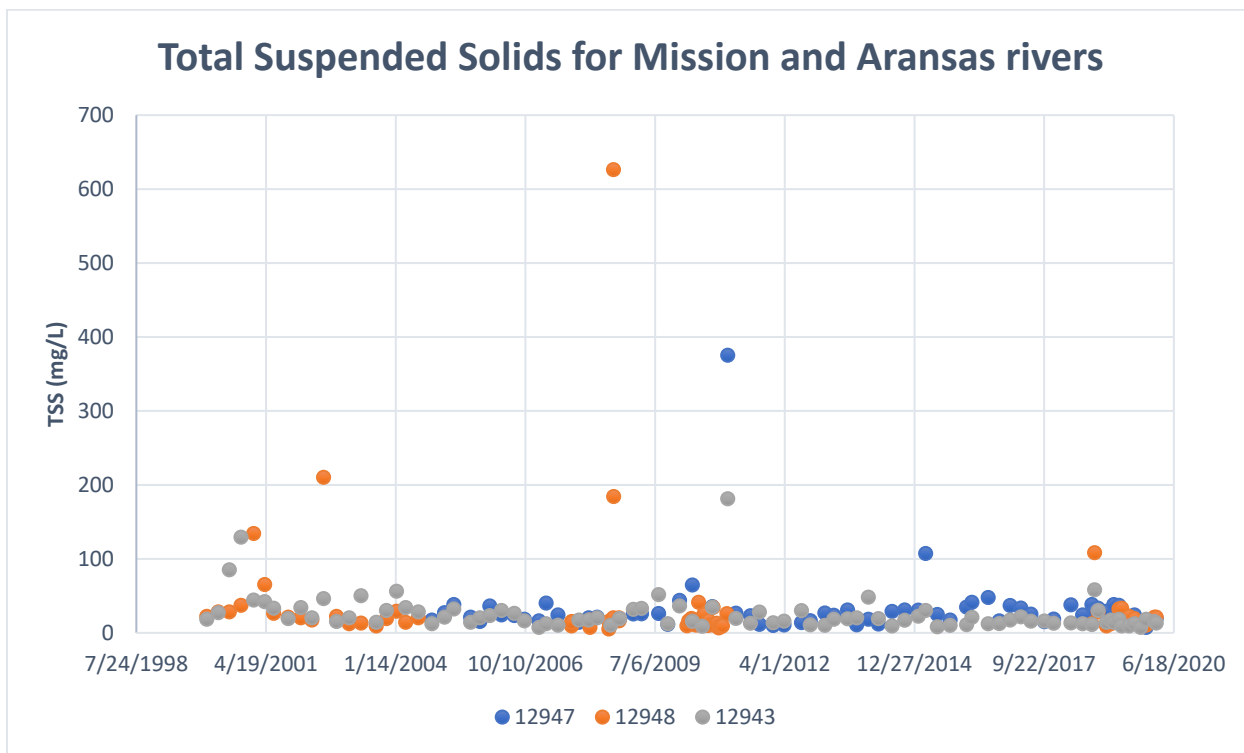
Figure 9. Total Suspended Solids (TSS) for the Mission (12943) and Aransas rivers (12947, 12948).

NNN mostly stayed below the criterion of concern of 2 mg/L throughout the project (Figure 4). There were two occasions where it was slightly above the criterion on the Aransas River. Ammonia N has remained consistent since data collection began in 2000 (Figure 5). TKN was highly variable prior to 2018 but has remained consistently at or below 1.5 mg/L since then (Figure 6). Total phosphorus loads in the Aransas River seem to have risen above the criterion of 0.7 mg/L during many of the sampling events during this project, while the phosphorus loads in the Mission River have remained consistent with historical data trends (Figure 7). DO has mainly stayed above the criterion of 5 mg/L; however, there have been some instances in recent years of reduced DO (< 5 mg/L) on the Mission River (Figure 8). Finally, TSS have remained consistent since data collection began in 2000, with only minor outliers scattered through the years (Figure 9).
