# Attoyac Bayou Watershed Protection Plan Implementation Effectiveness Monitoring and Facilitation Continuation

## Final Report

Texas State Soil and Water Conservation Board Project #19-53

Texas Water Resources Institute TR-532

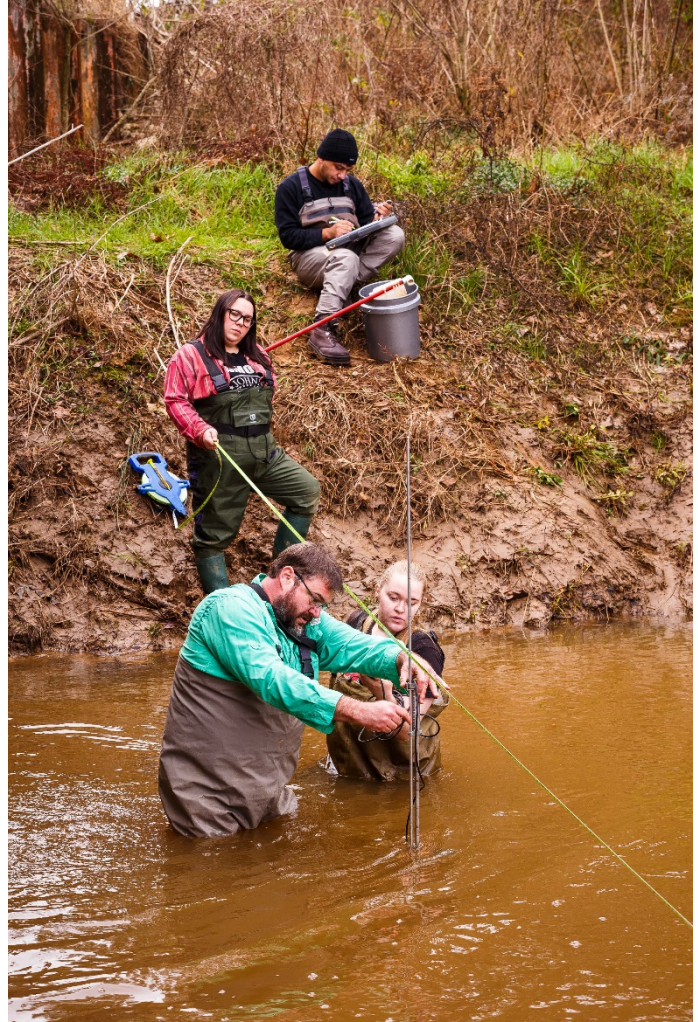
Flow measurement being taken at monitoring site.  
Photo by Ed Rhodes.

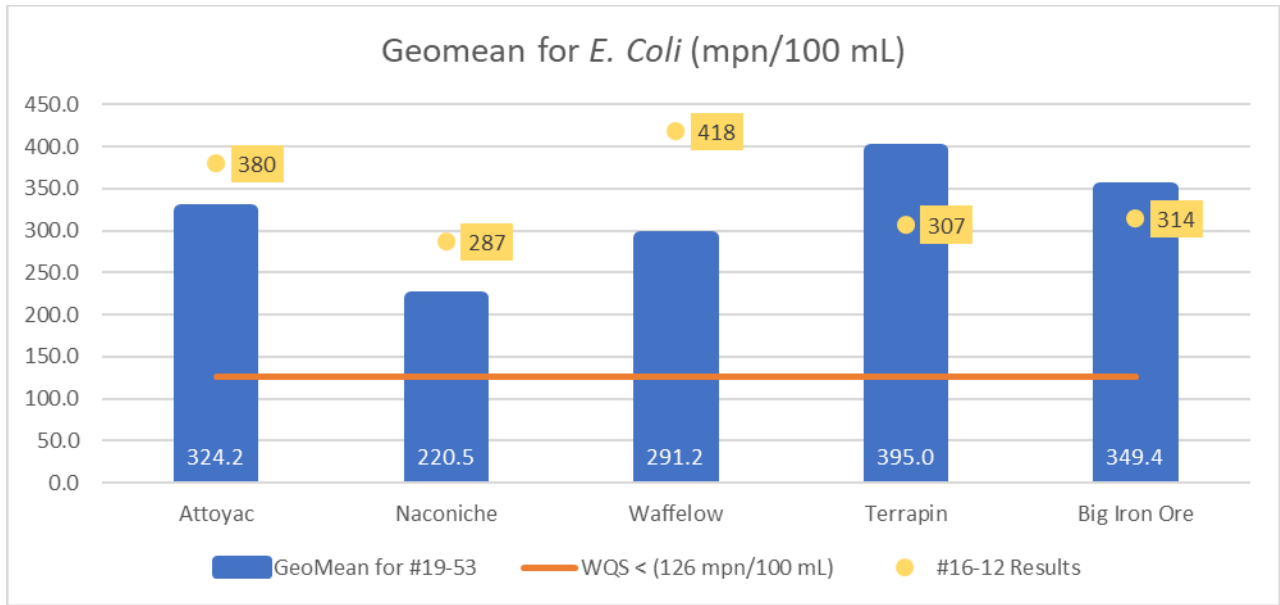
Figure 1: Geometric means of E. coli (mpn/100 mL) by site.

The geometric mean for E. coli remains elevated above the water quality standard (WQS) for primary contact recreation (126 most probable number (mpn) / 100 mL), but three of the stations saw some improvement at the Attoyac, Naconiche, and Waffelow Creek stations. The yellow markers in Figure 1 indicate the geomean for each site from the monitoring efforts during previous WPP implementation project, #16-12. Almost all observations were higher than the WQS, as seen in Figure 2.

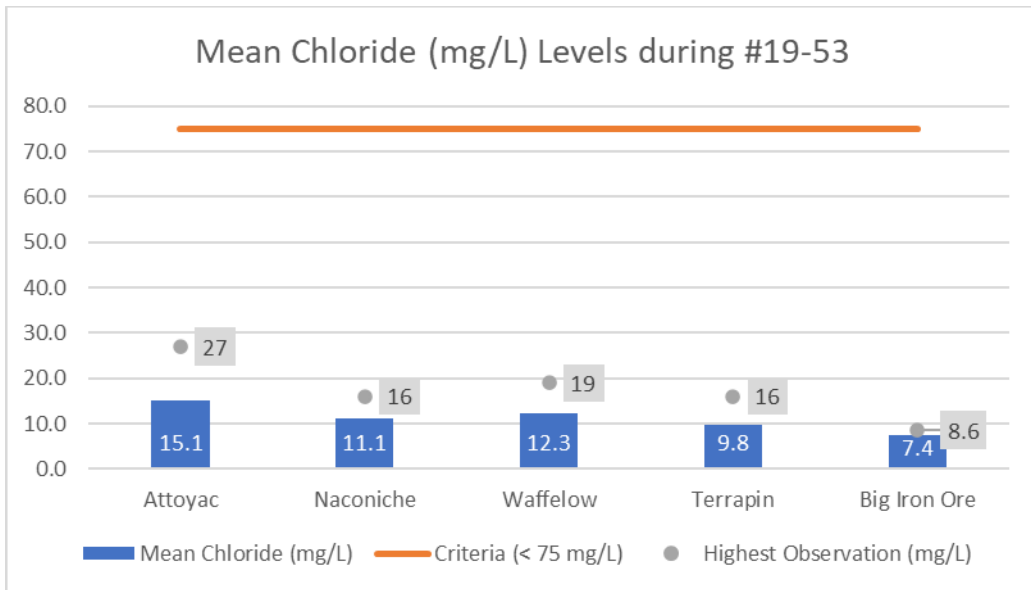
Figure 3: Mean Chloride (mg/L) by monitoring site.

The following charts show the average concentration of each of the nutrient parameters and in situ observations during the project period, as well as the water quality criteria set for each parameter in the Attoyac Bayou when applicable. The averages for each of the nutrient parameters fell below the relevant criteria, and only sulfate had observances that were higher than the criteria, as seen in Figure 4. This could indicate that excess nutrients are not a major concern for these portions of the Attoyac Bayou, apart from sulfate, potentially.
