Attoyac Bayou Recreational Use Attainability Analysis

**Attoyac Bayou
Recreational Use Attainability Analysis**

**Texas State Soil and Water Conservation Board
Project # 09-10**

October 2012

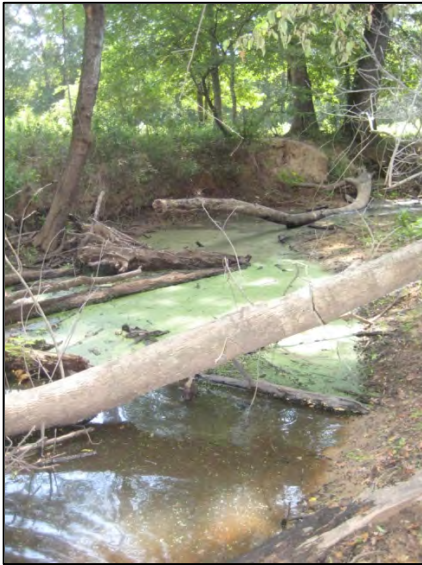
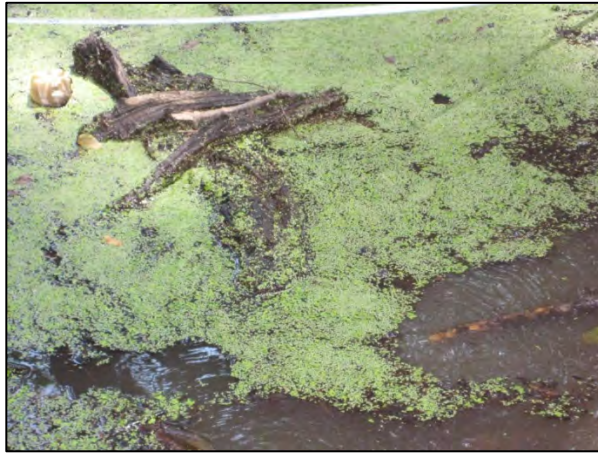
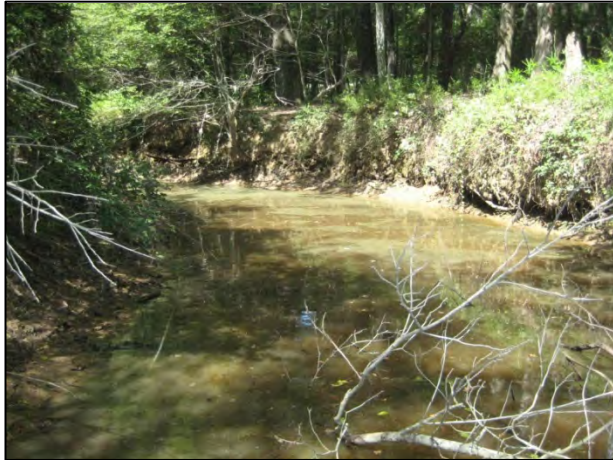
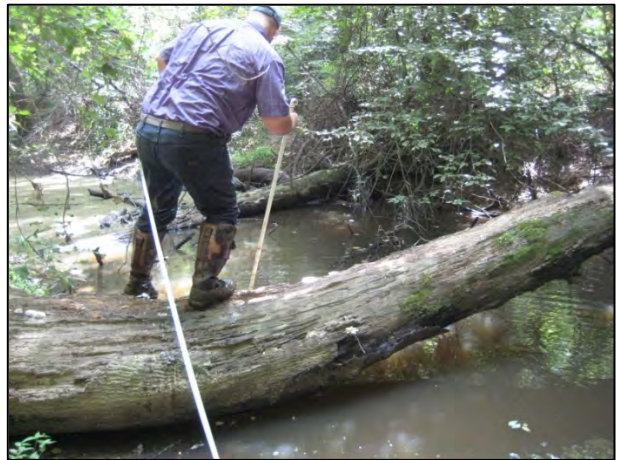
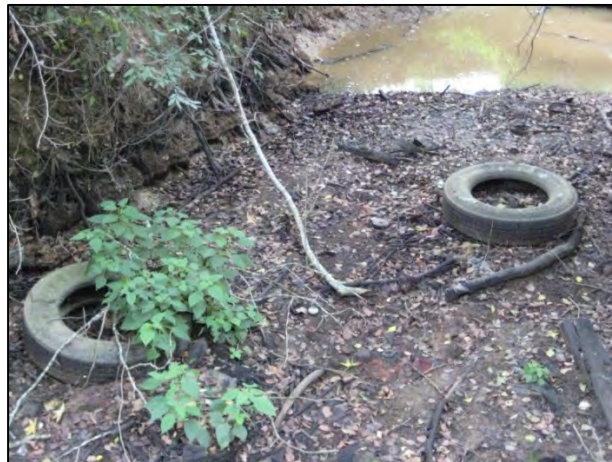
Photogroup 4-6 Attoyac 6 depicting water surface characteristics. All individuals featured are SFASU and CES staff. Top left: Large woody debris in channel, July 2012; Top right: Woody debris and aquatic vegetation, July 2012; Middle left: 150-m transect, downstream, July 2012; Middle right: Large woody debris, July 2012; Bottom: Large channel litter (tires), July 2012.

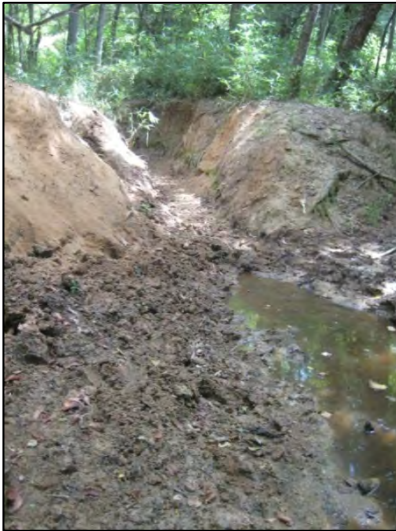
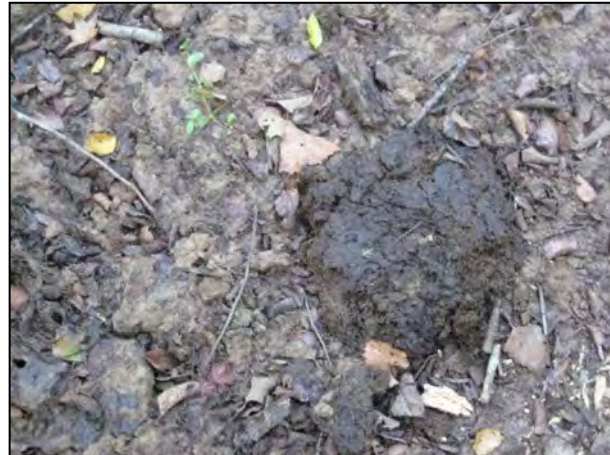
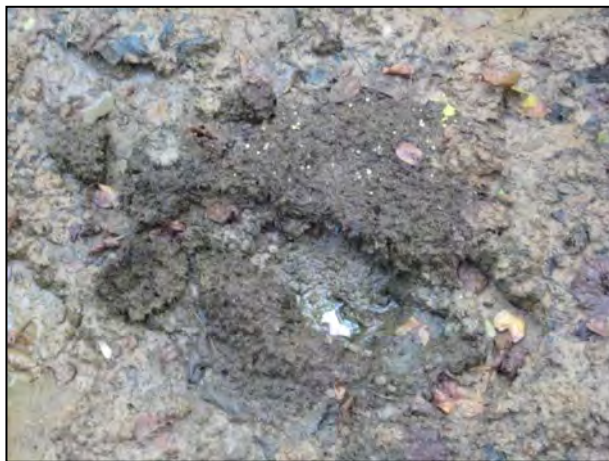
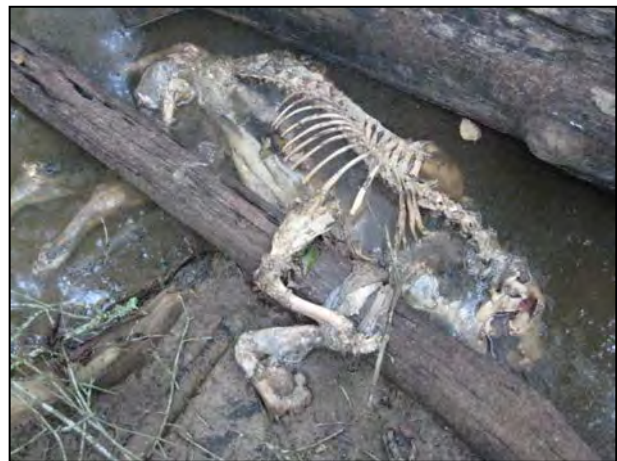
Photogroup 4-6 Attoyac 6 depicting potential contamination sources. Top left: Livestock access bank access, July 2012; Top right: Livestock fecal, August 2012; Bottom left: Livestock fecal, August 2012; Bottom right: 0-m transect, animal carcass, August 2012.

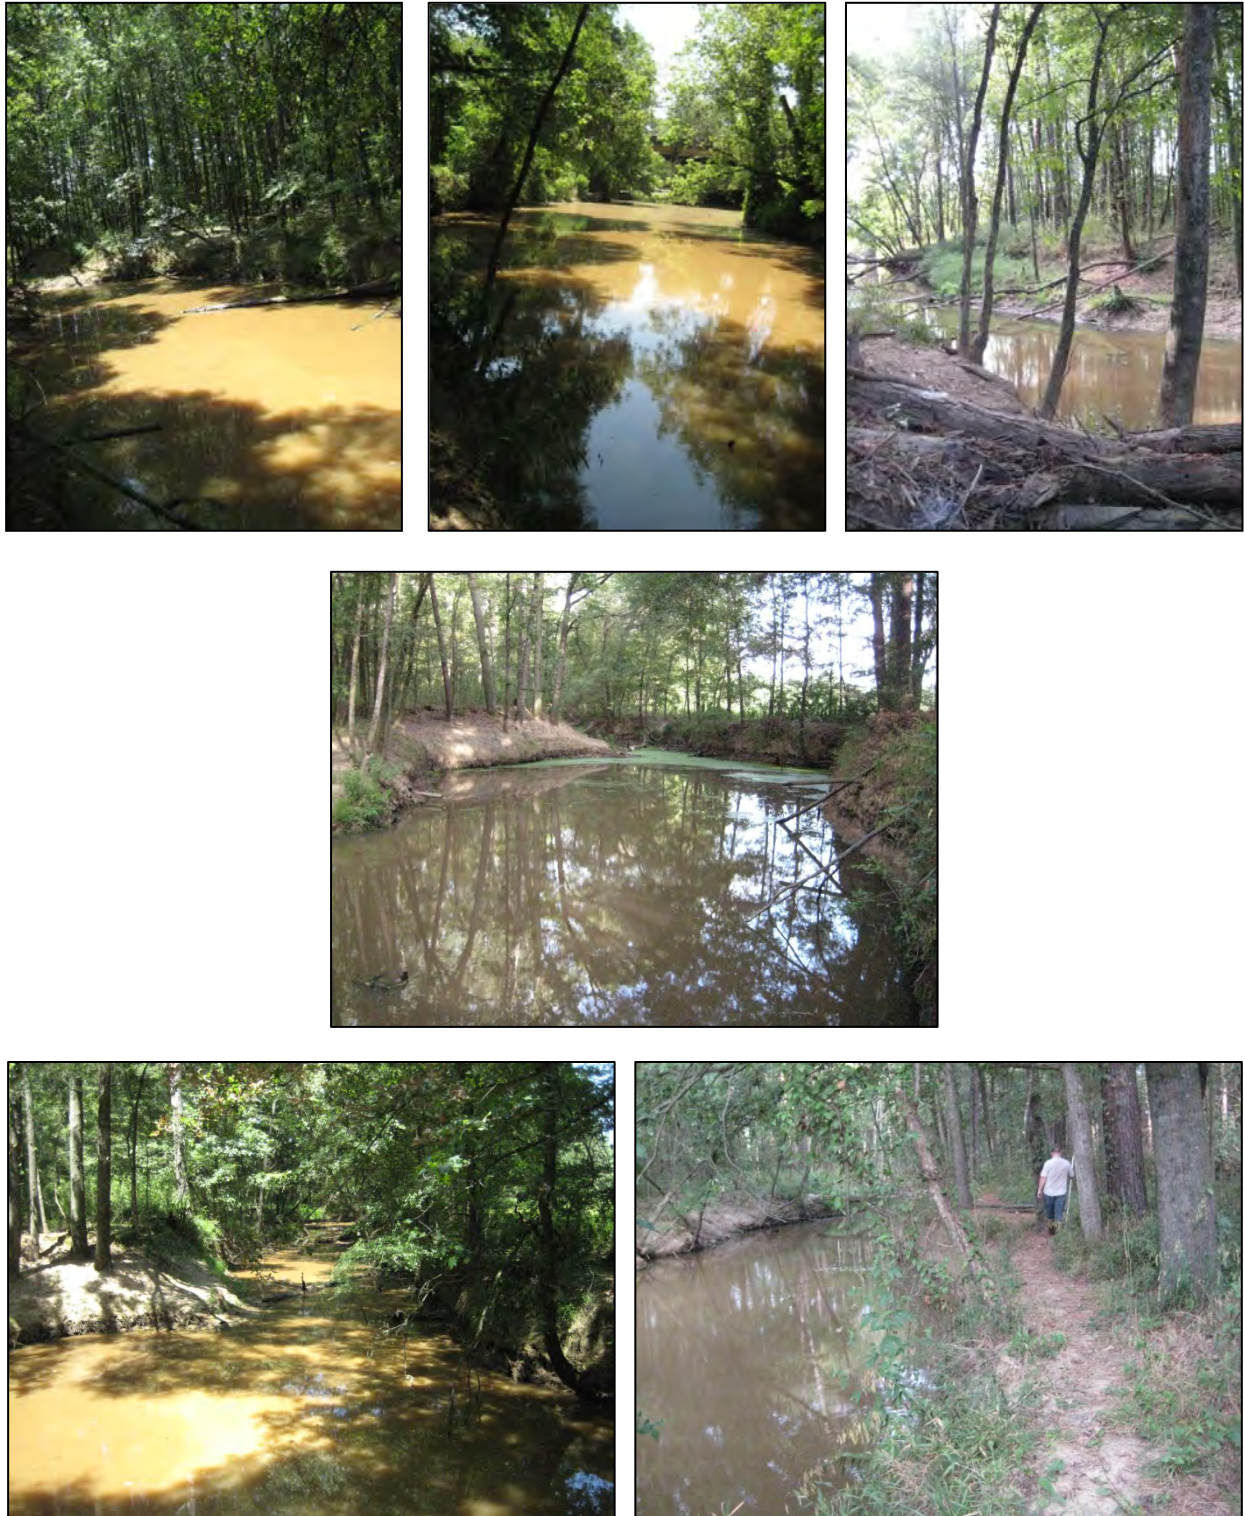
Photogroup 4-7 Attoyac 7 depicting general stream characteristics. All individuals featured are SFASU and CES staff. Top left: 150-m, downstream, July 2012; Top center: 30-m downstream, July 2012; Top right: 150-m, downstream, August 2012; Middle: 150-m, upstream, August 2012; Bottom left: 150-m, upstream, July 2012; Bottom right: Establish trail along left bank, August 2012.

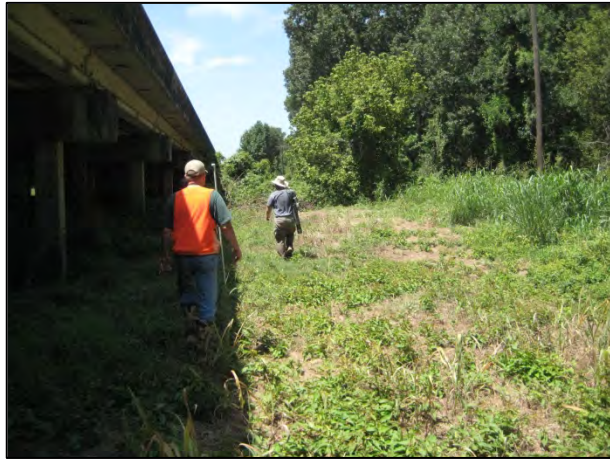
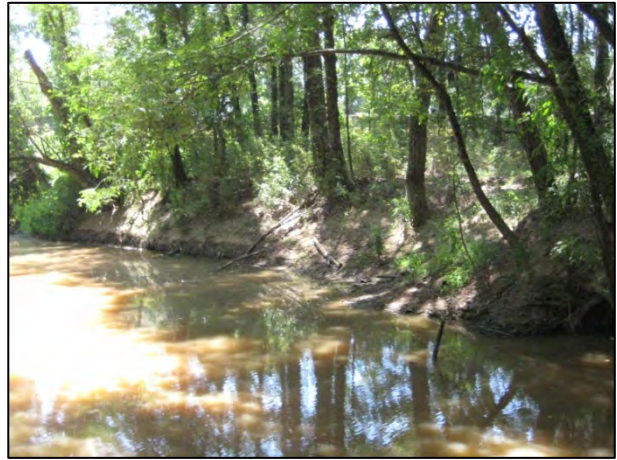
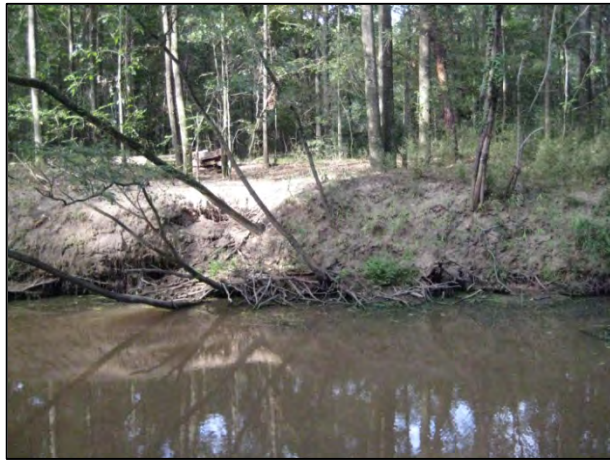
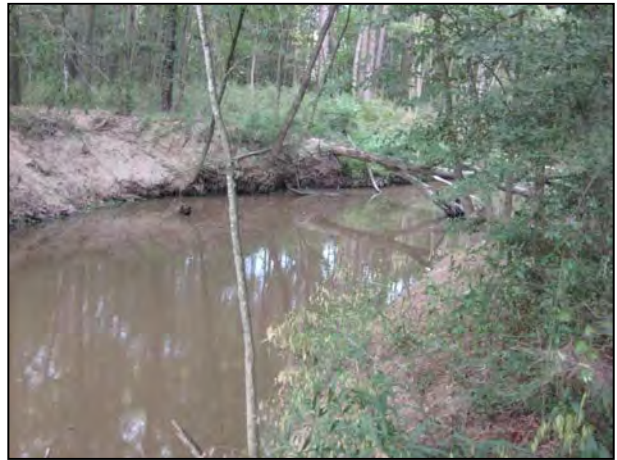
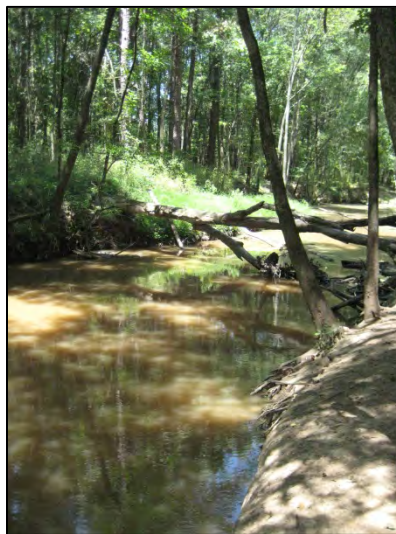
Photogroup 4-7 Attoyac 7 depicting bank access and general bank appearance. All individuals featured are SFASU and CES staff. Top left: Stream access point from Hwy 59, July 2012; Top right: 30-m, right bank, July 2012; Middle left: 150-m, right bank, August 2012; Middle right: 30-m, upstream, August 2012; Bottom: 30-m, upstream, July 2012.

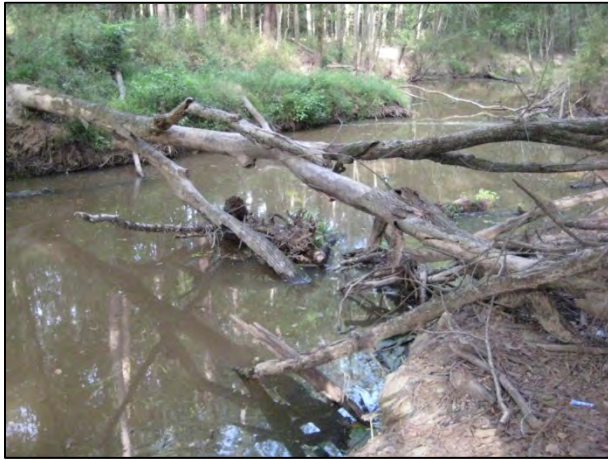
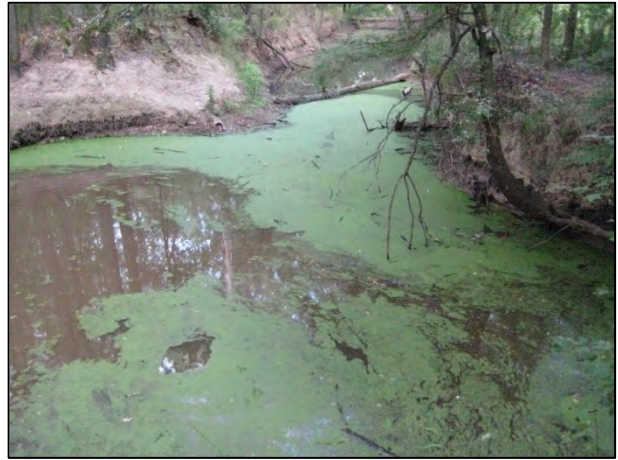
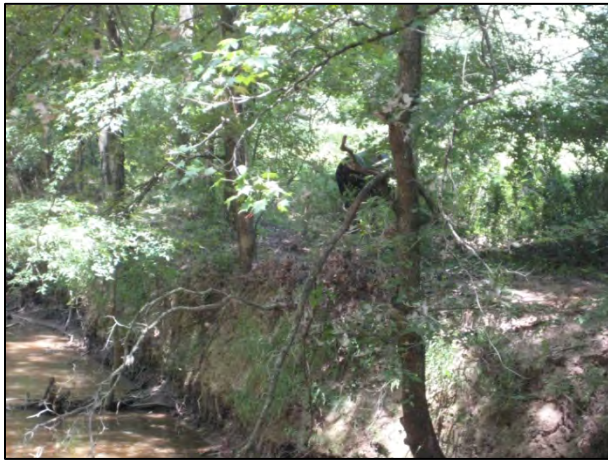
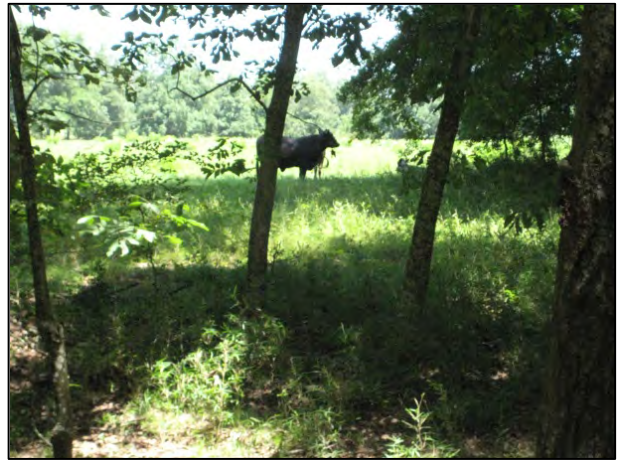
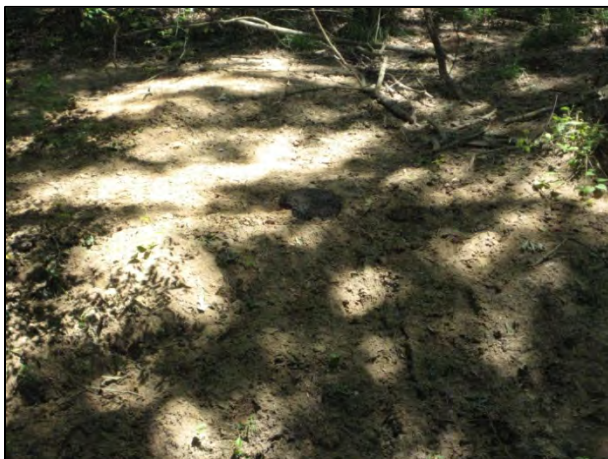
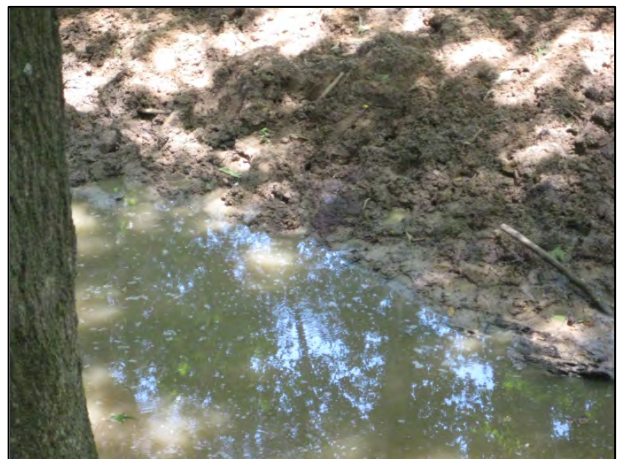
Photogroup 4-7 Attoyac 4-7 depicting water surface characteristics and potential sources of contamination. Top left: Large woody debris, August 2012; Top right: Aquatic vegetation, August 2012; Middle left: Livestock use, left bank, July 2012; Middle right: Livestock use, left bank, July 2012; Bottom left: Livestock fecal, July 2012; Bottom right: Livestock fecal and tracks, July 2012.

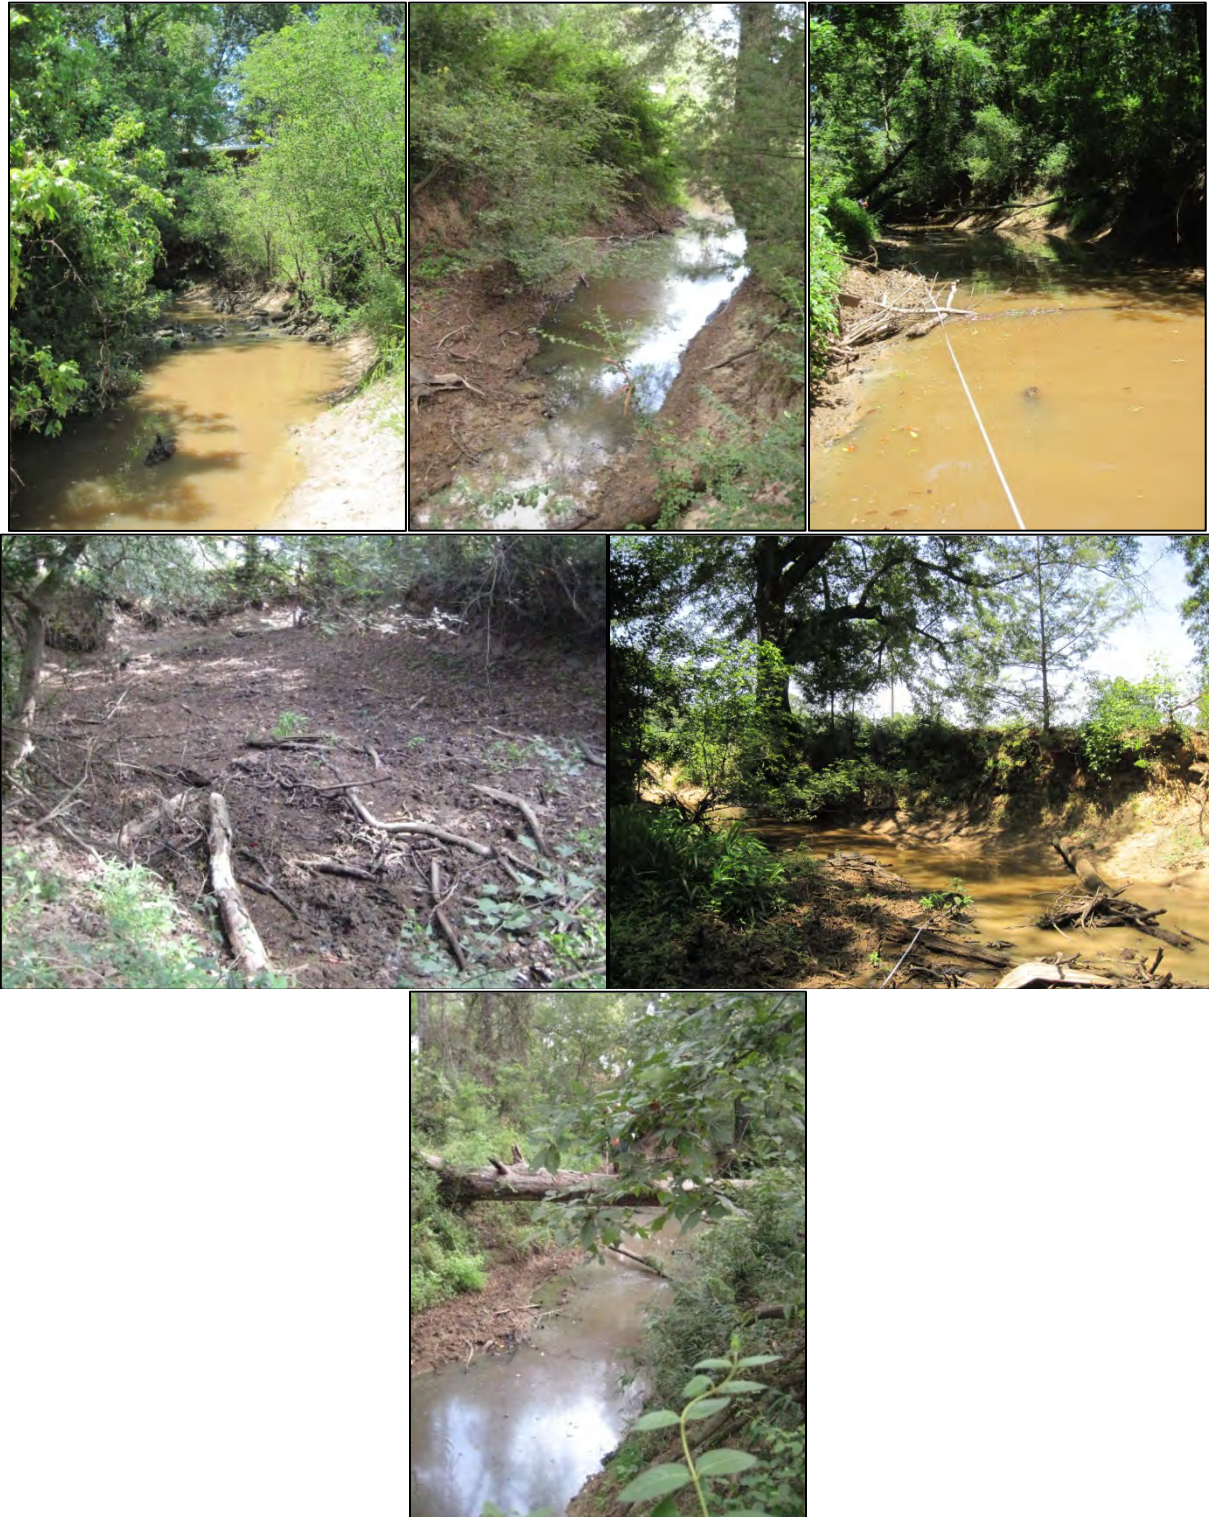
Photogroup 4-8 Attoyac 8 depicting general stream characteristics. Top left: 150-m, upstream, July 2012; Top center: 300-m, downstream, August 2012; Top right: 30-m, downstream, July 2012; Middle left: Dry stream channel, August 2012; Middle right: Upstream from major logjam; July 2012; Bottom: 30-m, upstream, August 2012.

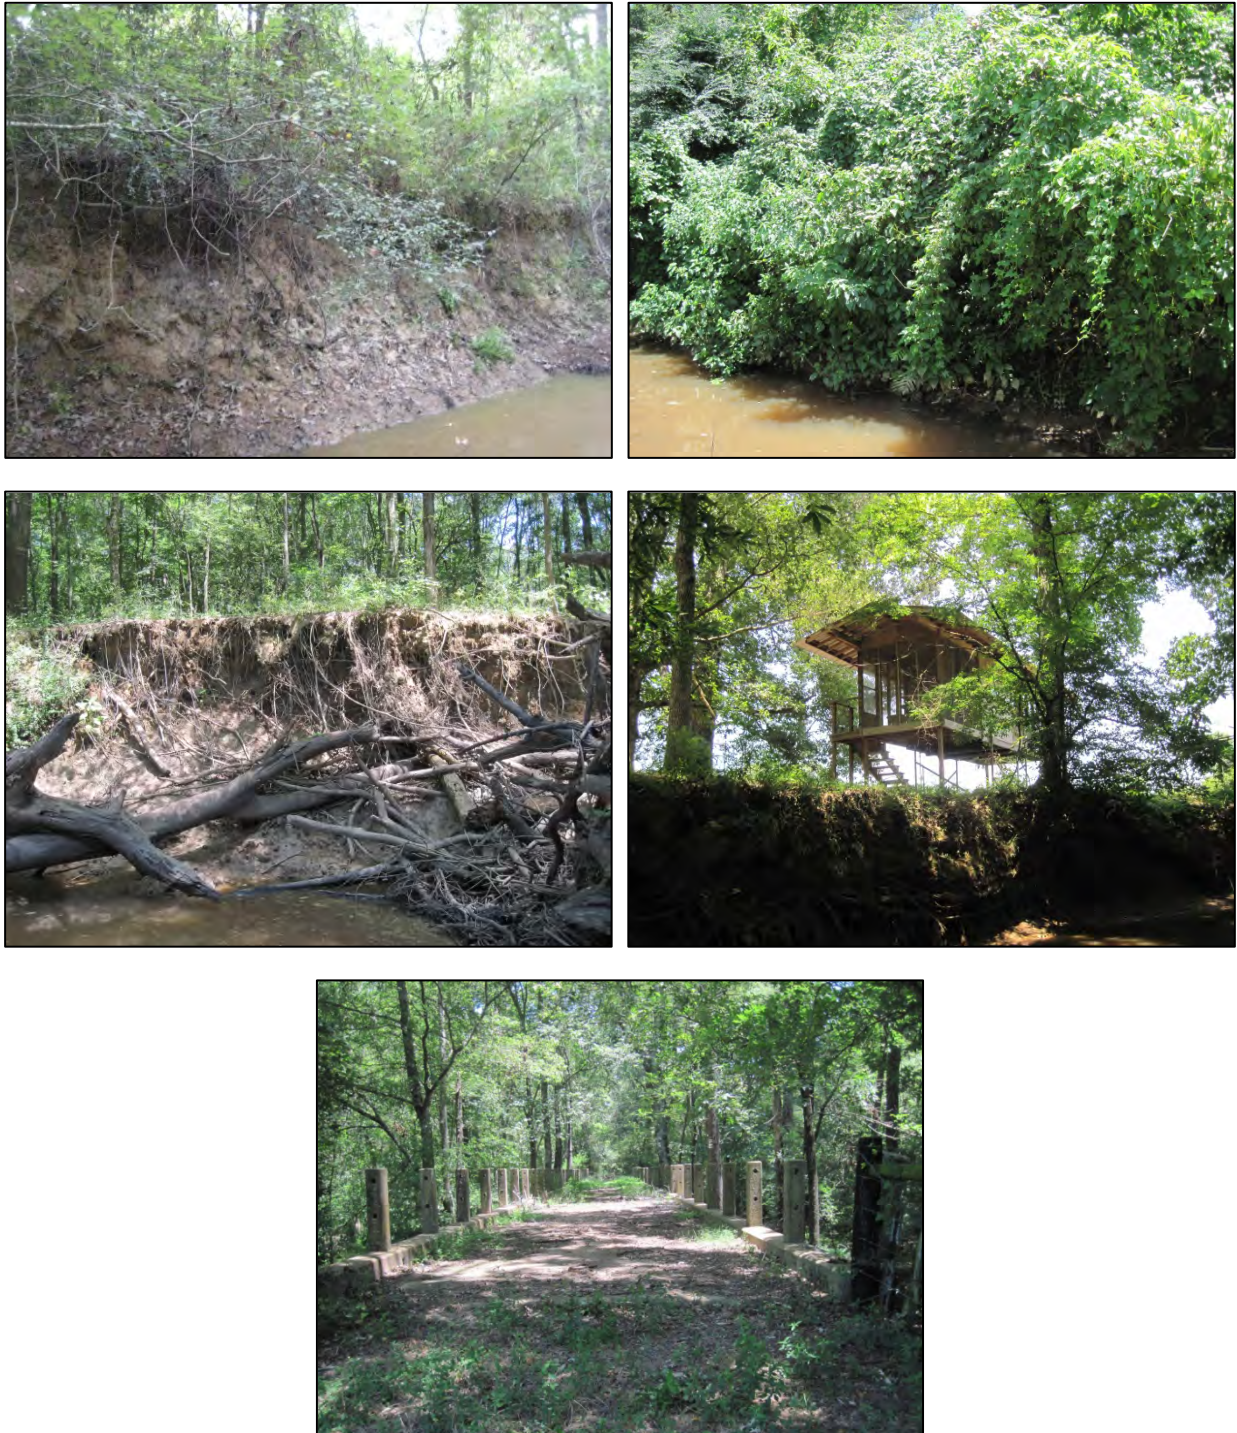
Photogroup 4-8 Attoyac 8 depicting bank access and general bank appearance. Top left: 150-m, leftbank, August 2012; Top right: 150-m; right bank, July 2012; Middle left: Large woody debris, July 2012; Middle right: Camp house on left bank, July 2012; Bottom: Defunct CR 294.

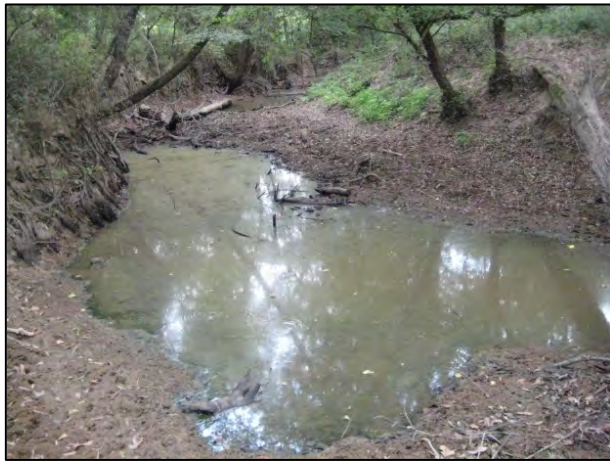
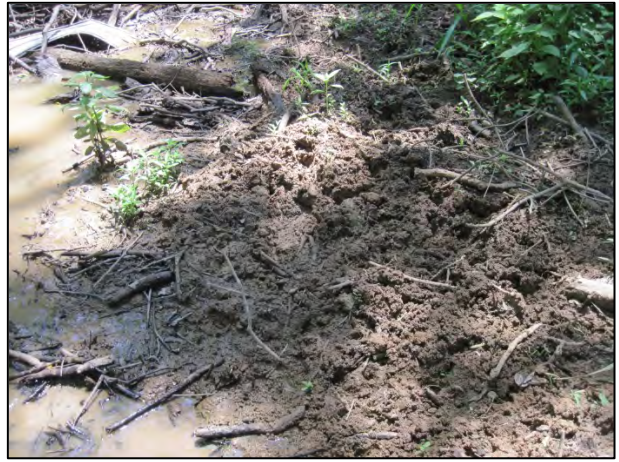
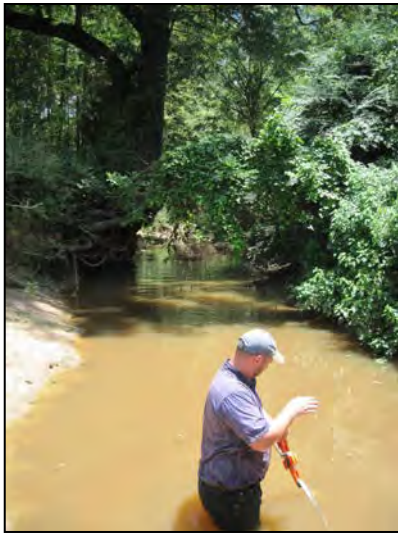
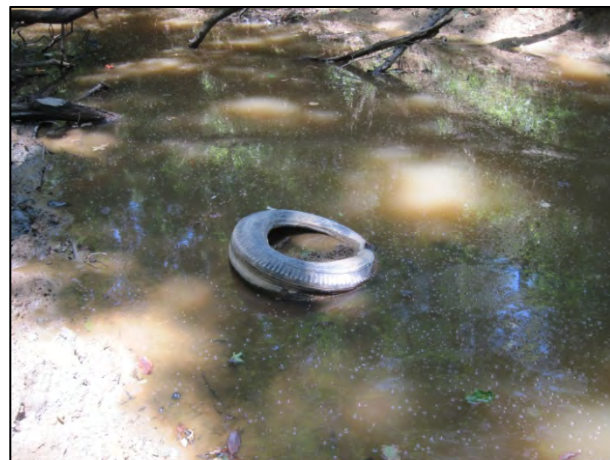
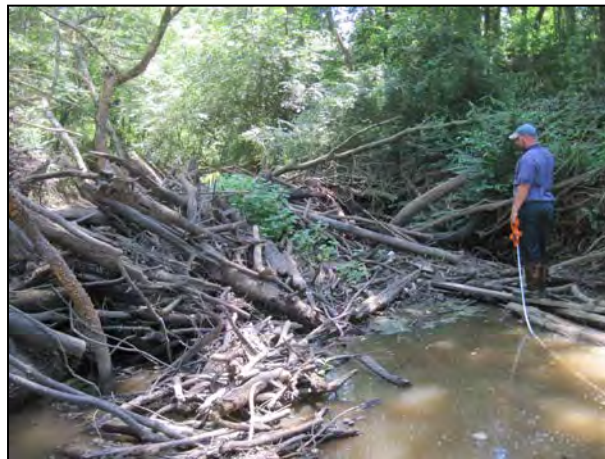
Photogroup 4-8 Attoyac 8 depicting stream surface characteristics and potential sources of contamination. Top left: Pool with scum, August 2012; Top right: Feral hog use, August 2012; Middle left: 150-m, downstream, July 2012; Middle right: Channel litter, July 2012; Bottom: Downstream logjam, July 2012.

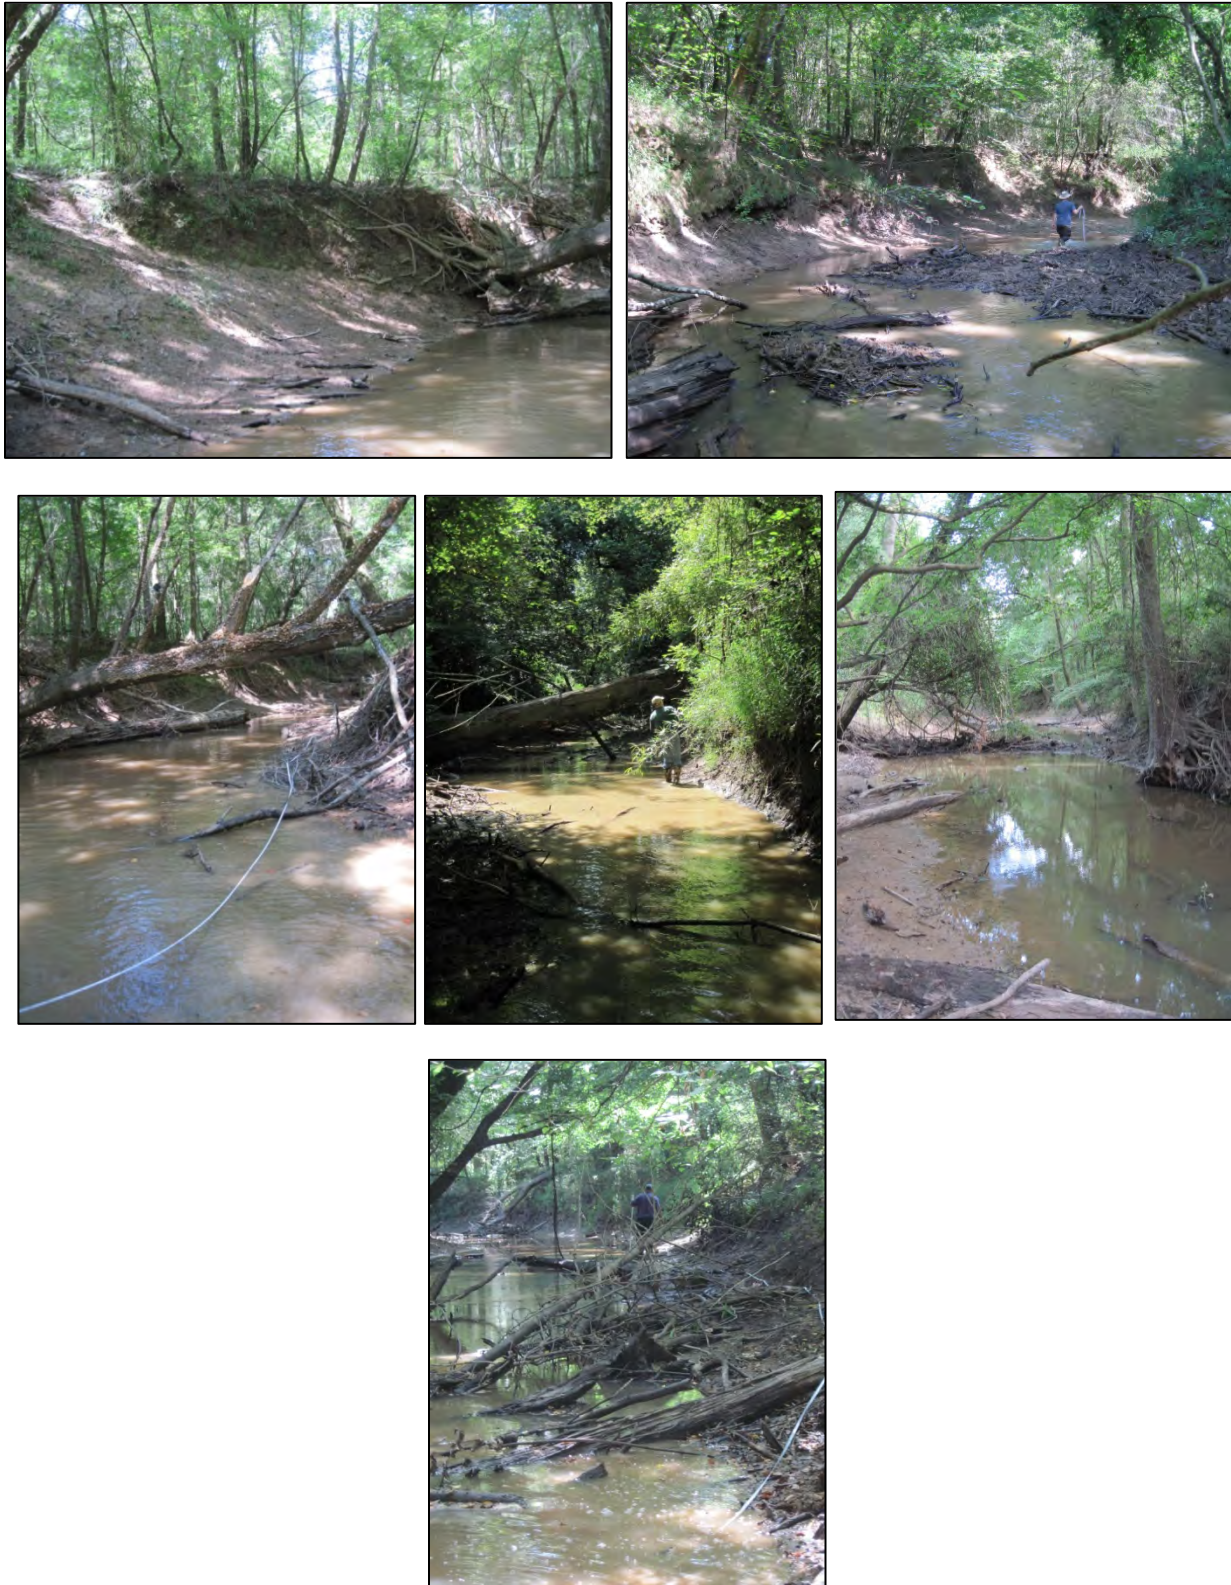
Photogroup 4-9 Attoyac 9 depicting general stream characteristics. All individuals featured are SFASU and CES staff. Top left: 30-m, left bank, July 2012; Top right: 150-m, downstream, July 2012; Middle left: 30-m, downstream, July 2012; Middle center: 150-m, upstream, July 2012; Middle right: 300-m, downstream, July 2012; Bottom: Large woody debris, July 2012.

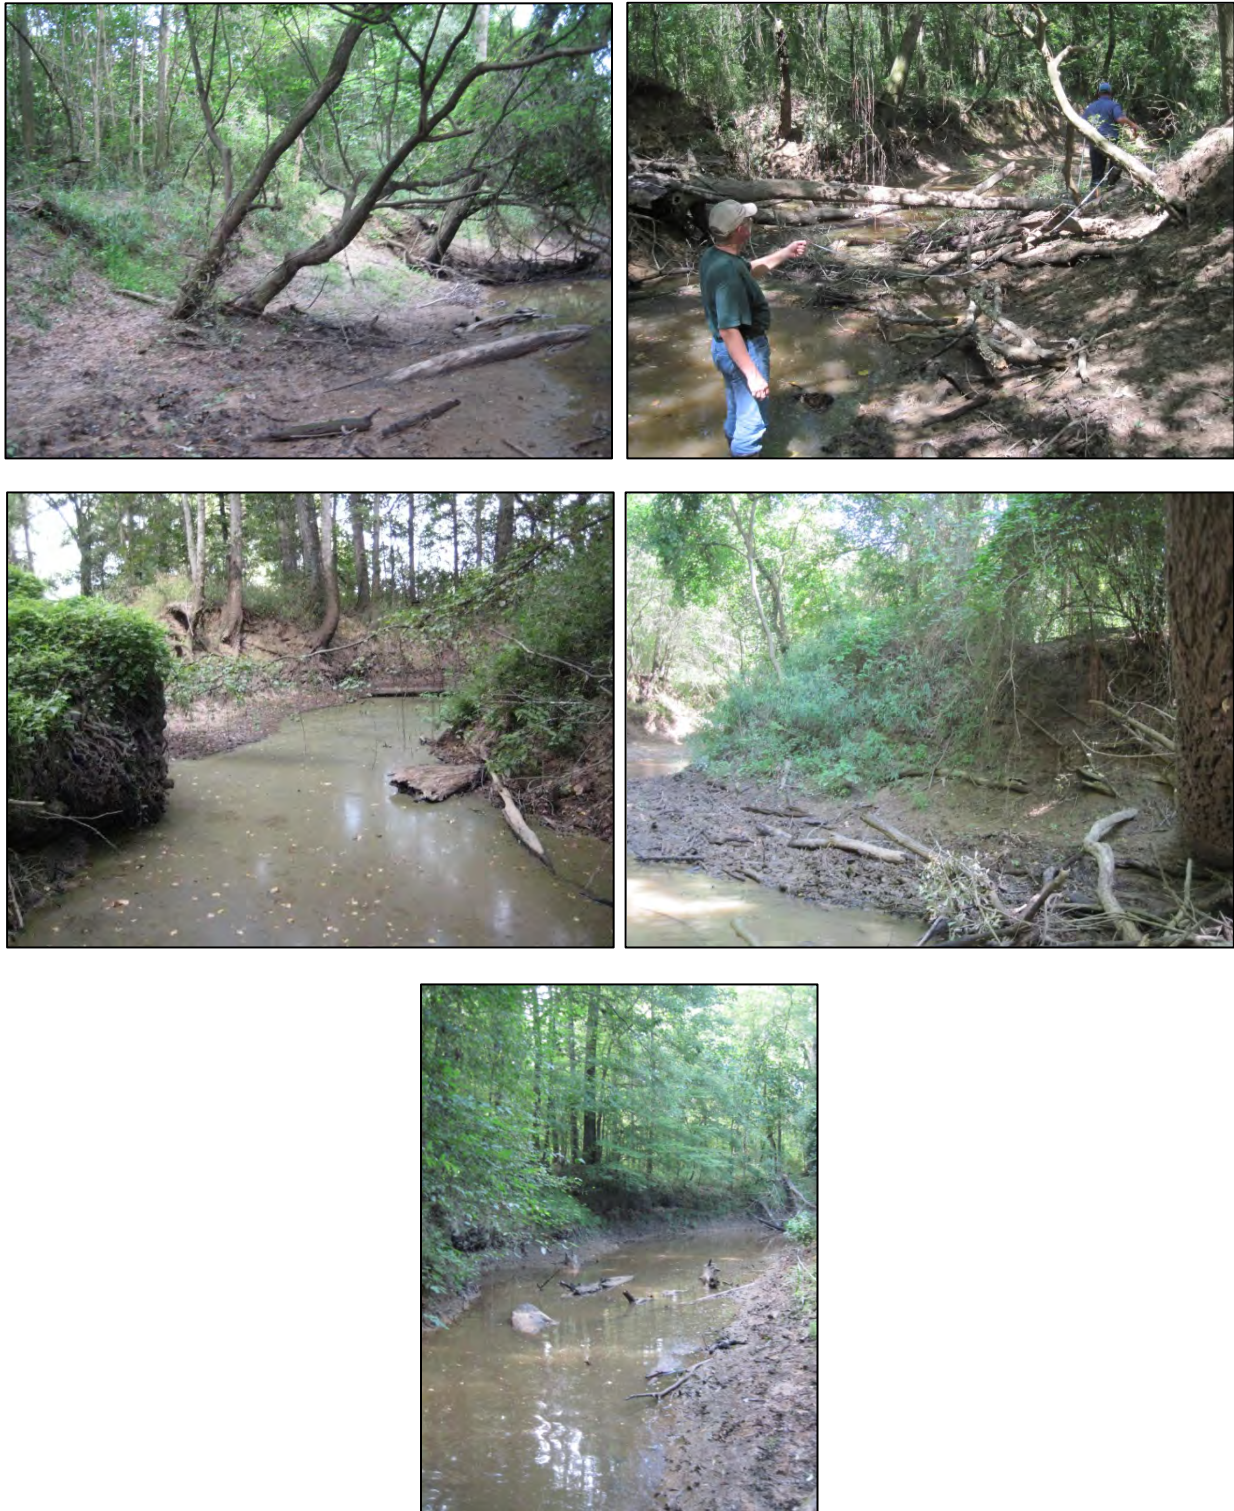
Photogroup 4-9 Attoyac 9 depicting general bank appearance. All individuals featured are SFASU and CES staff. Top left: 300-m, left bank, July 2012; Top right: Large woody debris, July 2012; Middle left: 30-m, upstream, August 2012; Middle right: 150-m, right bank, July 2012; Bottom: 300-m, upstream, July 2012.

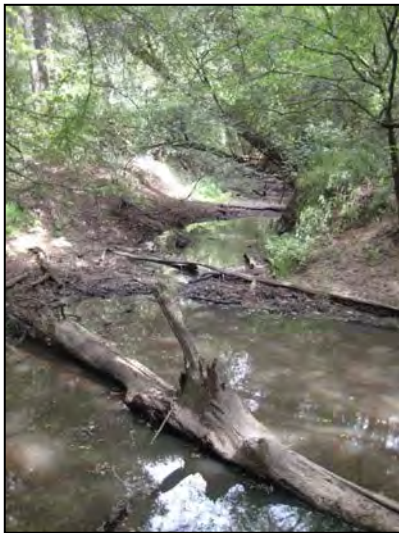
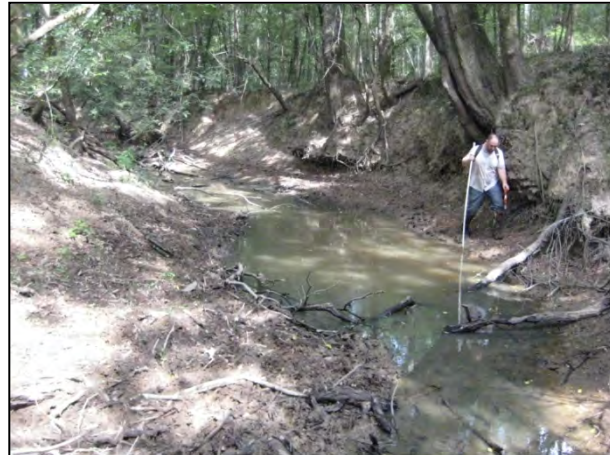
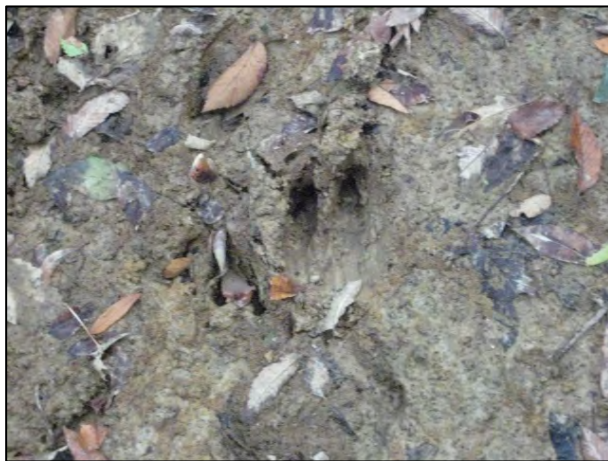
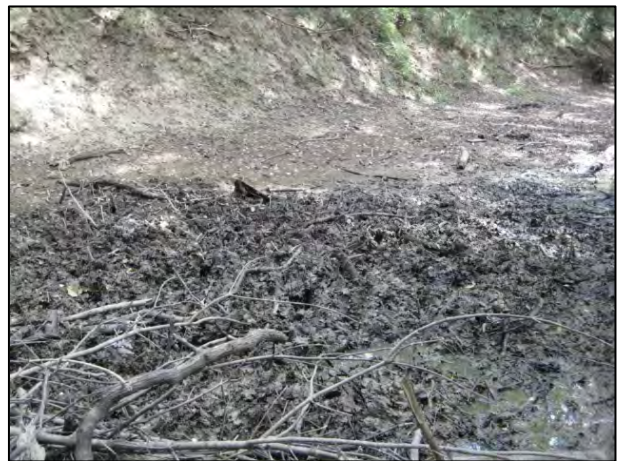
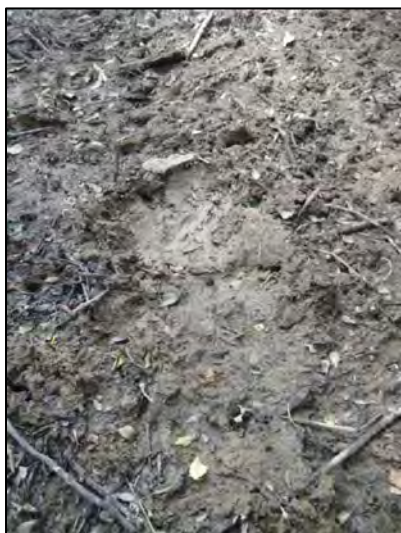
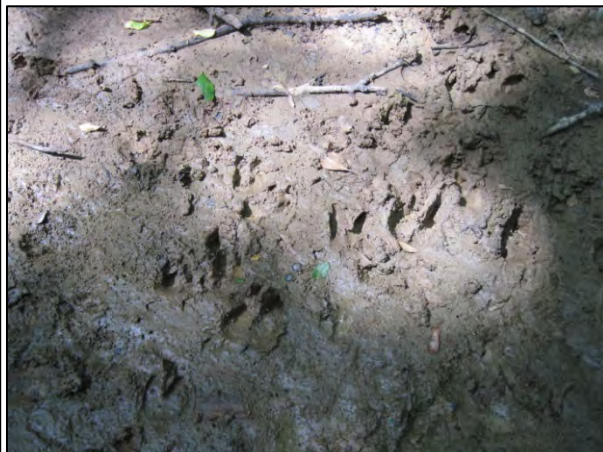
Photogroup 4-9 Attoyac 9 depicting general water surface appearance and potential sources of contamination. All individuals featured are SFASU and CES staff. Top left: Large woody debris, August 2012; Top right: 150-m, downstream, August 2012; Middle left: Feral hog track, August 2012; Middle right: Feral hog use; Bottom left: Feral hog wallow, August 2012; Bottom right: Feral hog tracks, August 2012.

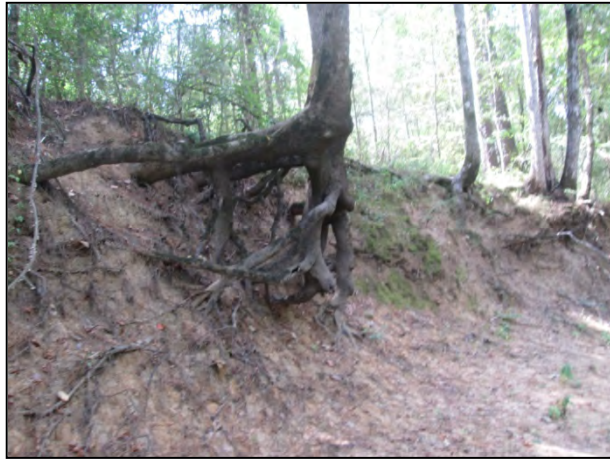
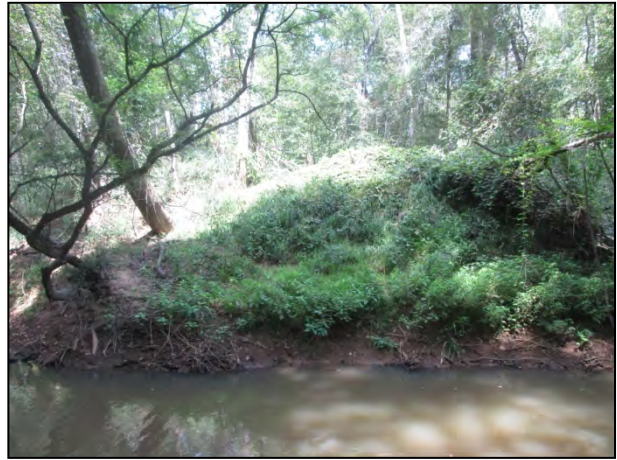
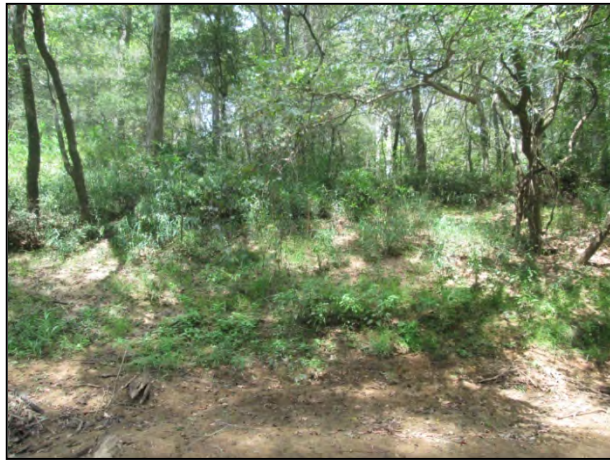
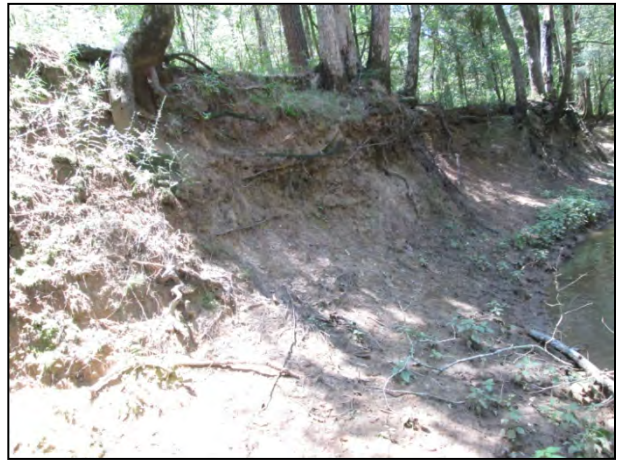
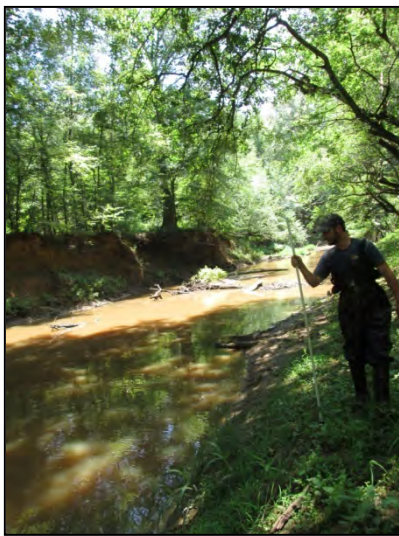
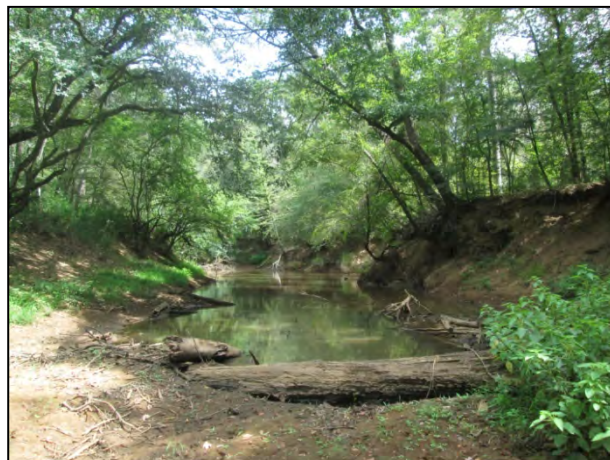
Photogroup 4-15 Attoyac 16 depicting general stream characteristics. All individuals featured are SFASU and CES staff. Top left: 30-m transect, downstream, July 2012; Top right: 30-m transect, upstream, July 2012; Middle left: 30-m transect, downstream, August 2012; Middle right: 150-m transect, upstream, July 2012; Bottom left: 30-m transect, upstream, August 2012; Bottom right: 150-m transect, downstream, August 2012.

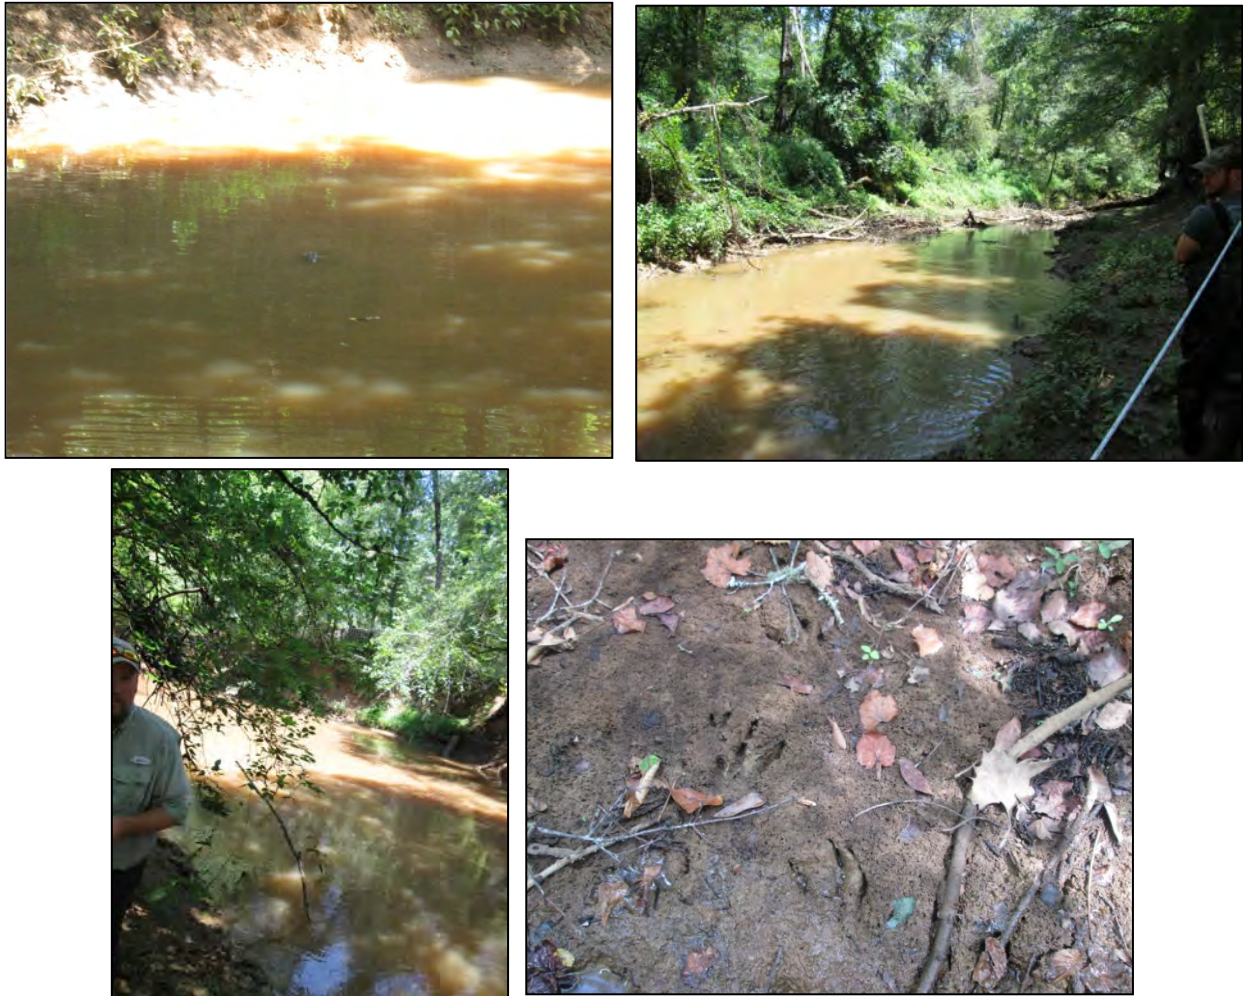
Photogroup 4-15 Attoyac 16 depicting general bank appearance. All individuals featured are SFASU and CES staff. Top left: 150-m transect, left bank, August 2012; Top right: 150-m transect, right bank, August 2012; Middle left: 300-m transect, left bank, August 2012; Middle right: 150-m transect, left bank, July 2012; Bottom left: 300-m transect, downstream, July 2012; Bottom right: 300-m transect, upstream, August 2012.
