Attoyac Bayou Recreational Use Attainability Analysis

**Attoyac Bayou
Recreational Use Attainability Analysis**

**Texas State Soil and Water Conservation Board
Project # 09-10**

October 2012

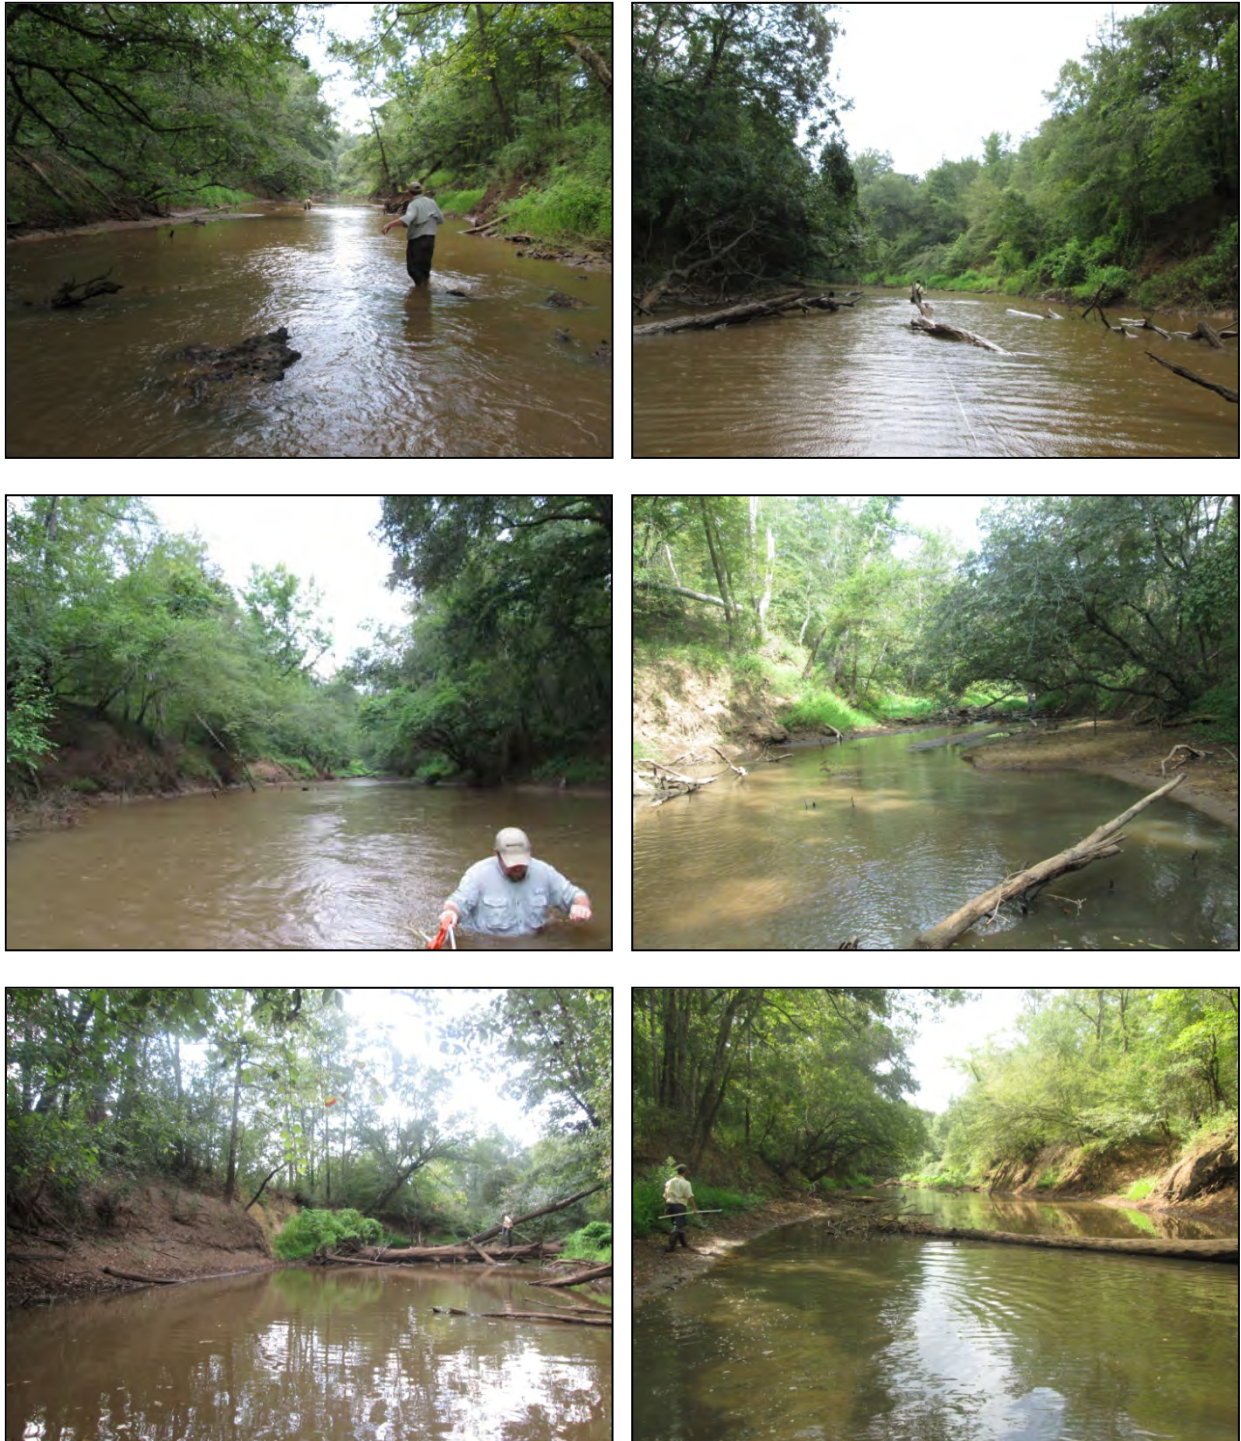
Photogroup 4-15 Attoyac 16 depicting water surface characteristics. All individuals featured are SFASU and CES staff. Top left: Adolescent Alligator, July 2012; Top right: 150-m transect, downstream, July 2012; Bottom left: 300-m transect, upstream, July 2012; Bottom right: Raccoon prints, August 2012.

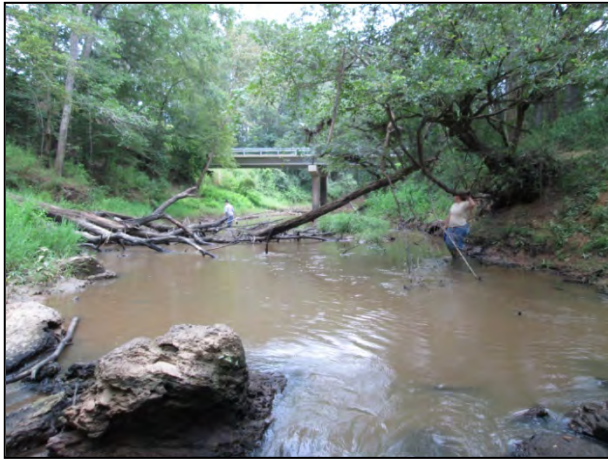
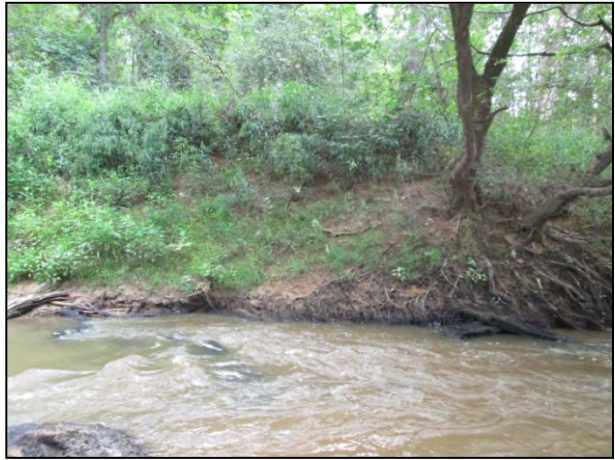
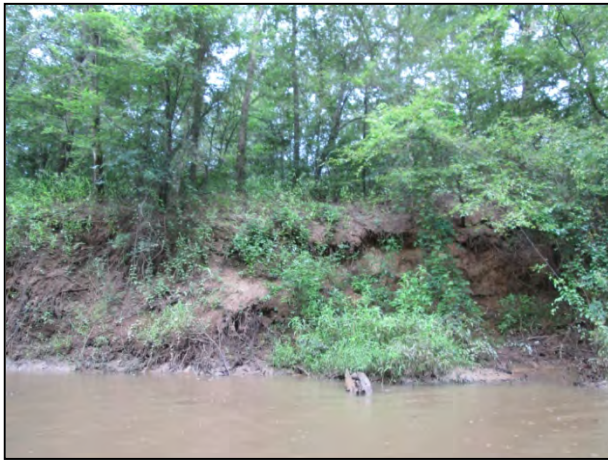
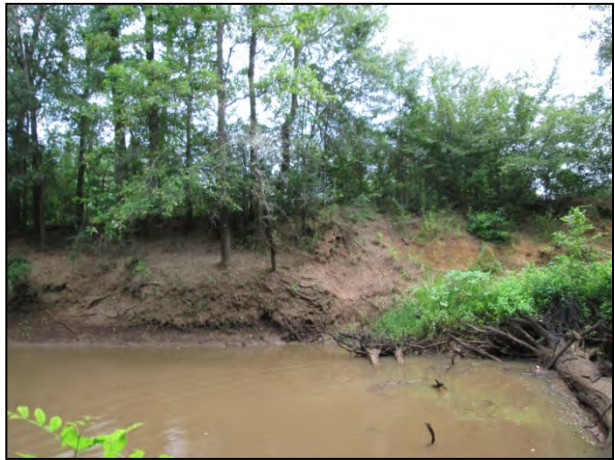
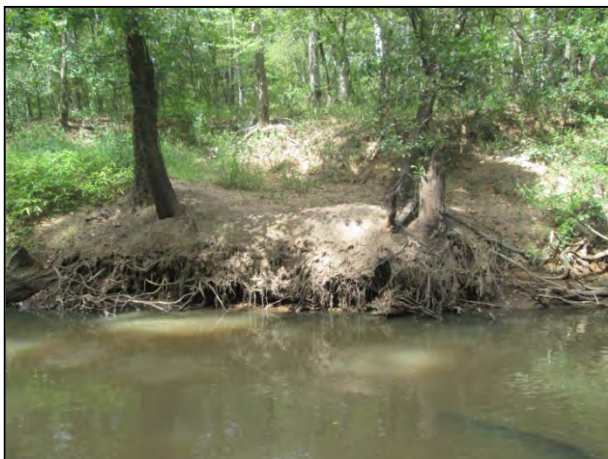
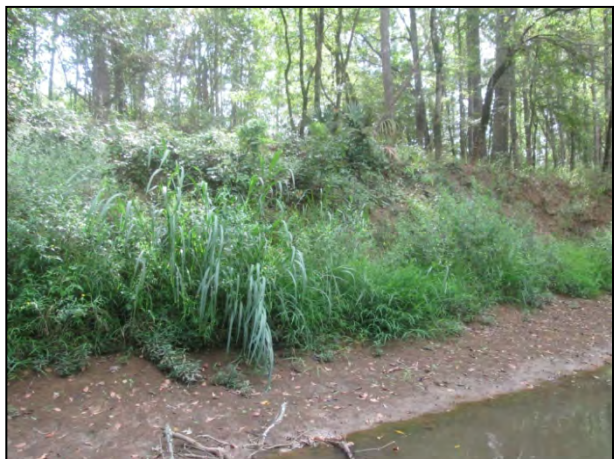
Photogroup 4-16 Attoyac 17 depicting general stream characteristics. All individuals featured are SFASU and CES staff. Top left: 30-m transect, downstream, July 2012; Top right: 150-m transect, downstream, July 2012; Middle left: 150-m transect, upstream, July 2012; Middle right: 30-m transect, downstream, August 2012; Bottom left: 300-m transect, upstream, August 2012; Bottom right: 30-m transect, upstream, August 2012.

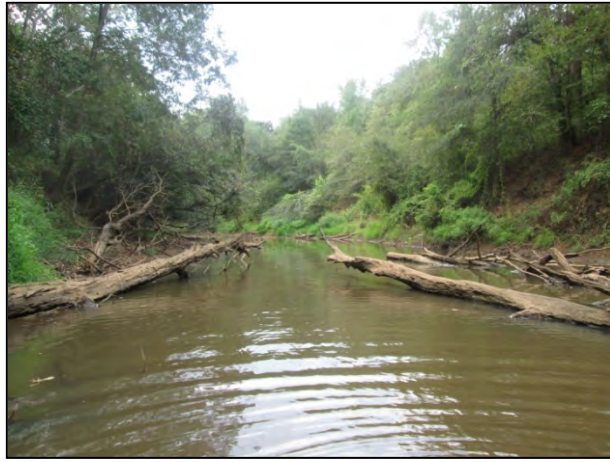
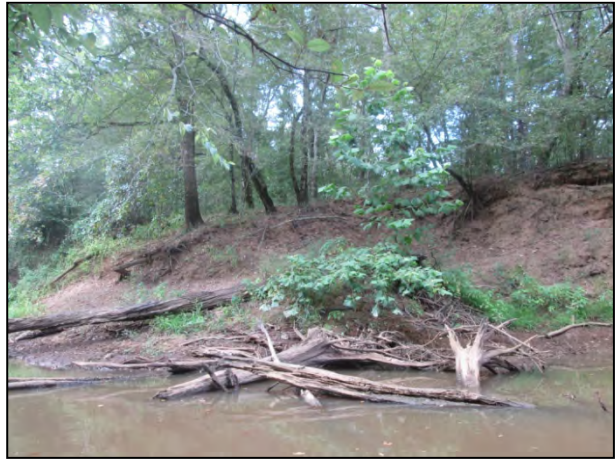
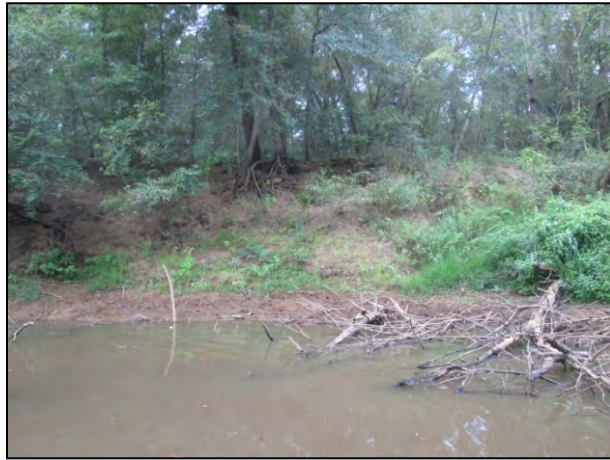
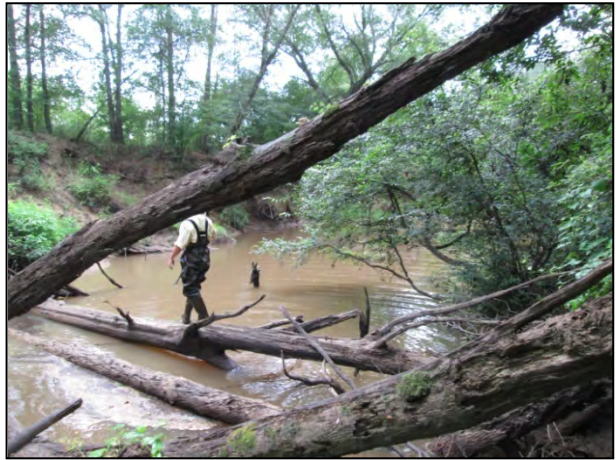
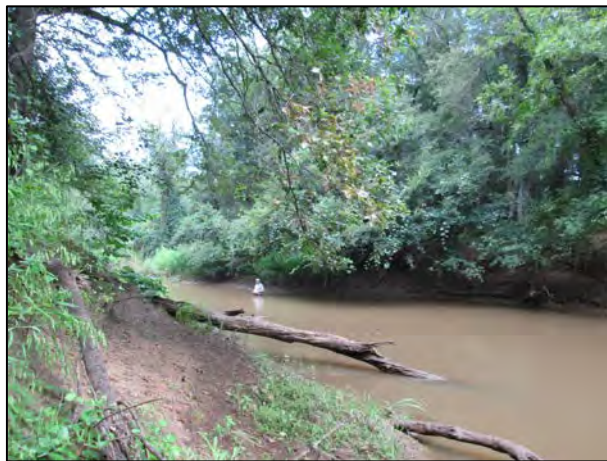
Photogroup 4-16 Attoyac 17 depicting general bank appearance. All individuals featured are SFASU and CES staff. Top left: 30-m transect, upstream, July 2012; Top right: 30-m transect, left bank, July 2012; Middle left: 150-m transect, right bank, July 2012; Middle right: 300-m transect, left bank, July 2012; Bottom left: 30-m transect, right bank, August 2012; Bottom right: 30-m transect, left bank, August 2012.

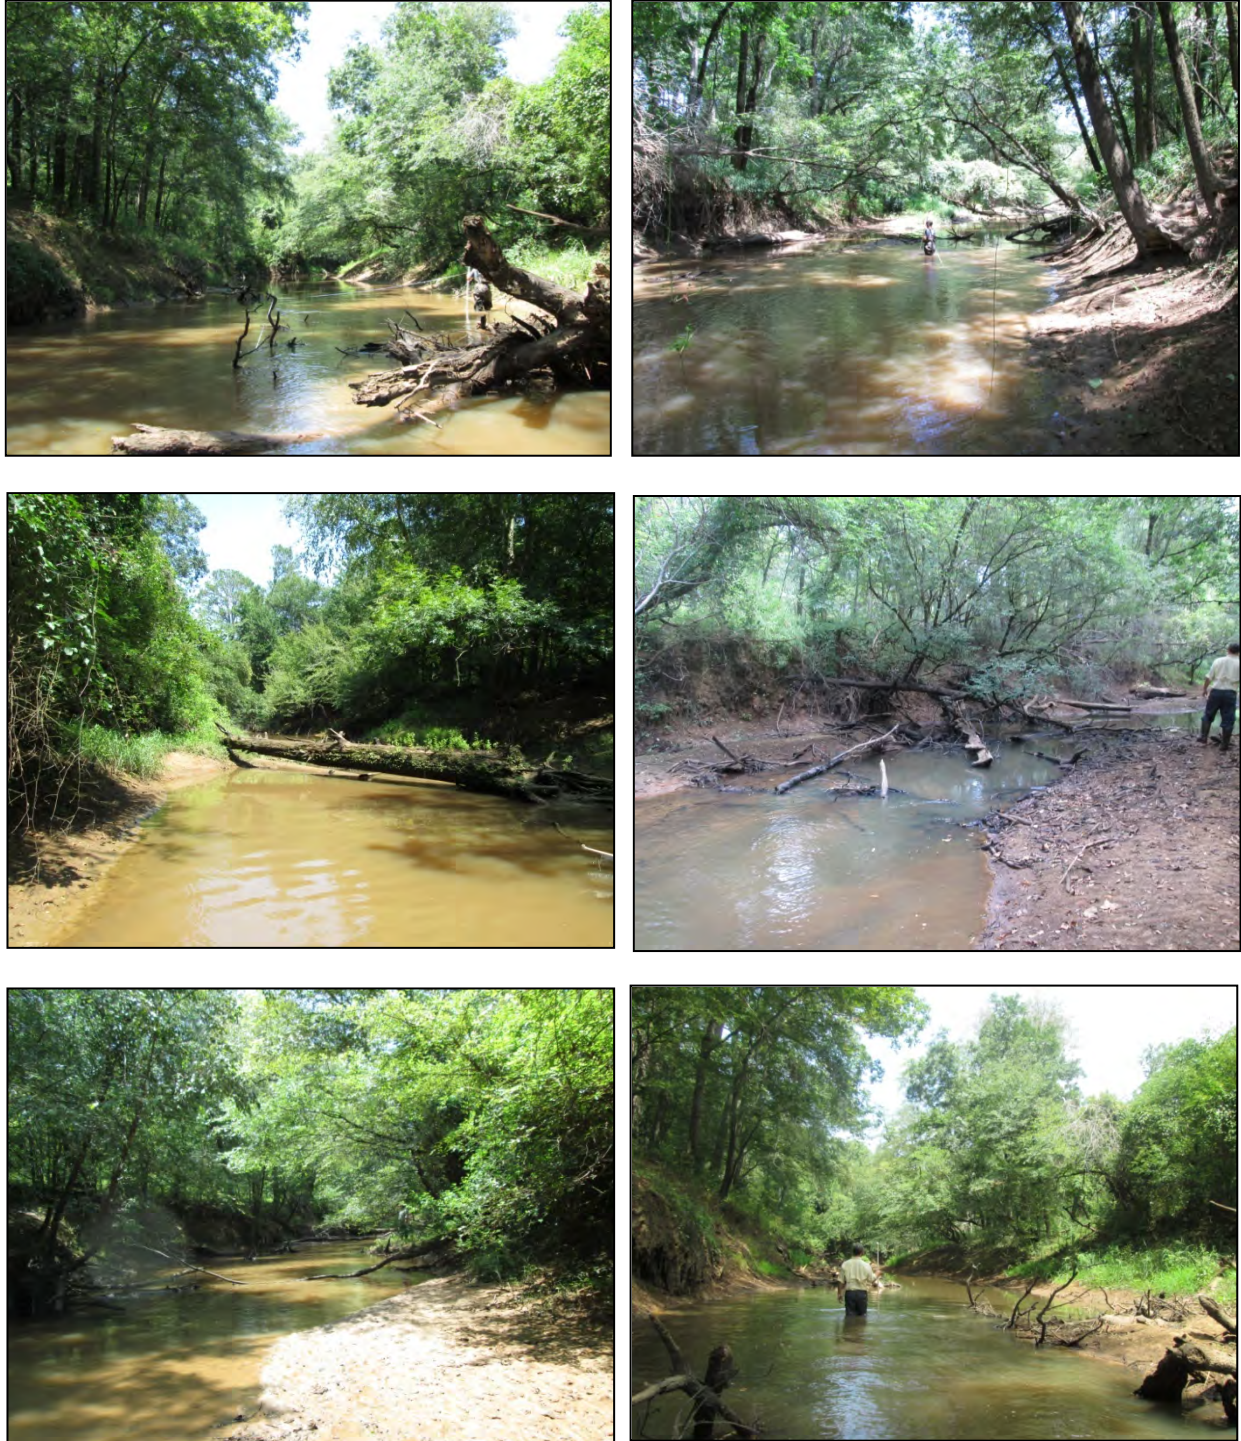
Photogroup 4-16 Attoyac 17 depicting water surface characteristics. All individuals featured are SFASU and CES staff. Top left: Large woody debris, August 2012; Top right: 300-m transect, left bank, August 2012; Middle left: 150-m transect, right bank, August 2012; Middle right: 300-m transect, downstream, July 2012; Bottom: 300-m transect, upstream, July 2012.

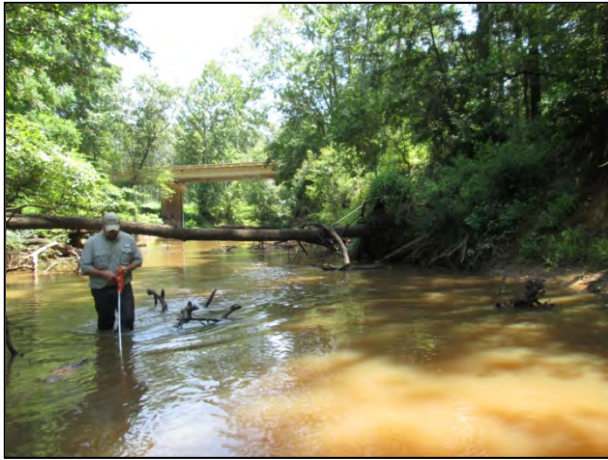
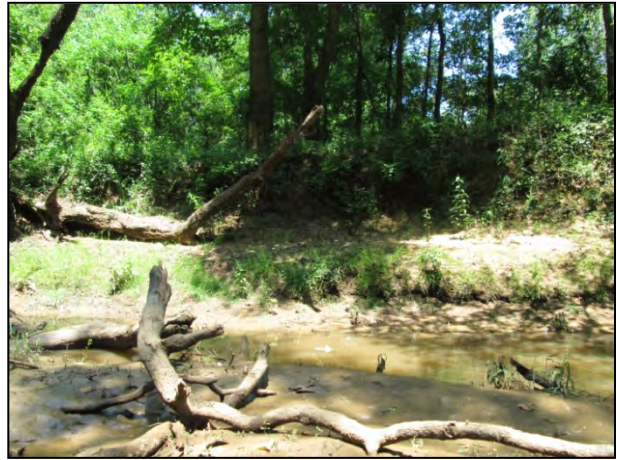
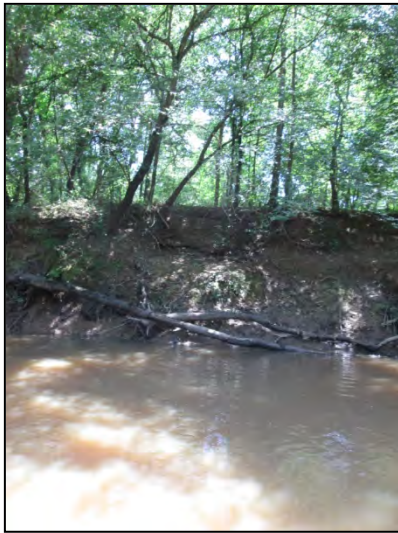
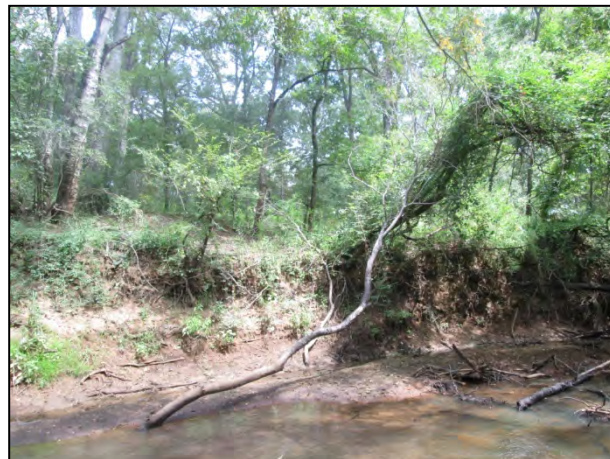
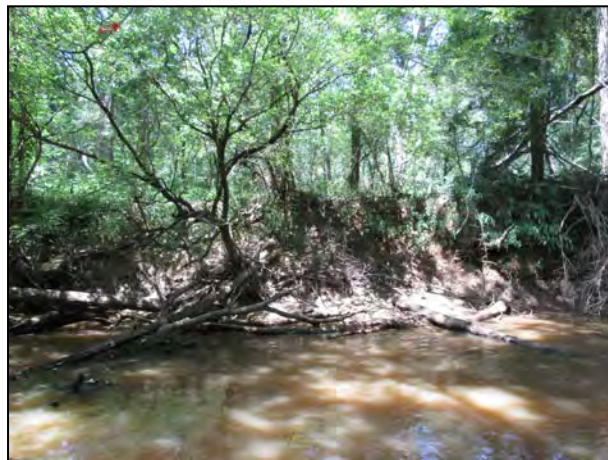
Photogroup 4-17 Attoyac 18 depicting general stream appearance. All individuals featured are SFASU and CES staff. Top Left: 30-m transect, upstream, July 2012; Top right: 150-m transect, upstream, July 2012; Middle left: 300-m transect, upstream, July 2012; Middle right: 150-m transect, upstream, August 2012; Bottom left: 300-m transect, downstream, July 2012; Bottom right: 30-m transect, upstream, August 2012.

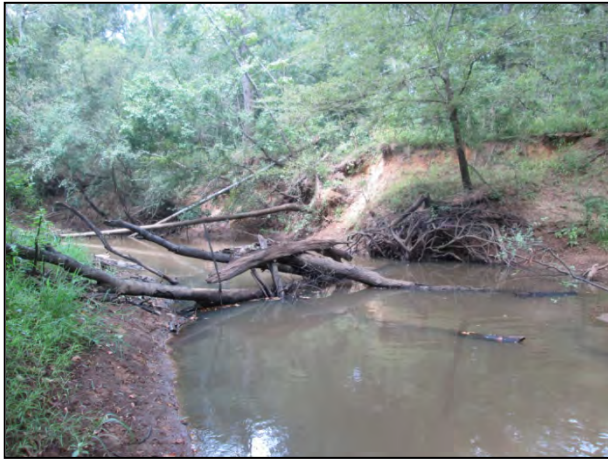
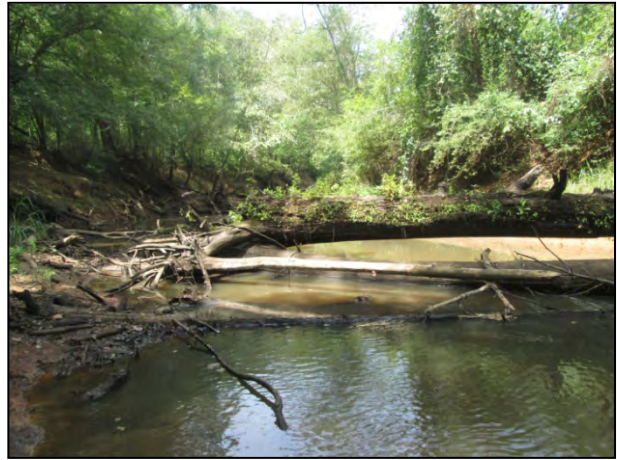
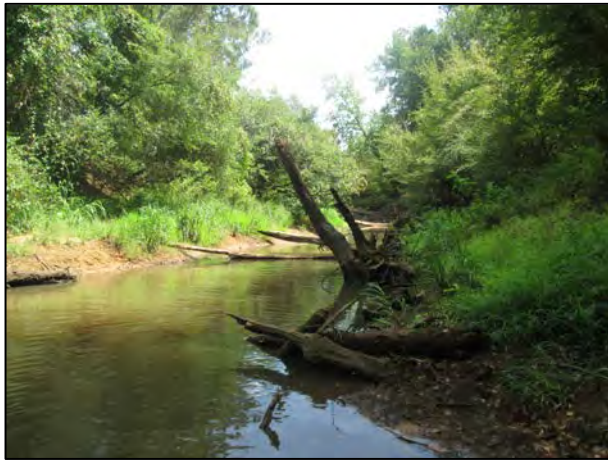
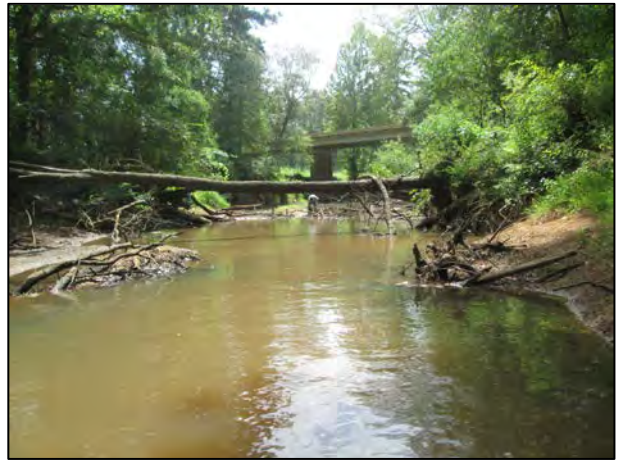
Photogroup 4-17 Attoyac 18 depicting general bank appearance. All individuals featured are SFASU and CES staff. Top left: 30-m transect, downstream, July 2012; Top right: 30-m transect, left bank, July 2012; Middle left: 300-m transect, right bank, August 2012; Middle right: 150-m transect, left bank, August 2012; Bottom: 150-m transect, left bank, July 2012.

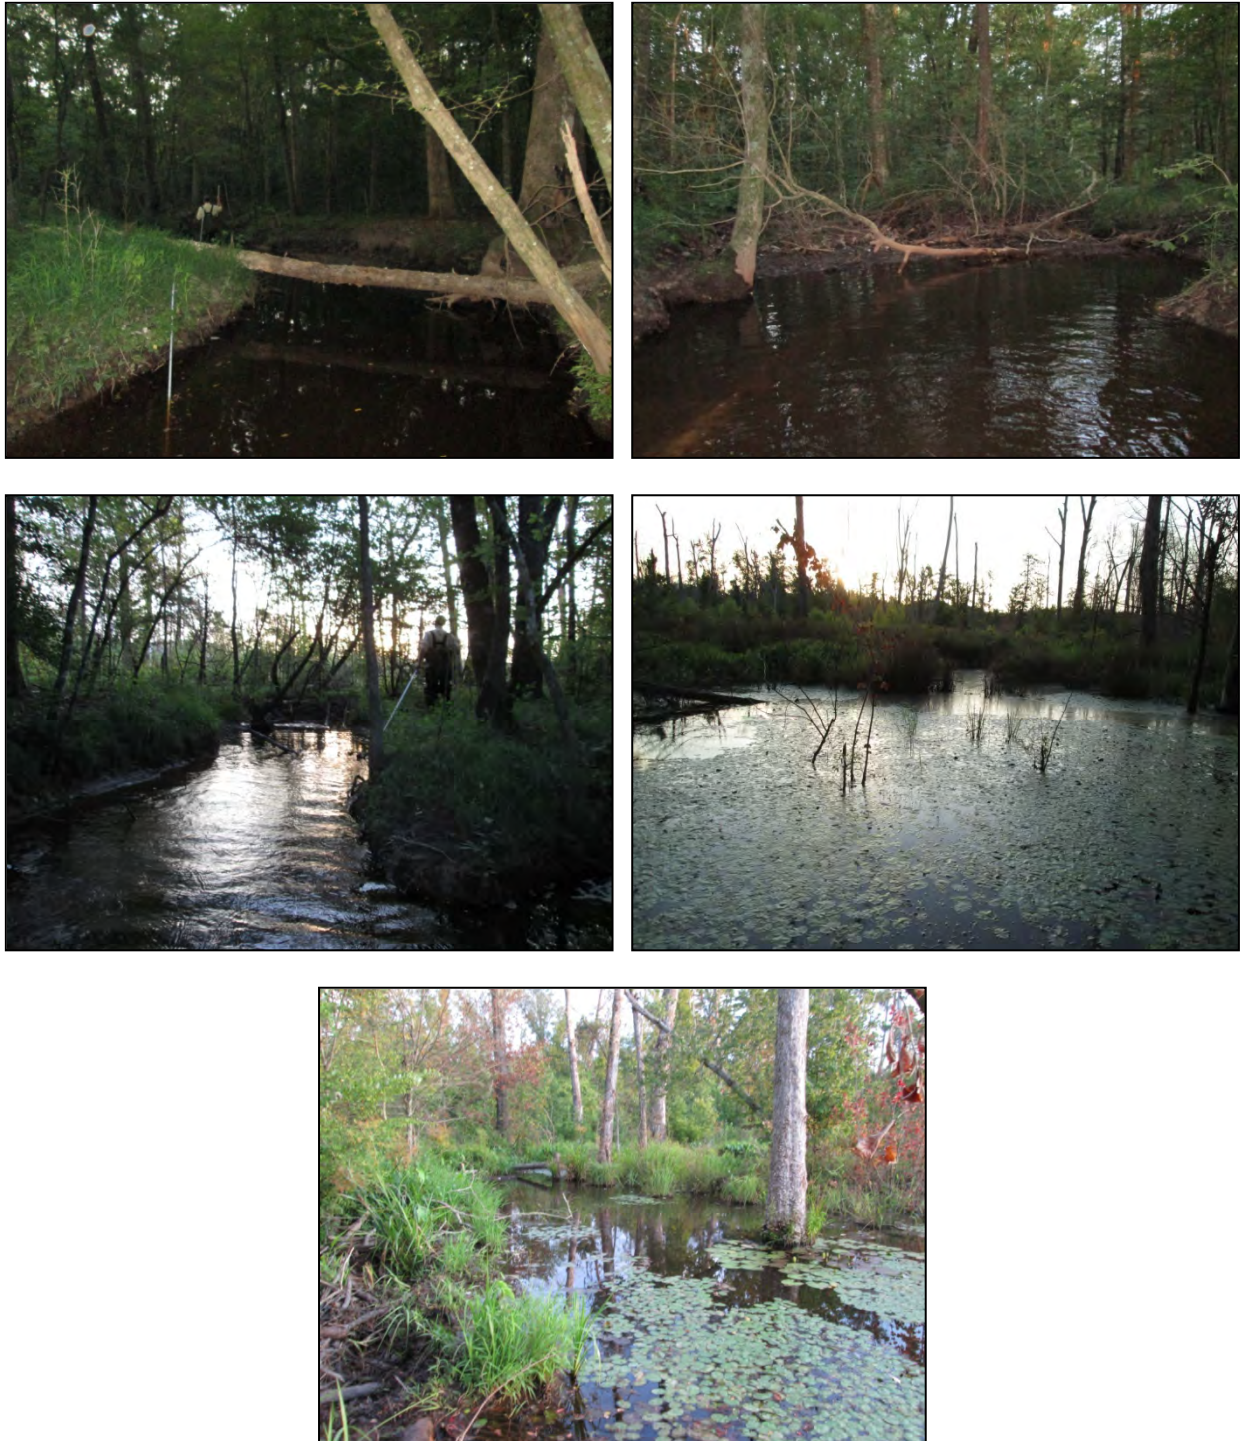
Photogroup 4-18 Big Iron Ore 1 depicting general stream characteristics. All individuals featured are SFASU and CES staff. Top left: 30-m transect, upstream, July 2012; Top right: 150-m transect, downstream, July 2012; Middle left: 150-m transect, upstream, July 2012; Middle right: 300-m transect, upstream, July 2012; Bottom: 300-m transect, left bank, July 2012.

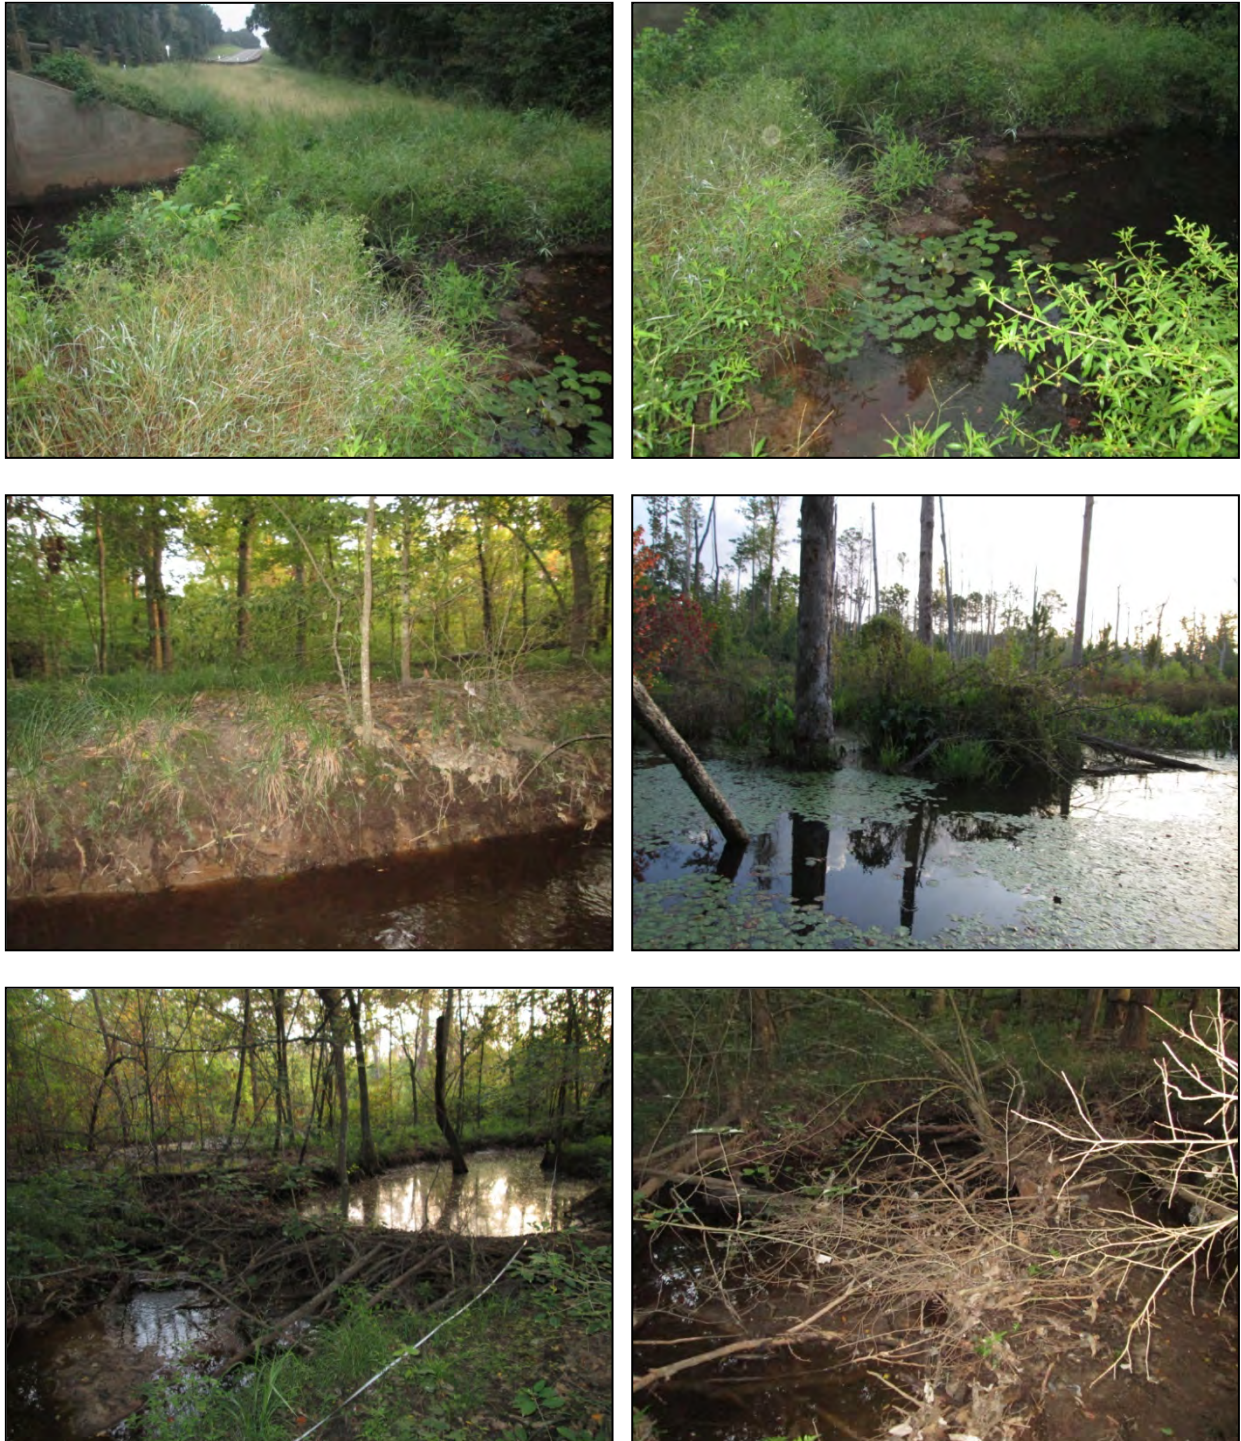
Photogroup 4-18 Big Iron Ore 1 depicting general bank appearance and water surface characteristics. 0-m transect, Highway 96 access point; Top right: 0-m transect, left bank, August 2012; Middle left: 150-m transect, left bank, July 2012; Middle right: 300-m transect, right bank, July 2012; Bottom left: Beaver dam; Bottom right: Woody debris.

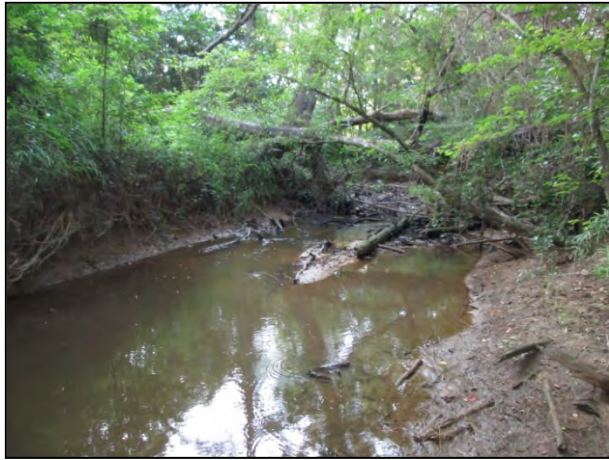
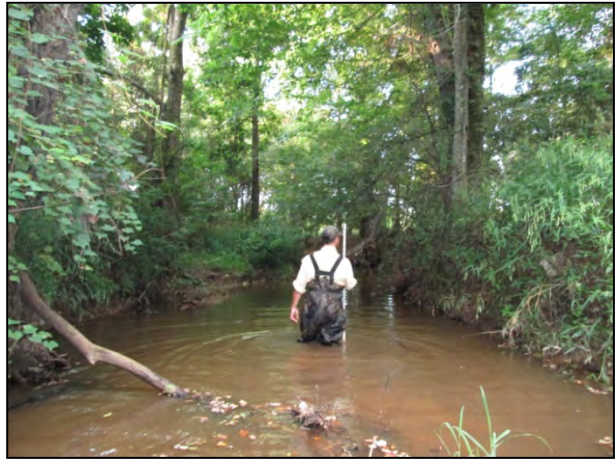
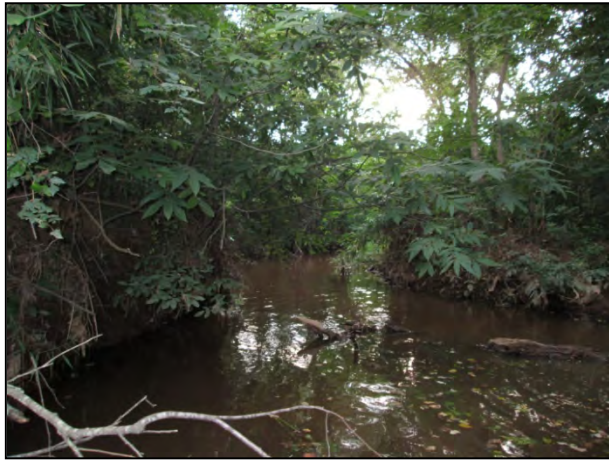
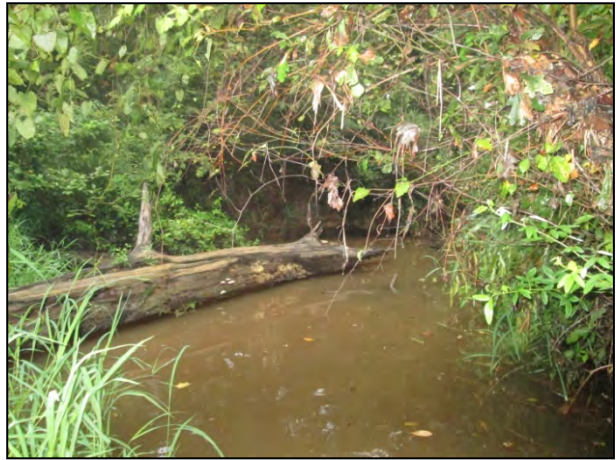
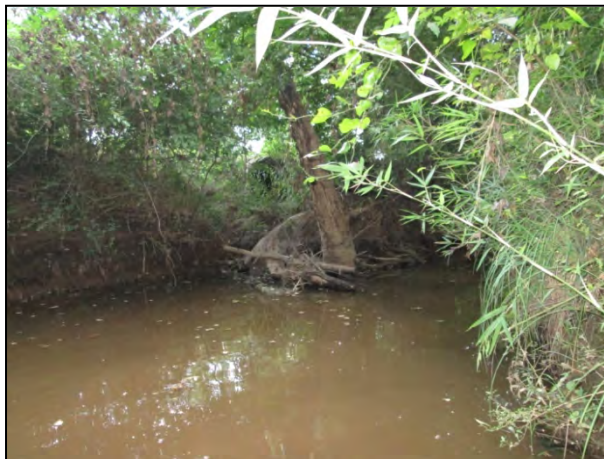
Photogroup 4-19 Big Iron Ore 2 depicting general stream characteristics. All individuals featured are SFASU and CES staff. Top left: 30-m transect, upstream, July 2012; Top right: 150-m transect, upstream, July 2012; Middle left: 300-m, upstream, July 2012; Middle right: 150-m transect, downstream, August 2012; Bottom: 300-m transect, downstream, August 2012.

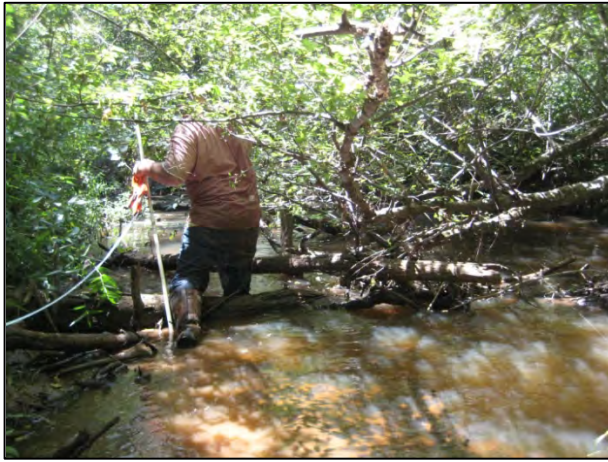
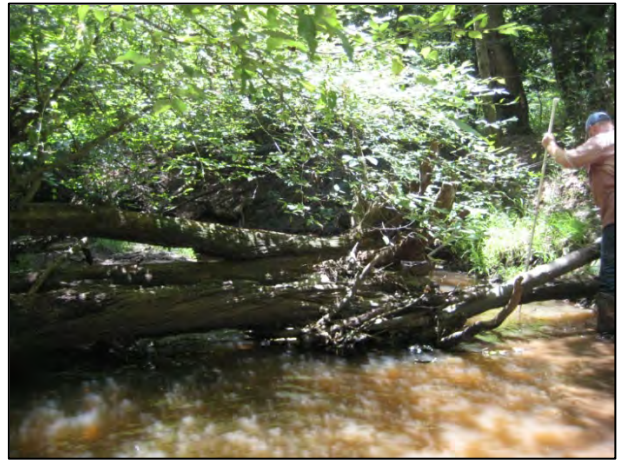
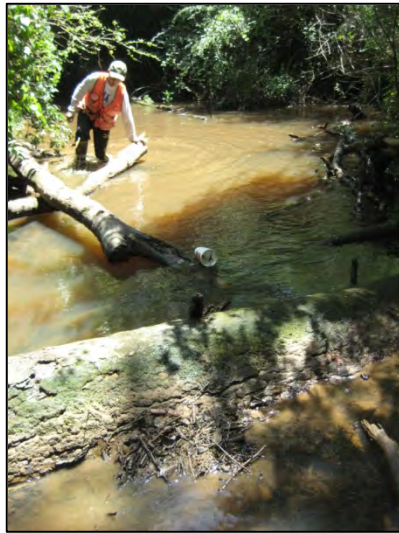
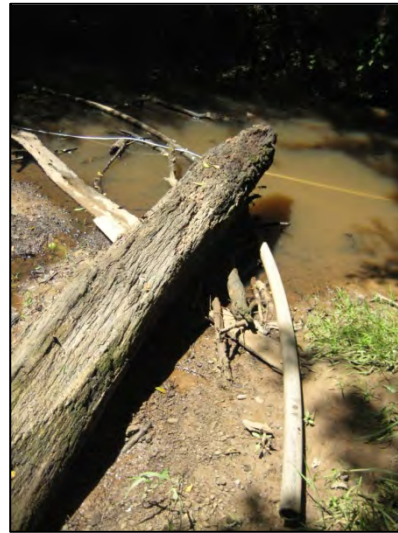
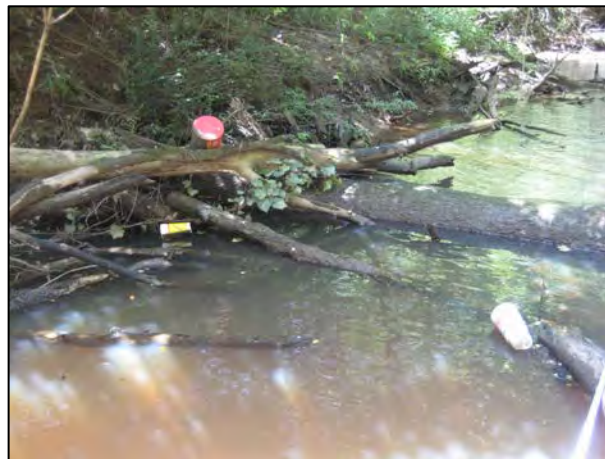
Photogroup 4-26 Naconiche 7 depicting water surface characteristics. All individuals featured SFASU and CES staff. Top left: Large woody debris across/within channel, July 2012; Top right: Large woody debris across/within channel, July 2012; Middle left: Large woody debris in channel, July 2012; Middle right: Large woody debris and littler within channel, July 2012; Bottom: Large woody debris and small litter within channel, July 2012.

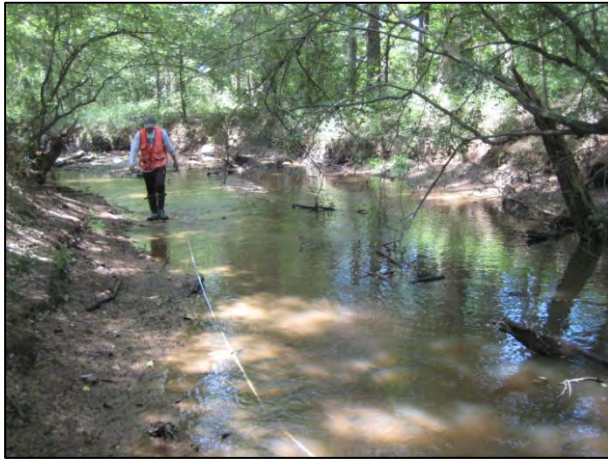
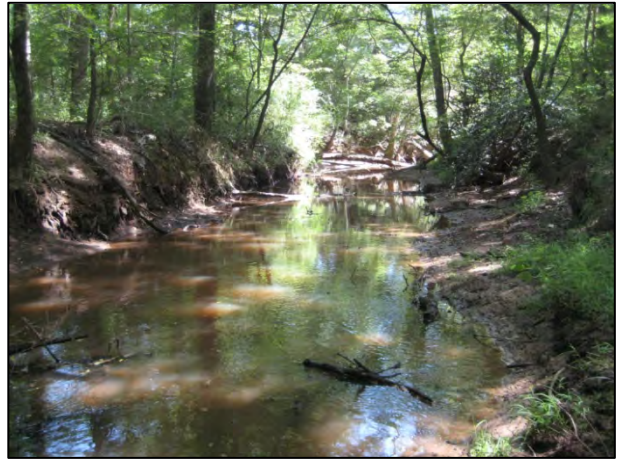
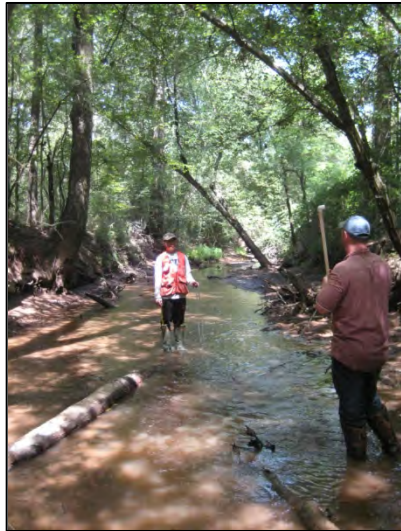
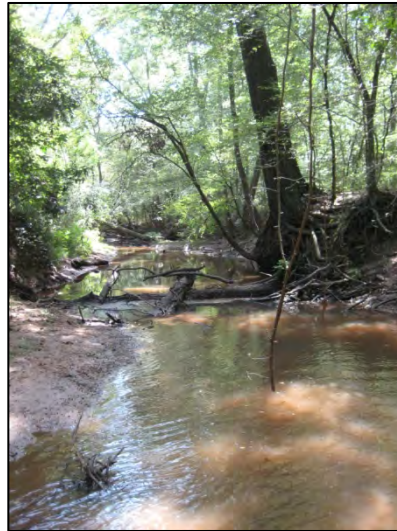
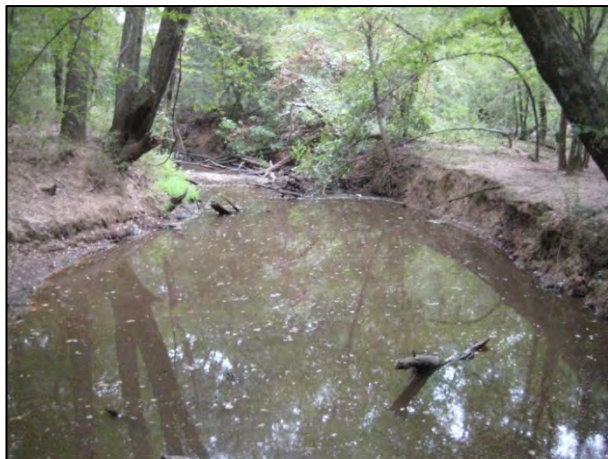
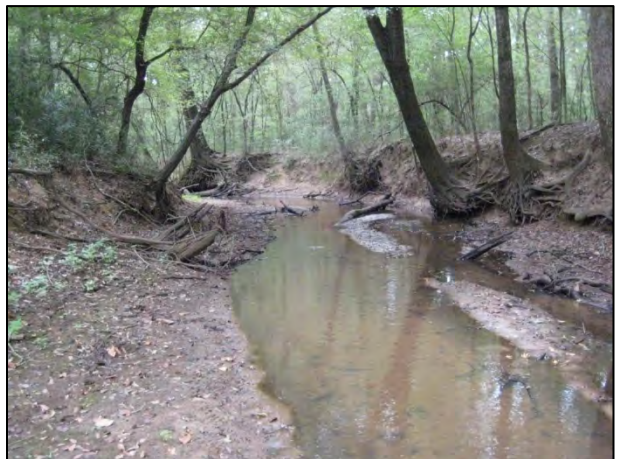
Photogroup 4-27 Naconiche 8 depicting general stream characteristics. All individuals featured are SFASU and CES staff. Top left: 150-m transect, upstream, July 2012; Top right: 150-m transect, downstream, July 2012; Middle left: 300-m transect, upstream, July 2012; Middle right: 300-m transect, downstream, July 2012; Bottom left: 30-m transect, downstream, August 2012; Bottom right: 300-m transect, downstream, August 2012.

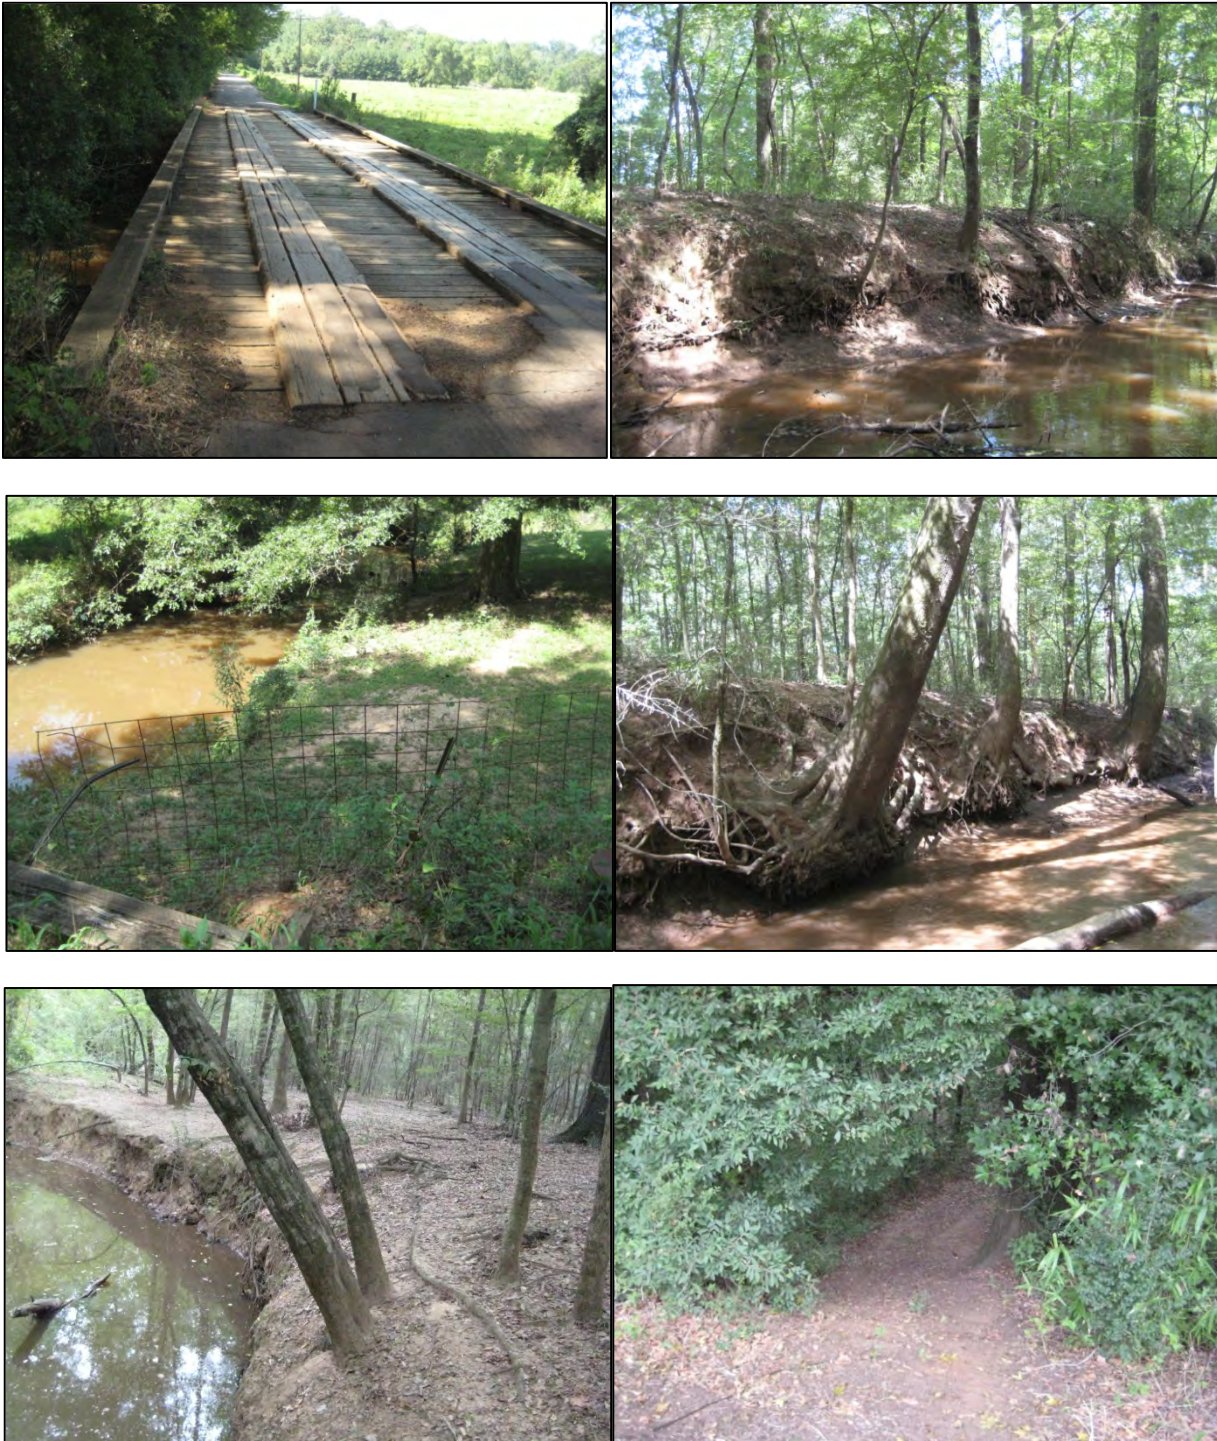
Photogroup 4-27 Naconiche 8 depicting general bank appearance. All individuals featured are SFASU and CES staff. Top left: Cedar Bluff Road (CR 273) crossing, July 2012; Top right: 150-m transect, left bank, July 2012; Middle left: Fenced bank upstream adjacent to road crossing, July 2012; Middle right: 300-m transect, right bank, July 2012; Bottom left: 30-m transect, right bank, August 2012; Bottom right: Possible ATV trail entrance adjacent to stream crossing, August 2012.

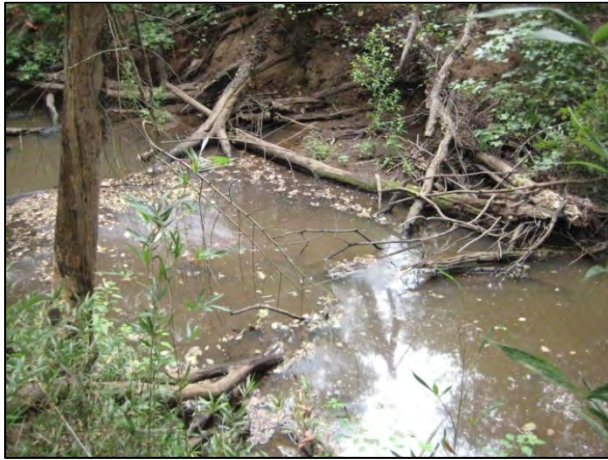
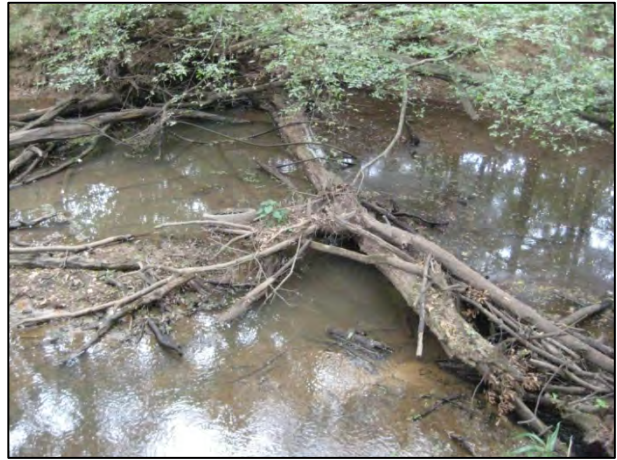
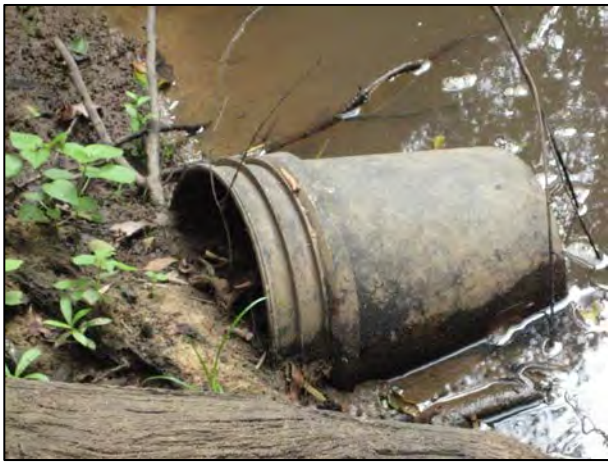
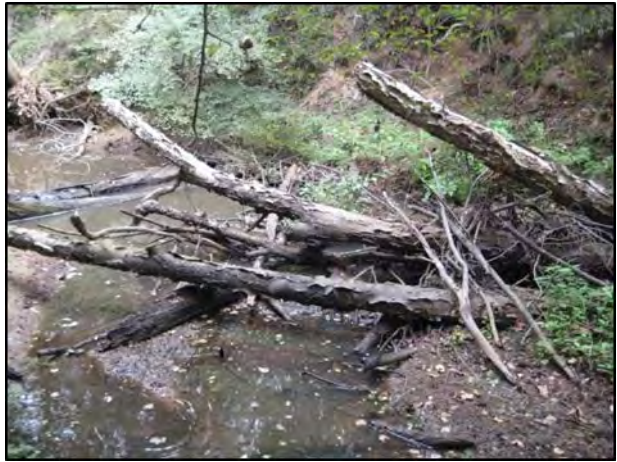
Photogroup 4-27 Naconiche 8 depicting stream surface characteristics. Top left: Large woody debris within channel, August 2012; Top right: Large woody debris across/within channel, August 2012; Bottom left: Large channel litter (bucket), August 2012; Bottom right: Large woody debris across channel, August 2012.

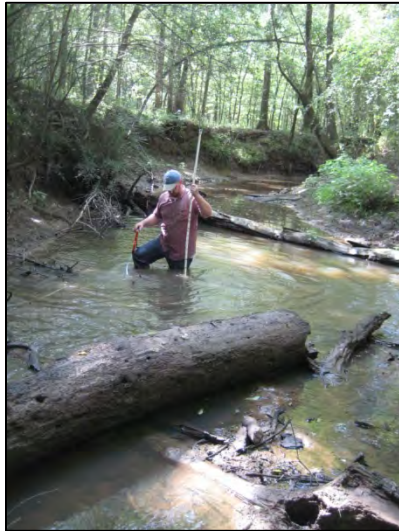
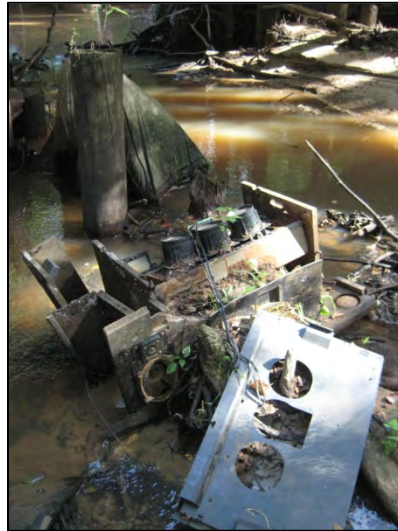
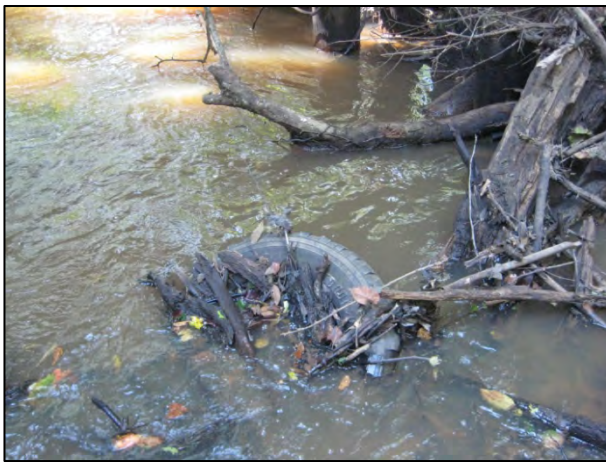
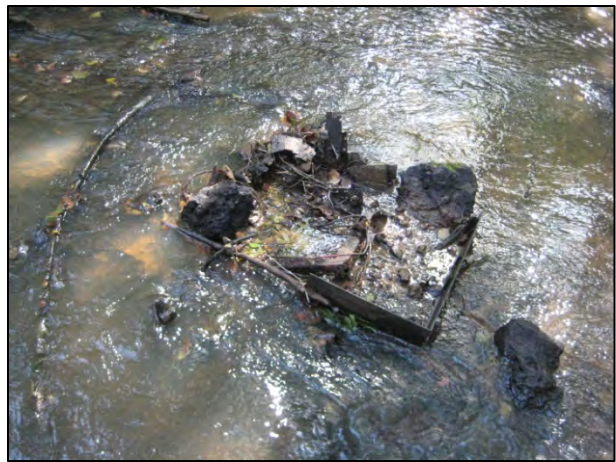
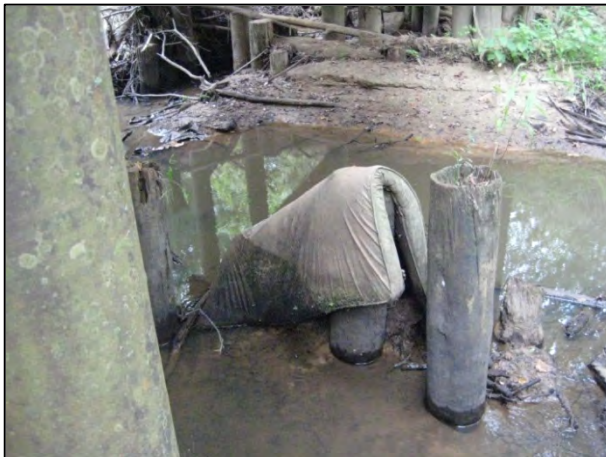
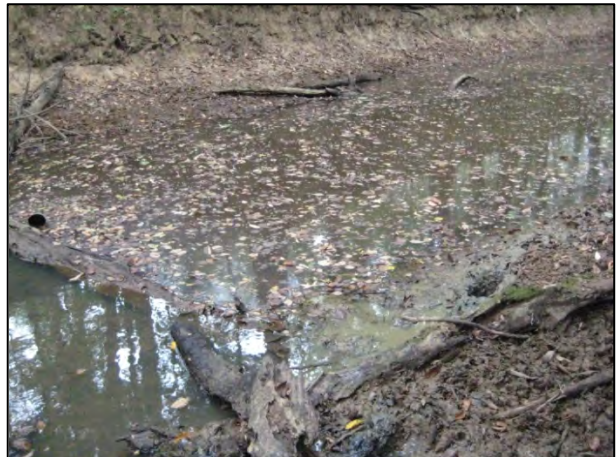
Photogroup 4-28 Naconiche 9 depicting water surface characteristics. All individuals featured are SFASU and CES staff. Top left: Large woody debris, July 2012; Top right: Large channel litter (electronic metal object) under CR 280 crossing July 2012; Middle left: Large channel litter (tire) adjacent to CR 280 crossing, July 2012; Middle right: Large channel litter (metal object) adjacent to CR 280 crossing; Bottom left: Large channel litter (mattress) under CR 280 crossing, July 2012; Bottom right: Organic debris on water surface, August 2012.
