Attoyac Bayou Recreational Use Attainability Analysis

**Attoyac Bayou
Recreational Use Attainability Analysis**

**Texas State Soil and Water Conservation Board
Project # 09-10**

October 2012

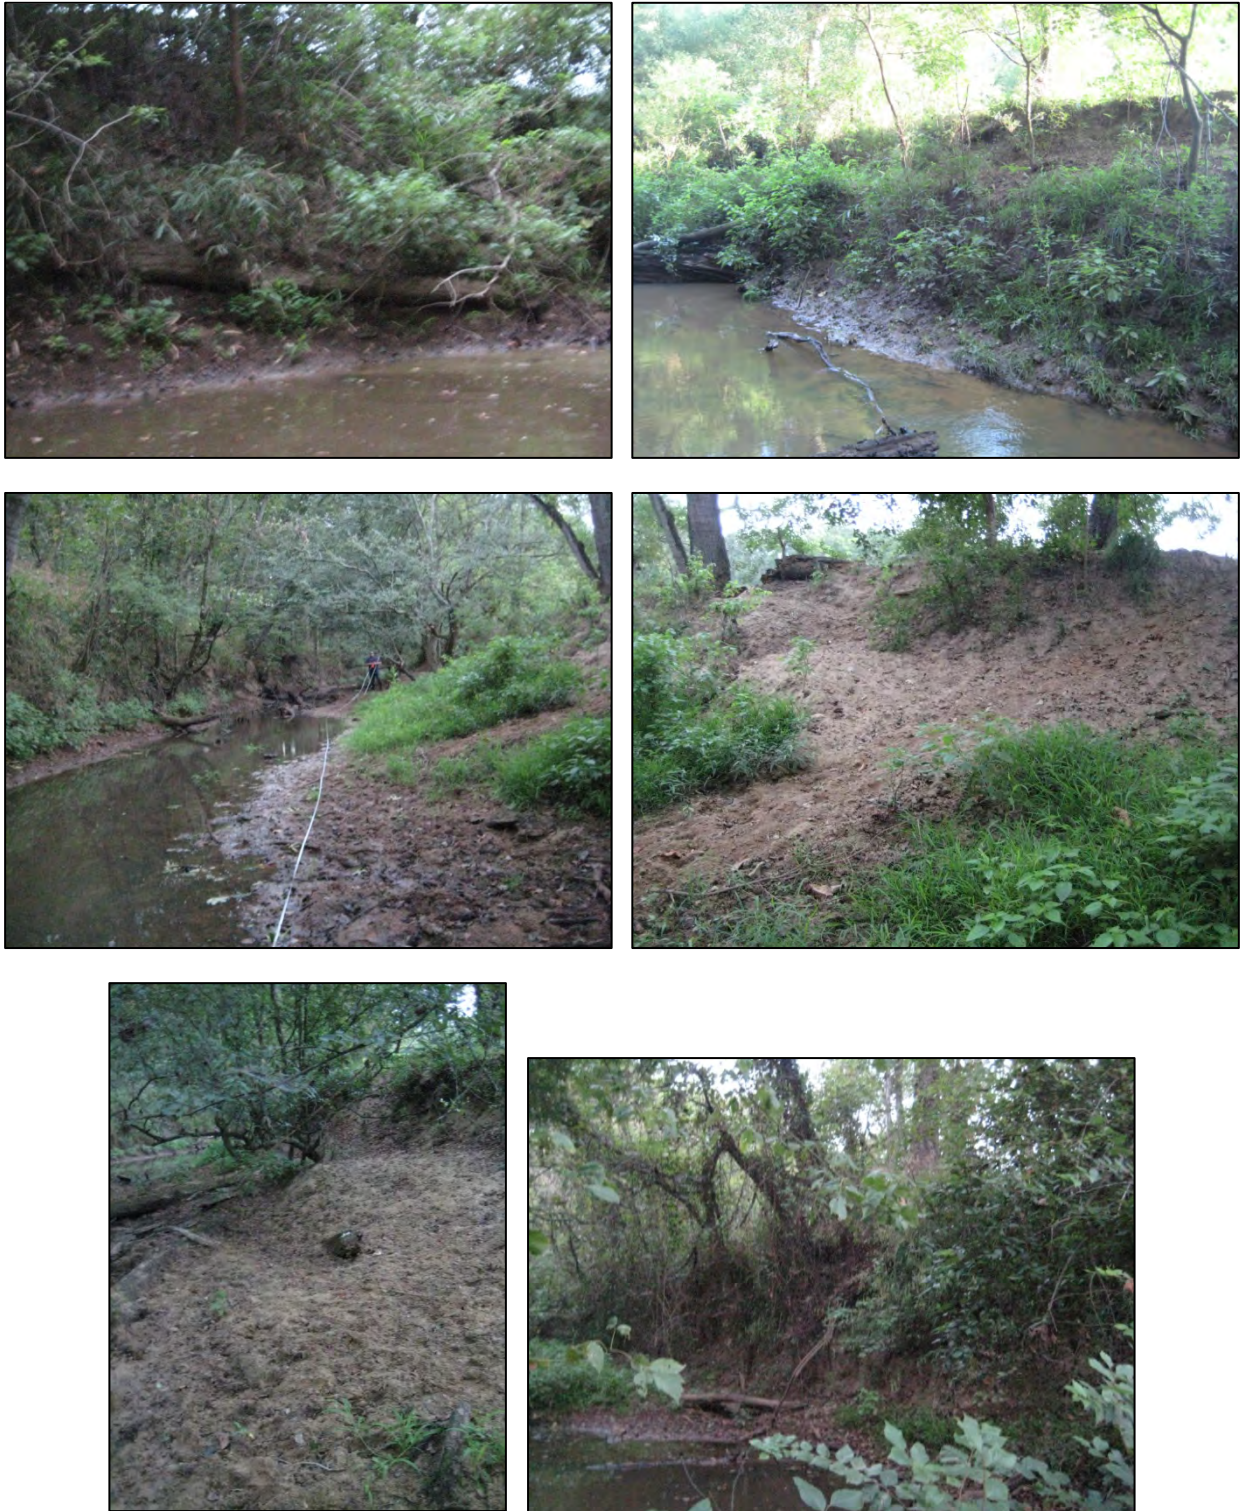
Photogroup 4-29 Naconiche 10 depicting general bank appearance. Top left: 300-m transect, left bank, August 2012; Top right: 300-m transect, left bank, July 2012; Middle left: Downstream view with cattle access along bank, August 2012; Middle right: Livestock access along bank, August 2012; Bottom left: Heavy cattle use along right bank; August 2012; Bottom right: 150-m transect, right bank, August 2012.

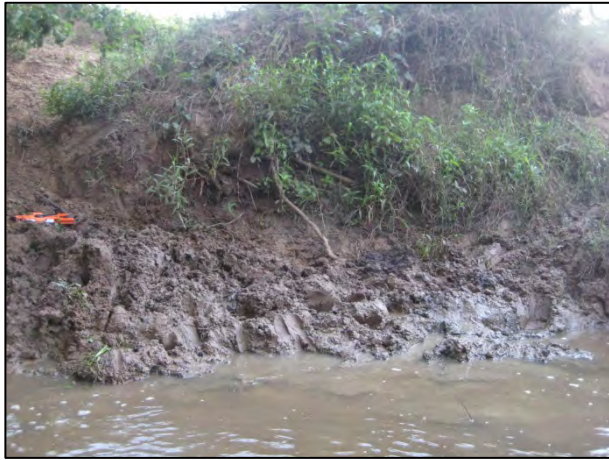
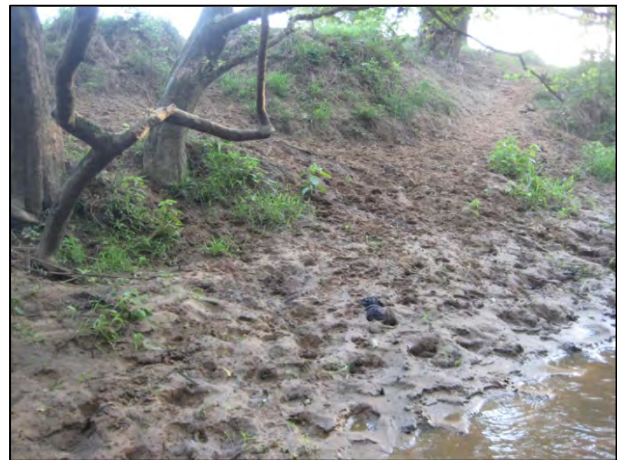
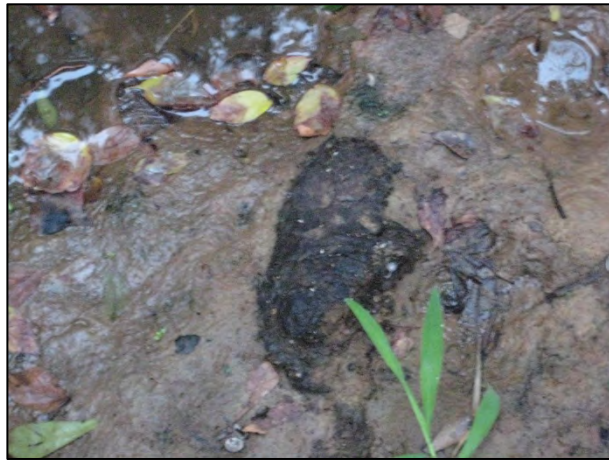
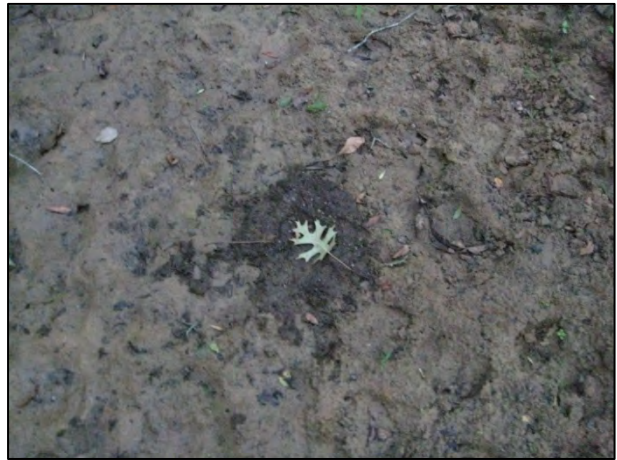
Photogroup 4-29 Naconiche 10 depicting livestock access and potential sources of contamination. Top left: Heavy livestock use along stream bank, July 2012; Top right: Heavy livestock use with fecal matter along stream bank, July 2012; Bottom left: Livestock fecal, August 2012; Bottom right: Livestock fecal, August 2012.

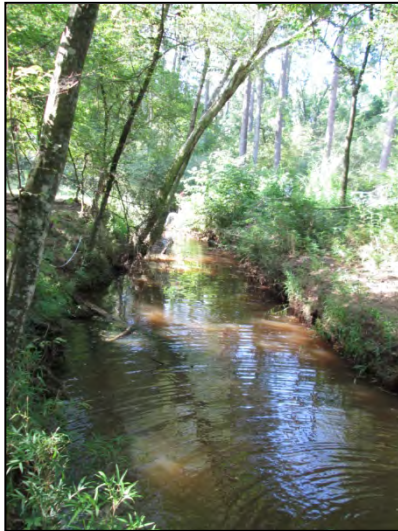
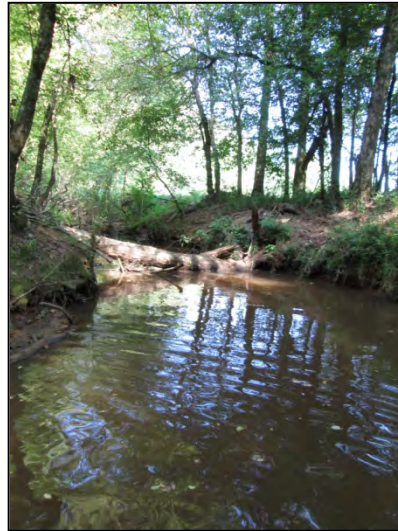
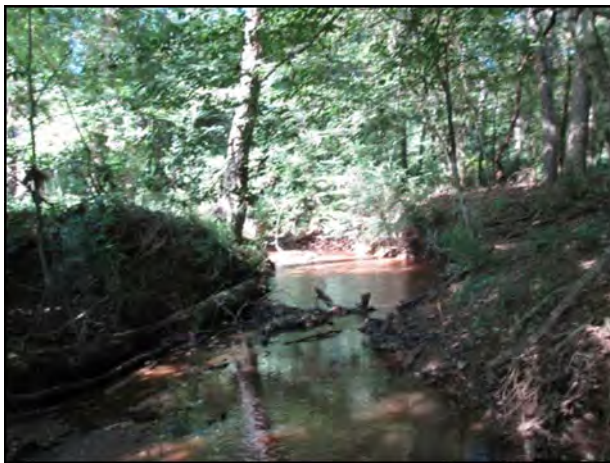
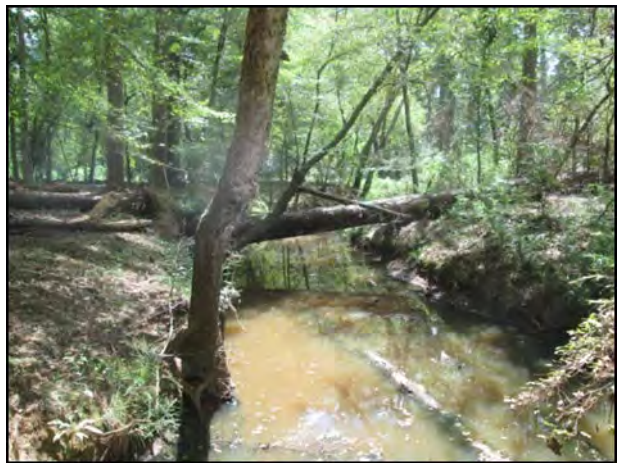
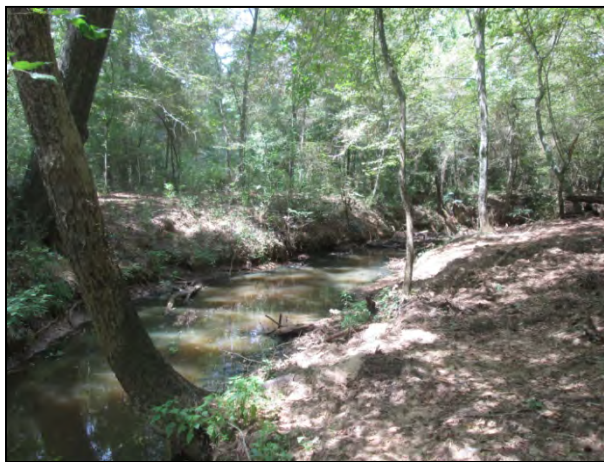
Photogroup 4-31 Terrapin 1 depicting general stream characteristics. Top left: 0-m transect, downstream, July 2012; Top right: 0-m transect, upstream, July 2012; Bottom left: Downstream, dry stream channel, August 2012; Bottom center: Downstream, dense vegetation covering channel, August 2012; Bottom right: 0-m transect, downstream, view from CR 234 crossing, July 2012.

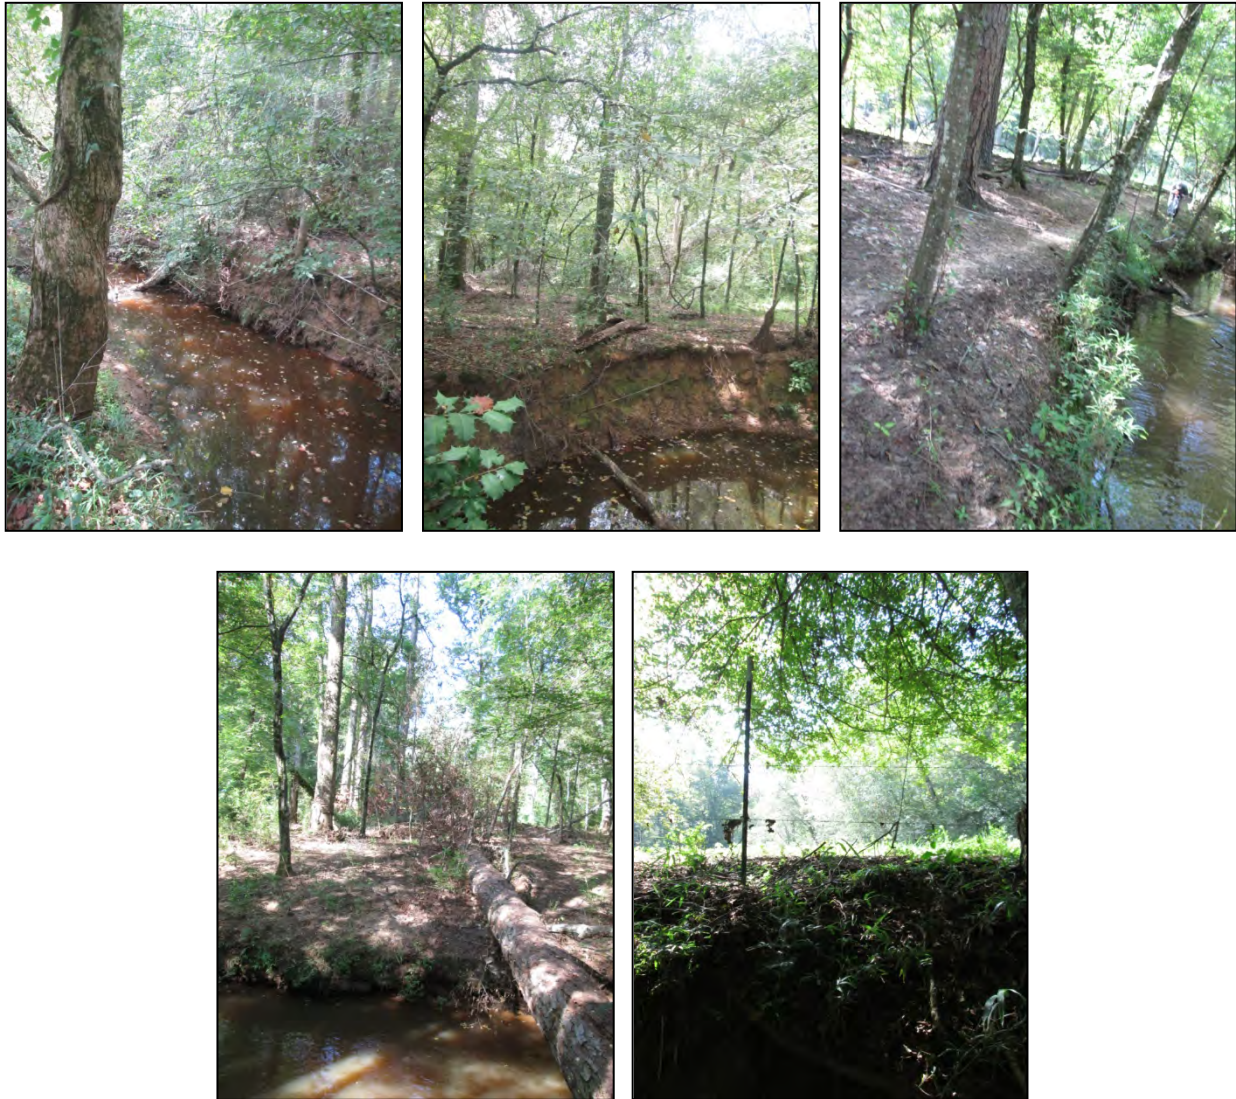
Photogroup 4-32 Terrapin 2 depicting general stream characteristics. Top left: 30-m transect, downstream, July 2012; Top right: 150-m transect, upstream, July 2012; Middle left: 300-m transect, downstream, July 2012; Middle right: 30-m transect, downstream, August 2012; Bottom: 30-m transect, upstream, August 2012.

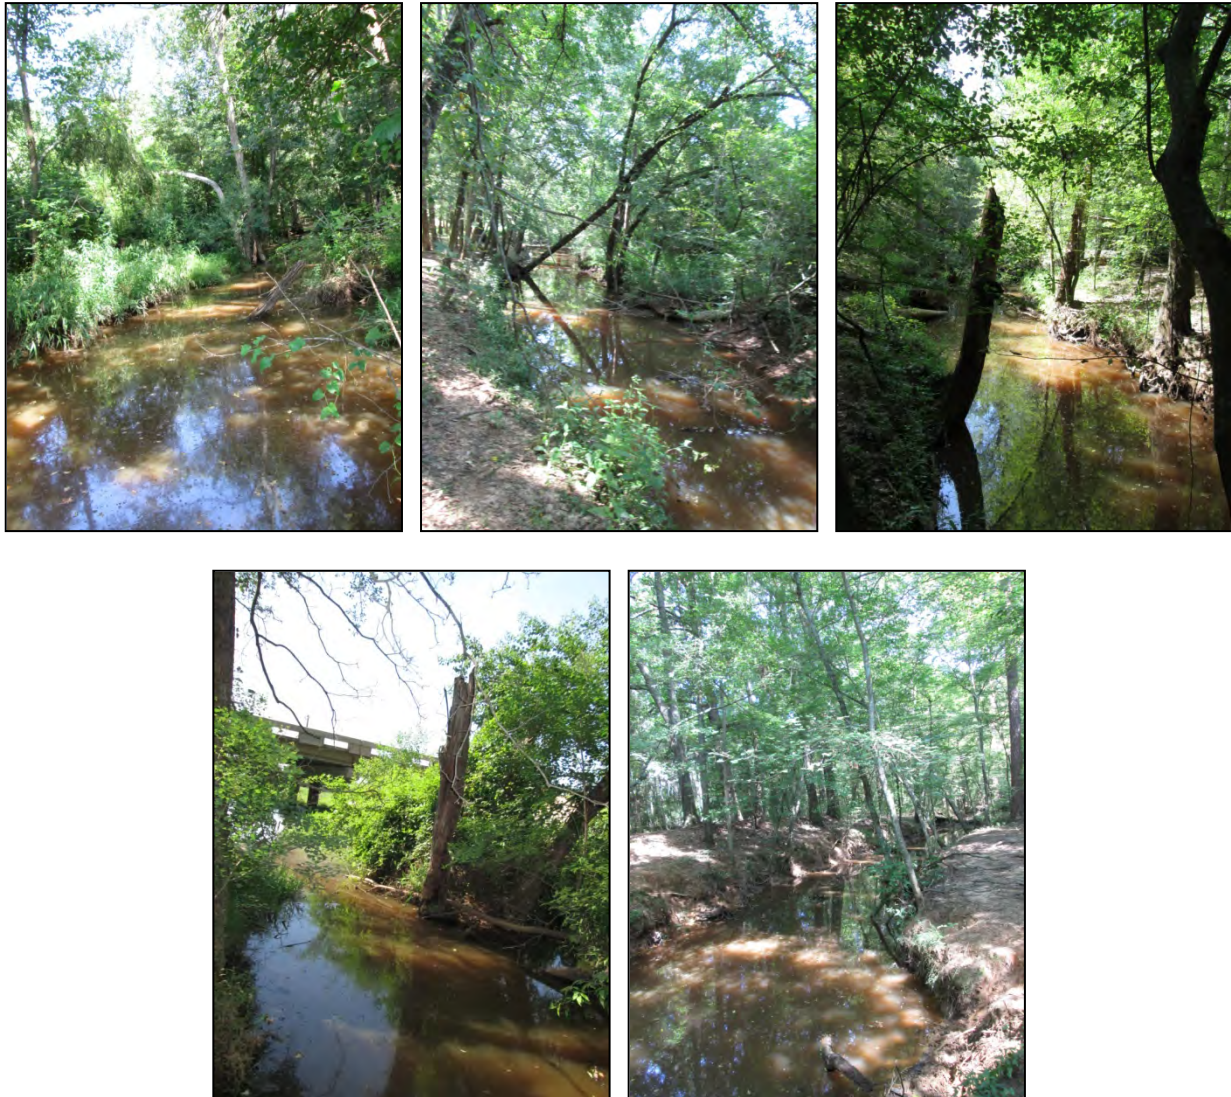
Photogroup 4-32 Terrapin 2 depicting water surface characteristics. All individuals featured are SFASU and CES staff. Top left: Logjam with foam, July 2012; Top right: Logjam within channel, July 2012; Middle left: 150-m transect, upstream, August 2012; Middle right: 150-m transect, downstream, July 2012; Bottom: 300-m transect, upstream, July 2012.

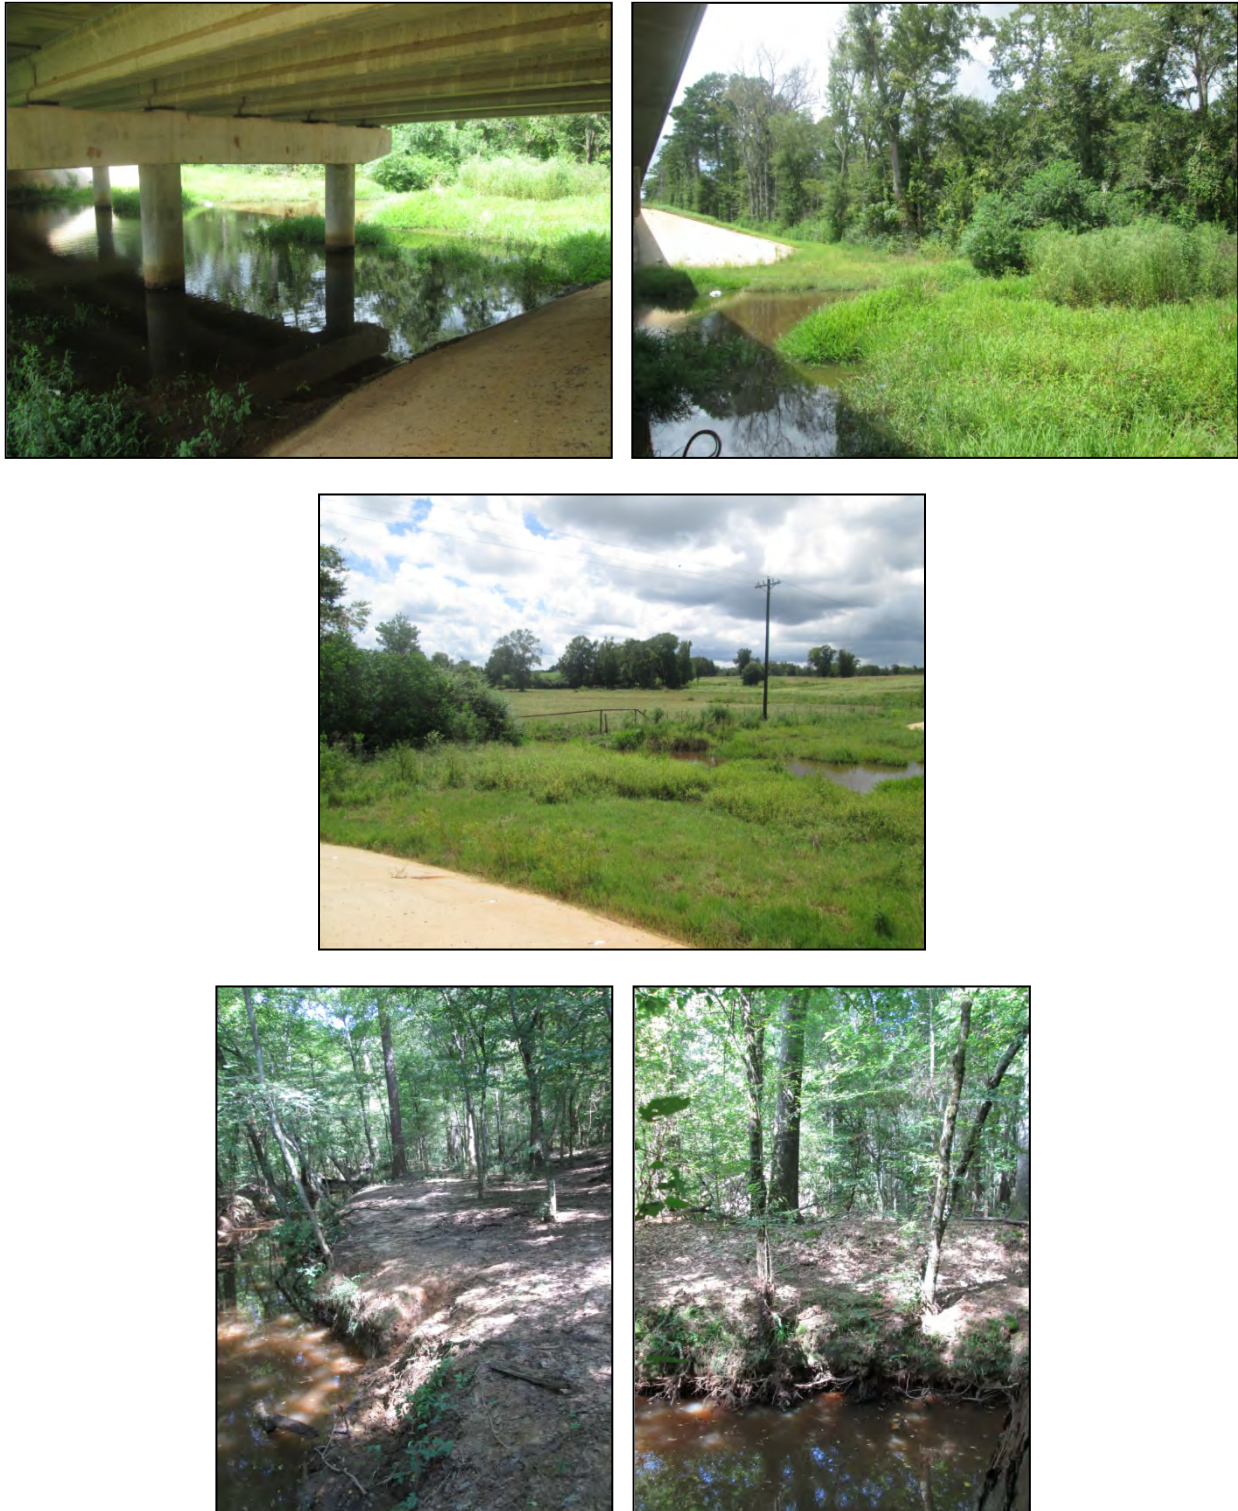
Photogroup 4-33 Terrapin 3 depicting general stream characteristics. Top left: 30-m transect, upstream, July 2012; Top center: 150-m transect, downstream, July 2012; Top right: 300-m transect, downstream, July 2012; Bottom left: 30-m transect, downstream, July 2012; Bottom right: 300-m transect, upstream, July 2012.

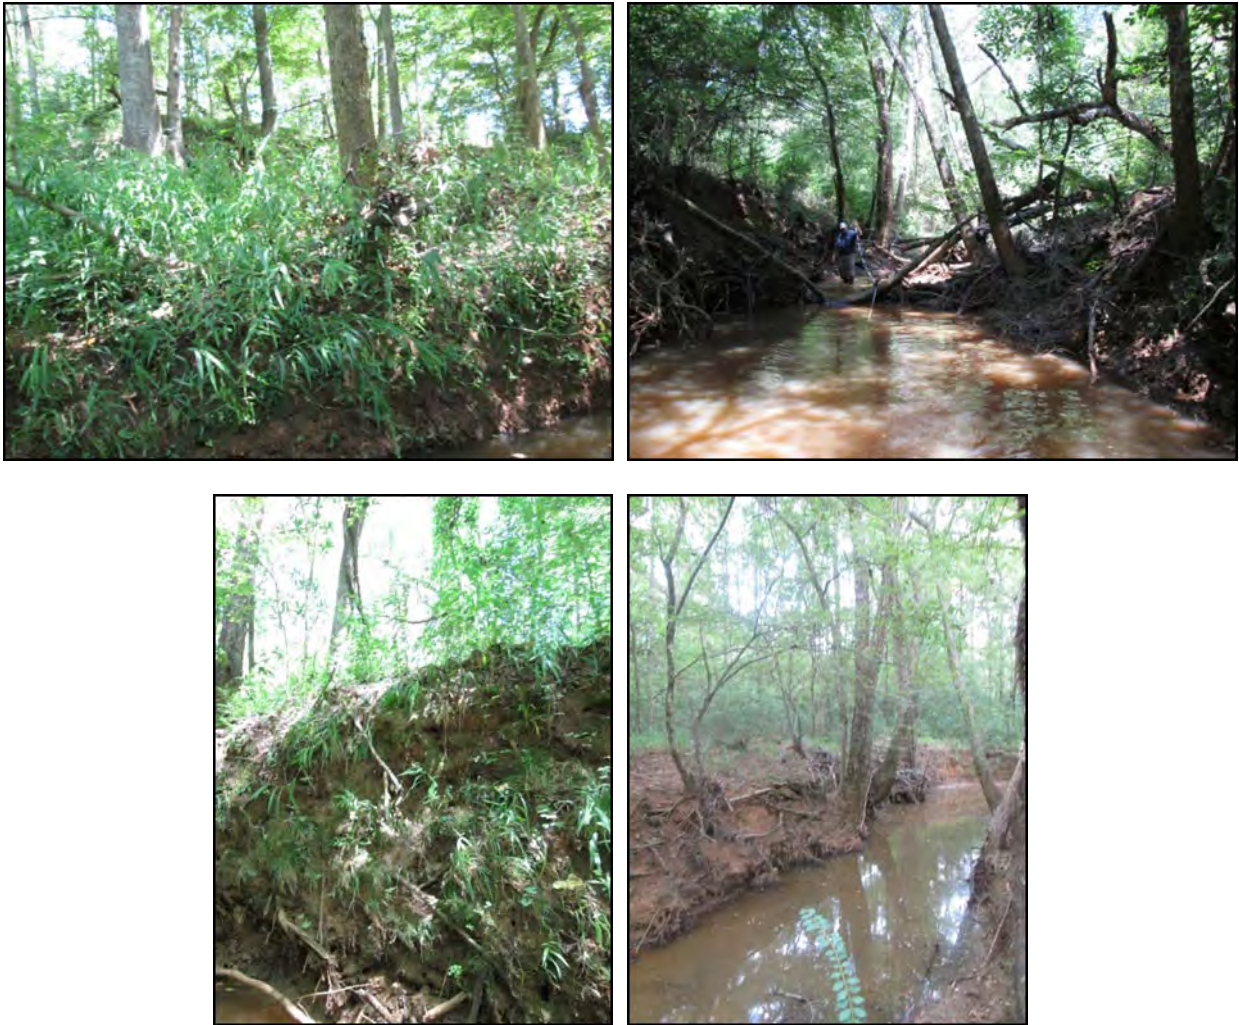
Photogroup 4-34 Terrapin 4 depicting general stream characteristics. Top left: 300-m transect, downstream, August 2012; Top right: 150-m transect, downstream, July 2012; Bottom left: 300-m transect, downstream, July 2012; Bottom center: 150-m transect, downstream, August 2012; Bottom right: 150-m transect, upstream, August 2012.

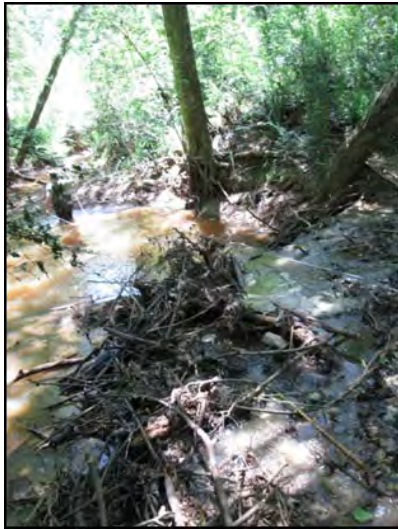
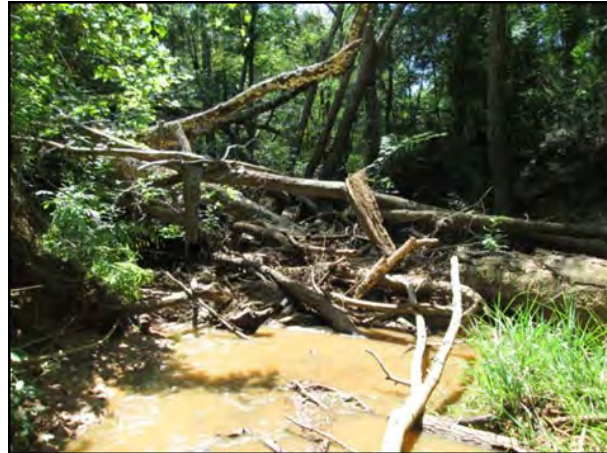
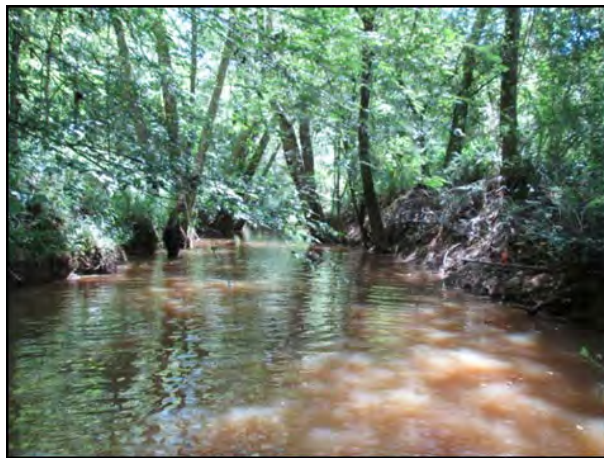
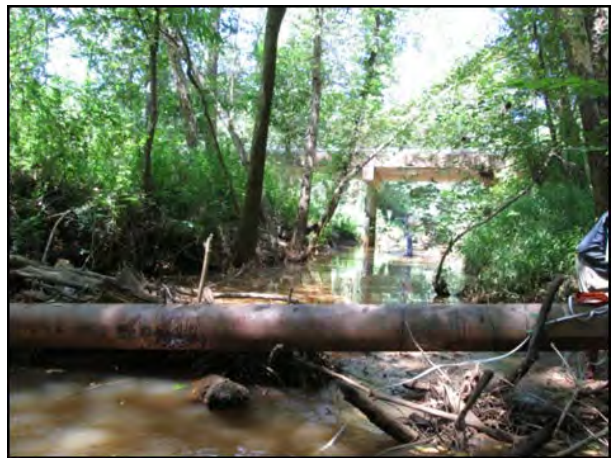
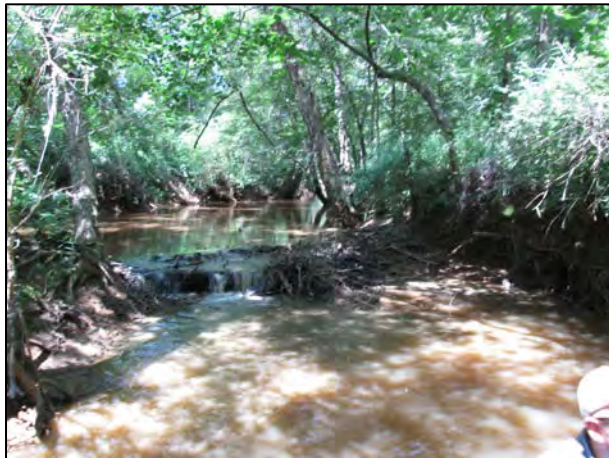
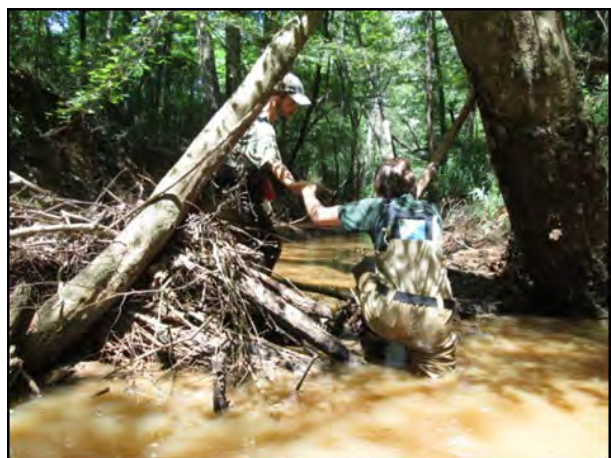
Photogroup 4-34 Terrapin 4 depicting general bank appearance. Top left: 30-m transect, right bank, July 2012; Top right: 150-m transect, upstream, July 2012; Bottom left: 150-m transect, right bank, July 2012; Bottom right: 300-m transect, upstream, August 2012.

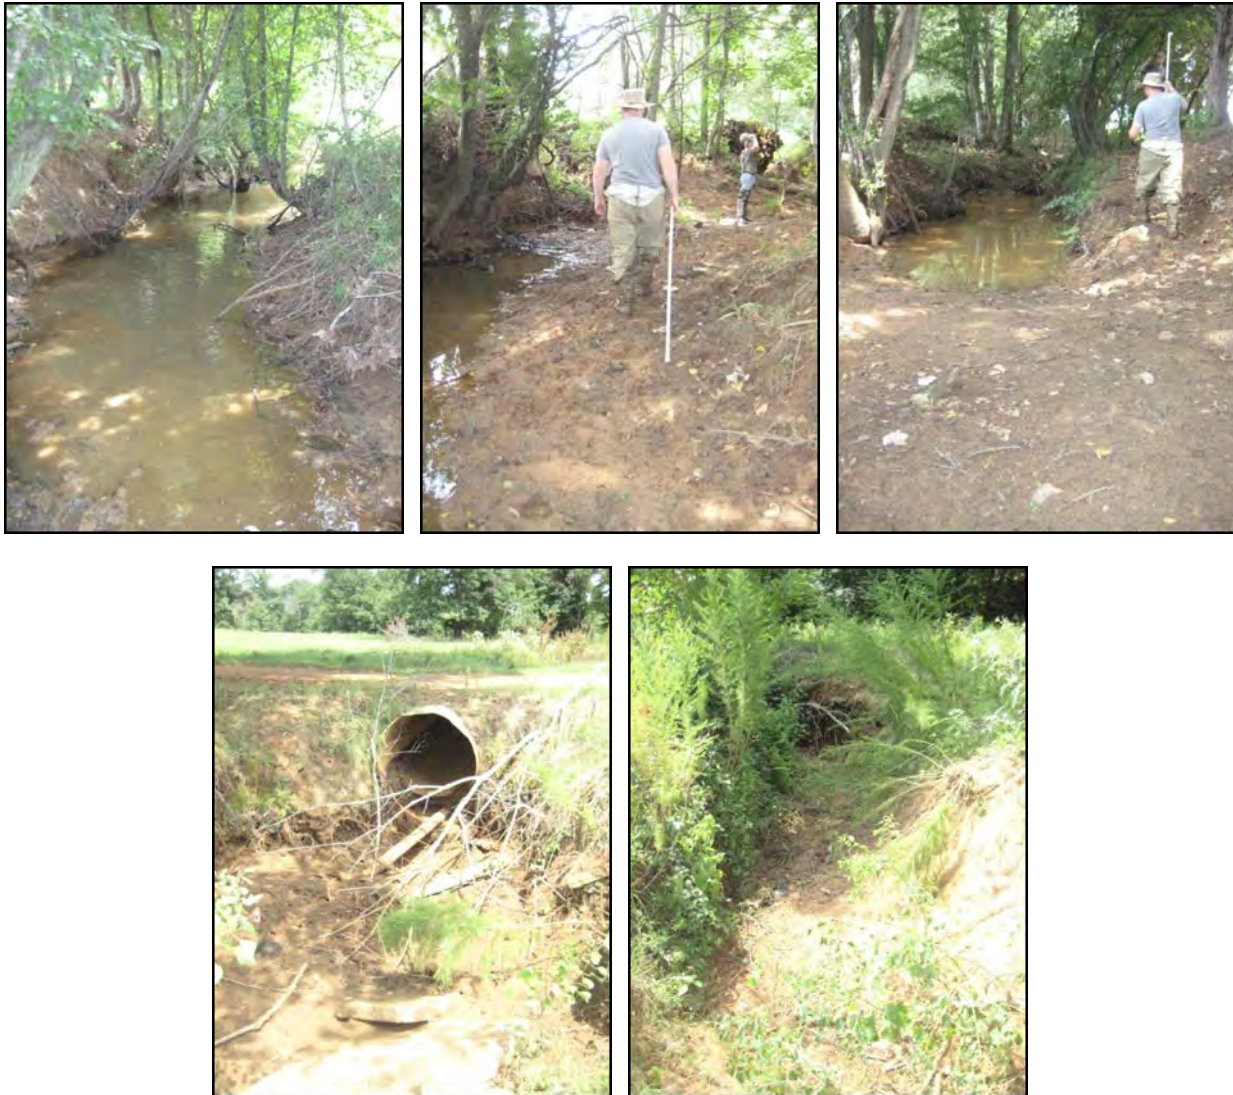
Photogroup 4-35 Waffelow 1 depicting general stream characteristics. All individuals featured are SFASU and CES staff. Top left: 30-m transect, downstream, July 2012; Top center: 30-m transect, upstream, July 2012; Top right: 150-m transect, upstream, July 2012; Bottom left: 300-m transect, upstream, July 2012; Bottom right: 300-m transect, downstream, July 2012.

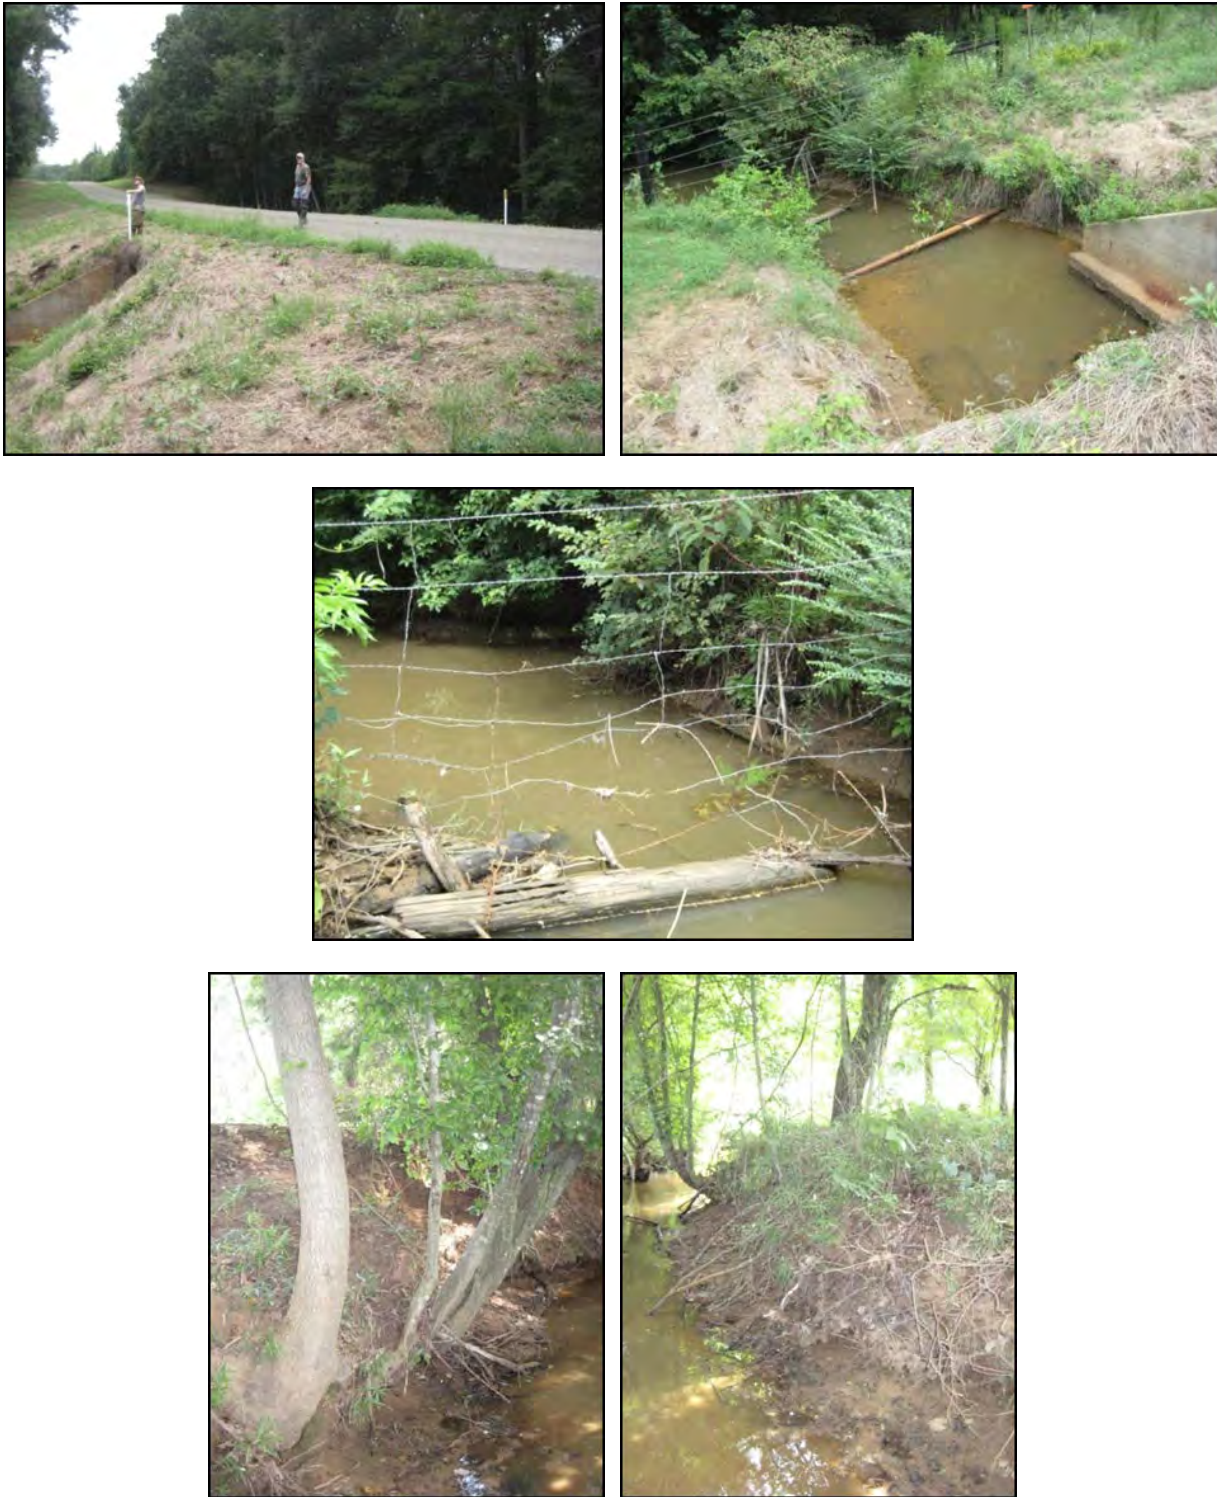
Photogroup 4-35 Waffelow 1 depicting bank appearance. All individuals featured are SFASU and CES staff. Top left: FM 1878 crossing/access point, July 2012; Top right: 0-m transect, July 2012; Middle: 0-m transect, fenced stream channel, July 2012; Bottom left: 30-m transect, left bank, July 2012; Bottom right: 30-m transect, right bank, July 2012.

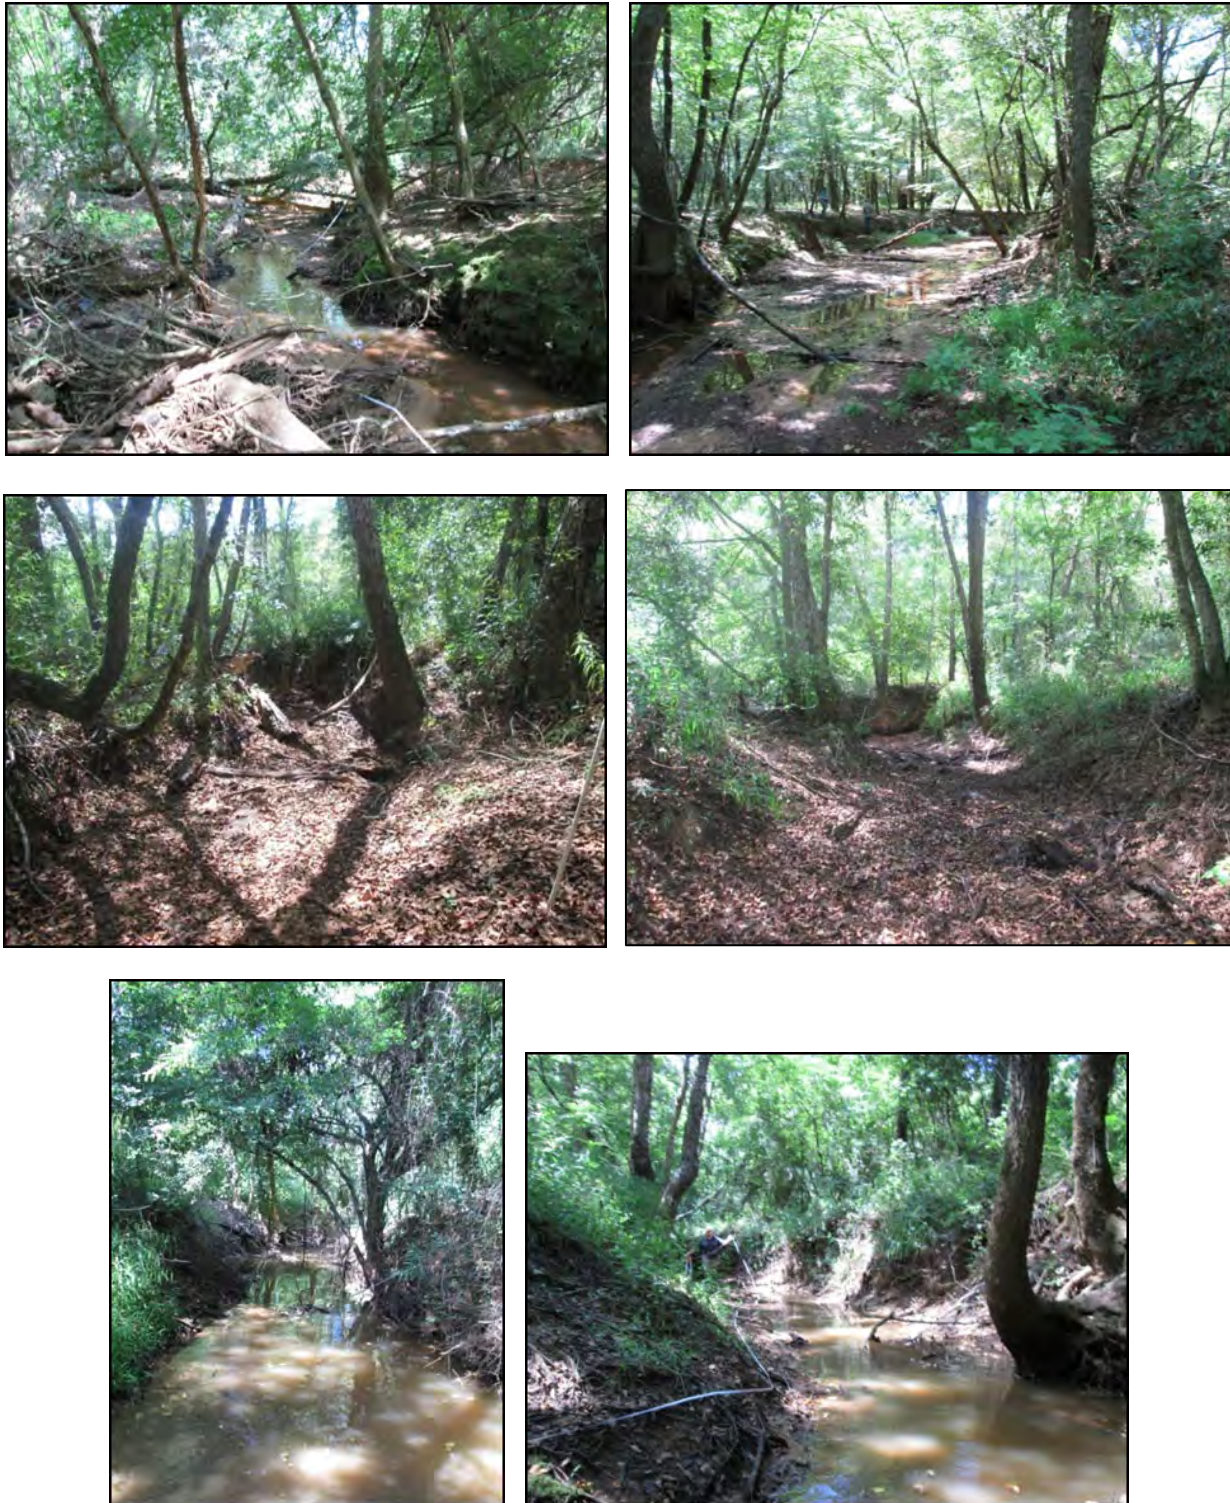
Photogroup 4-36 Waffelow 2 depicting general stream characteristics. Top left: 30-m transect, upstream, July 2012; Top right: 30-m transect, downstream, July 2012; Middle left: 300-m transect, downstream, August 2012; Middle right: 150-m transect, downstream, August 2012. Bottom left: 300-m transect, upstream, July 2012; Bottom right: 150-m transect, downstream, July 2012.

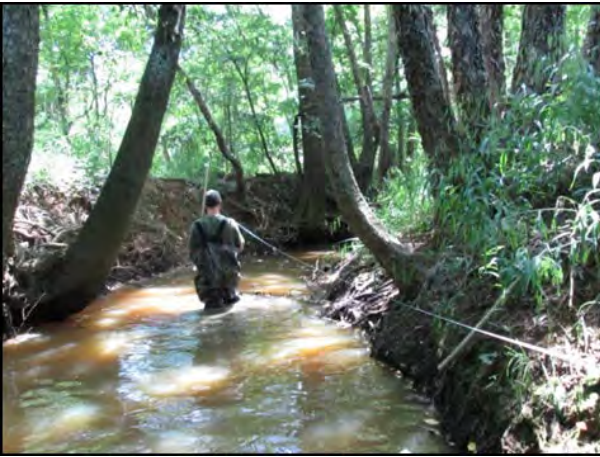
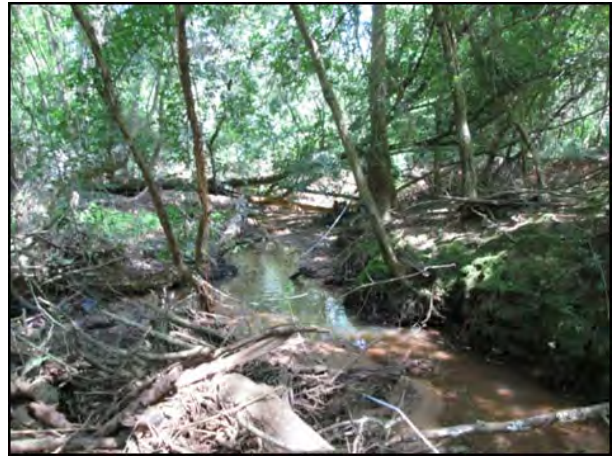
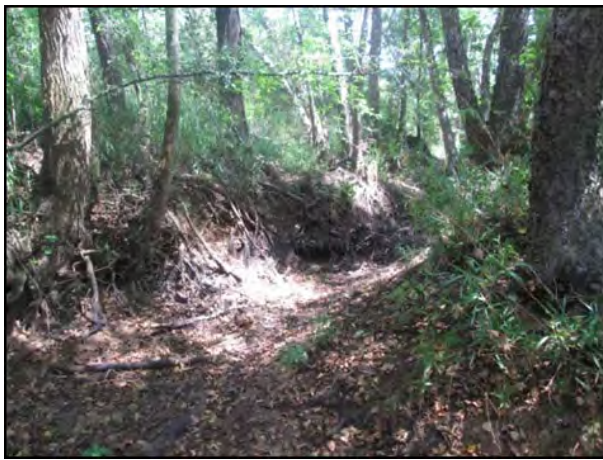
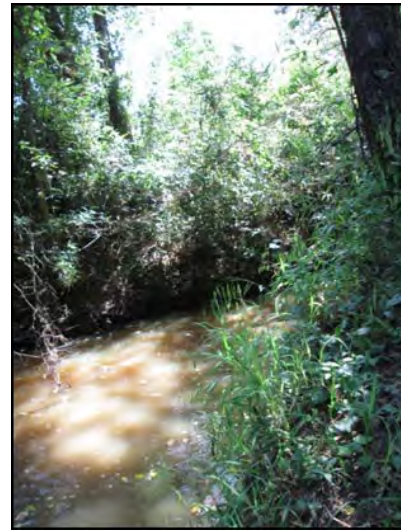
Photogroup 4-36 Waffelow 2 depicting general bank appearance. All individuals featured are SFASU and CES staff. Top left: 150-m transect, upstream, July 2012; Top right: 30-m transect, upstream, July 2012; Bottom left: 300-m transect, upstream, August 2012; Bottom right: 300-m transect, downstream, July 2012.

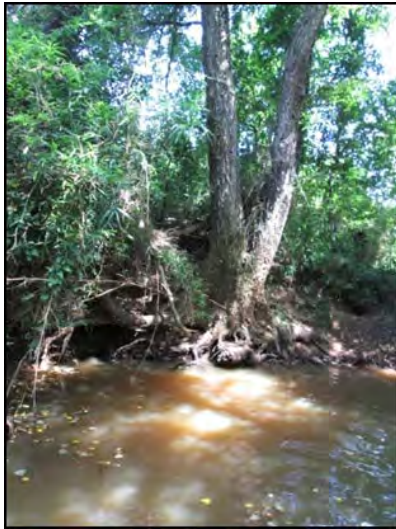
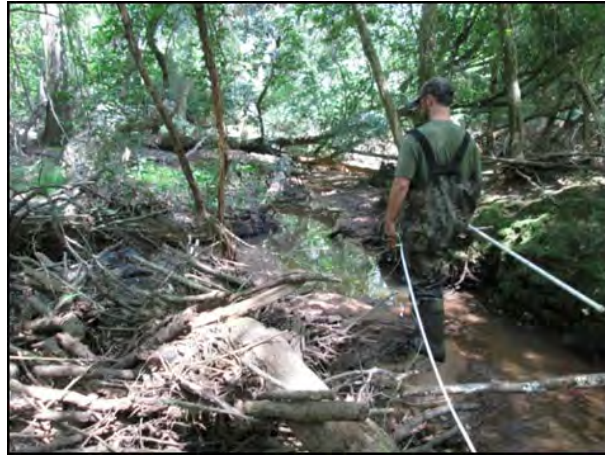
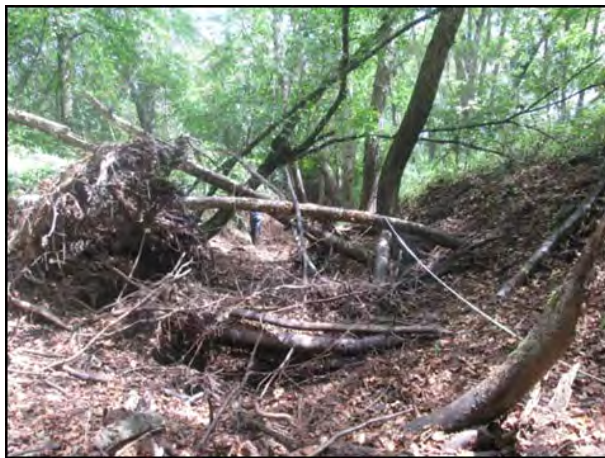
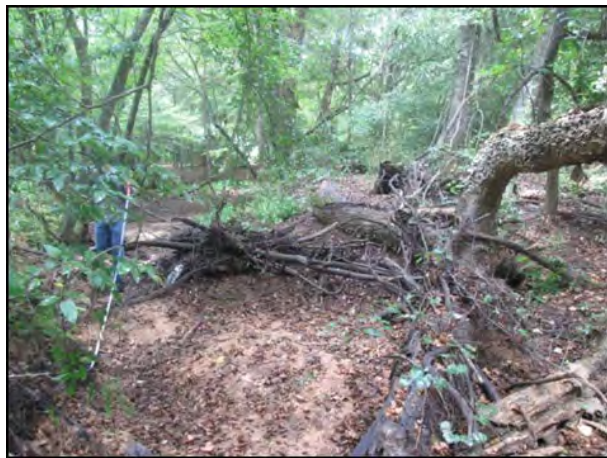
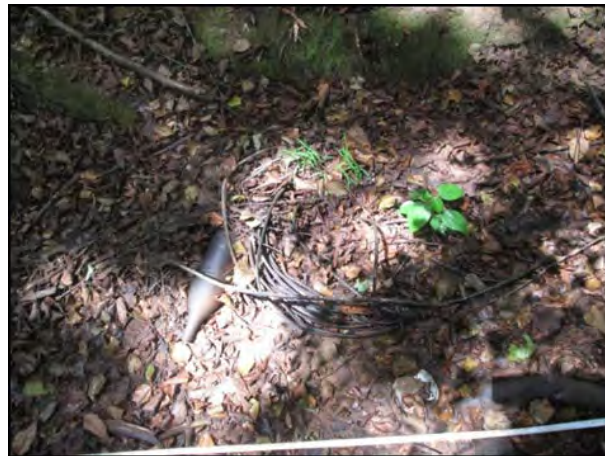
Photogroup 4-36 Waffelow 2 depicting water surface characteristics. All individuals featured are SFASU and CES staff. Top left: 300-m transect, downstream, July 2012; Top right: Large woody debris along bank/within channel, July 2012; Middle left: 150-m transect, upstream, August 2012; Middle right: 30-m transect, upstream, August 2012; Bottom: Small channel litter (glass bottle and wire), August 2012.

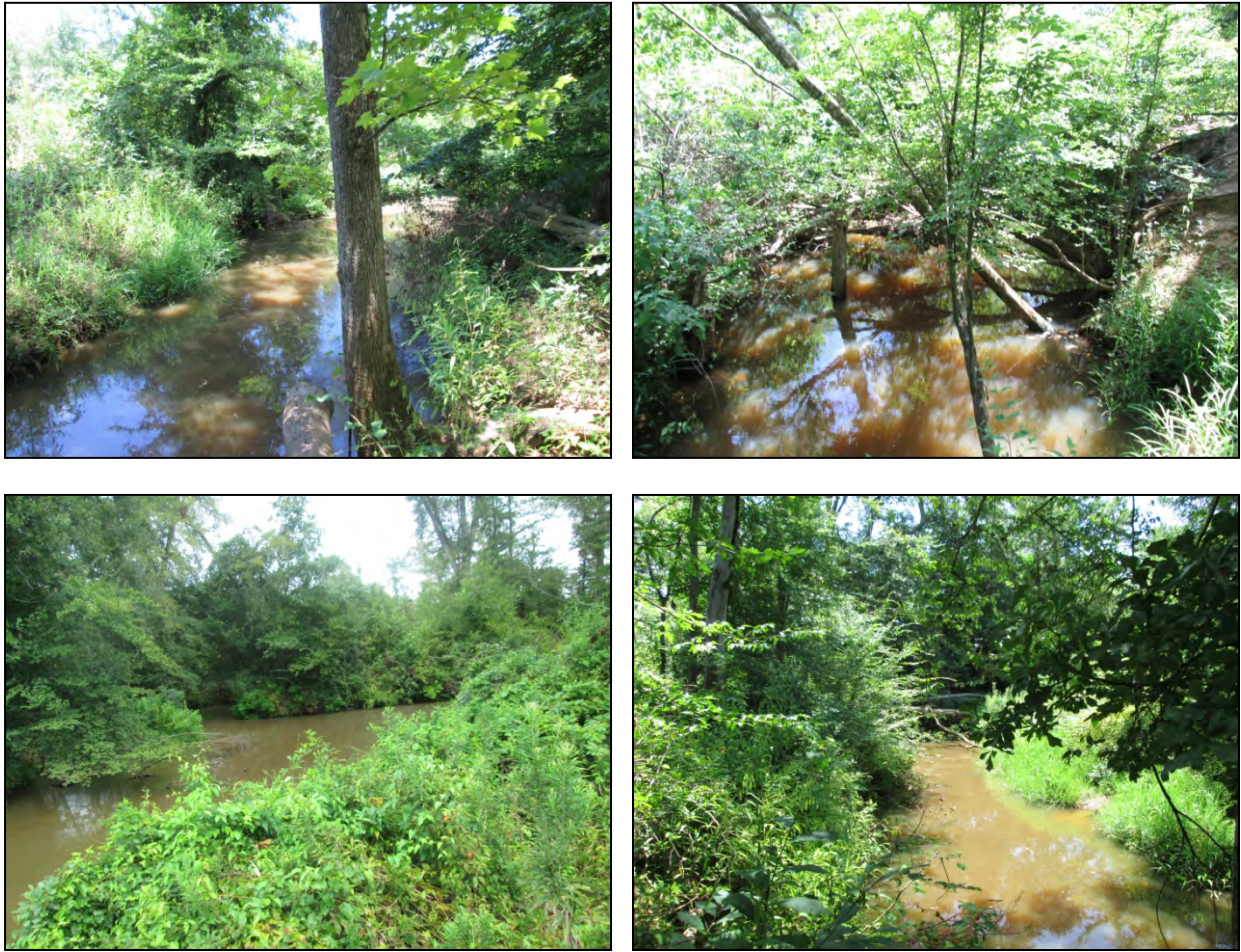
Photogroup 4-37 Waffelow3 depicting general stream characteristics. Top left: 30-m transect, downstream, July 2012; Top right: 150-m transect, downstream, July 2012; Bottom left: 0-m transect, upstream, August 2012; Bottom right: 30-m transect, upstream, July 2012.

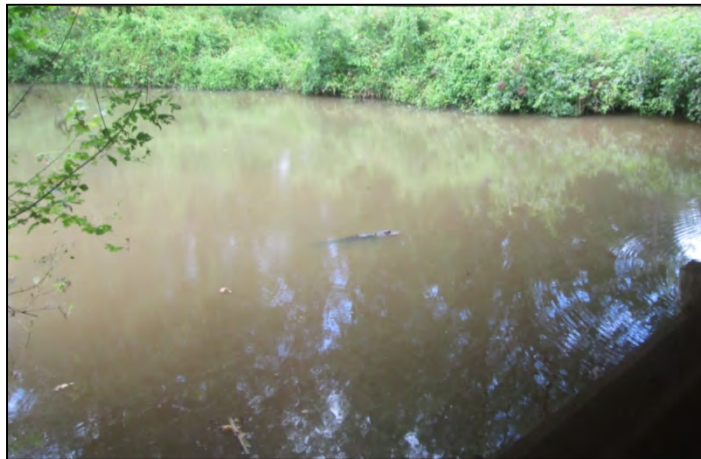
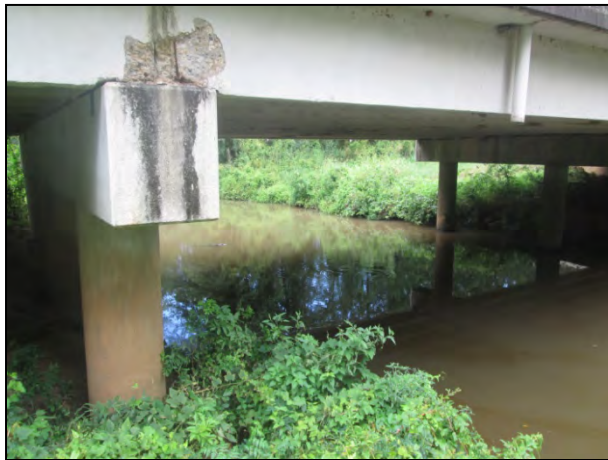
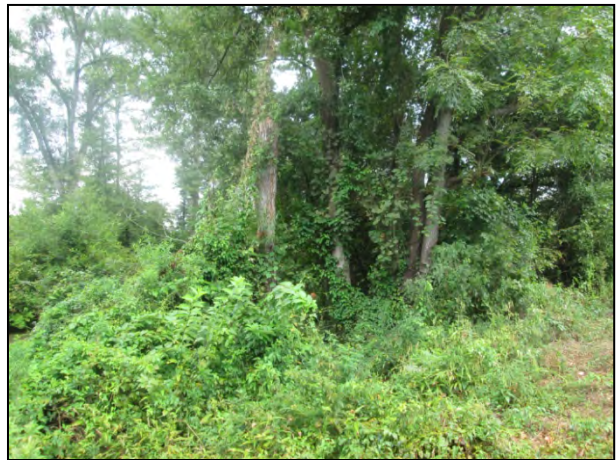
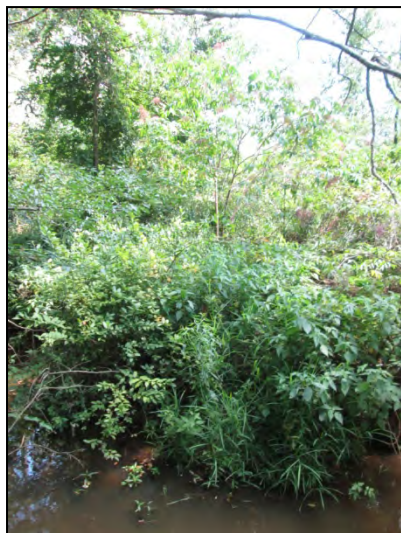
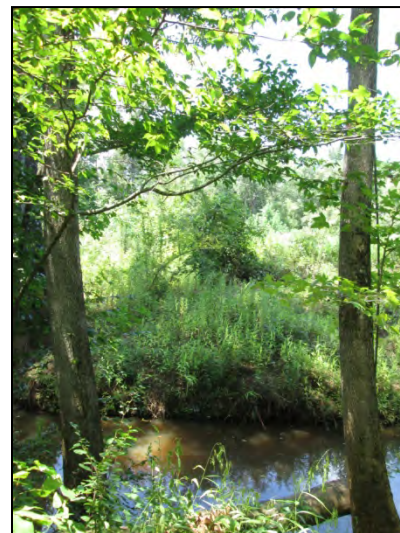
Photogroup 4-37 Waffelow3 depicting general bank appearance. Top: 0-m transect, Juvenile alligator at FM 95 crossing access point, August 2012; Middle left: 0-m transect, FM 95 crossing, downstream, August 2012; Middle right: Dense bank vegetation; Bottom left: 150-m transect, right bank, July 2012; Bottom right: 30-m transect, left bank, July 2012.
