## Attoyac Bayou Watershed Protection Plan and Monitoring Implementation Effectiveness Final Report

Texas Water Resources Institute TR-521 September 2019

Texas State Soil and Water Conservation Board Project #16-12

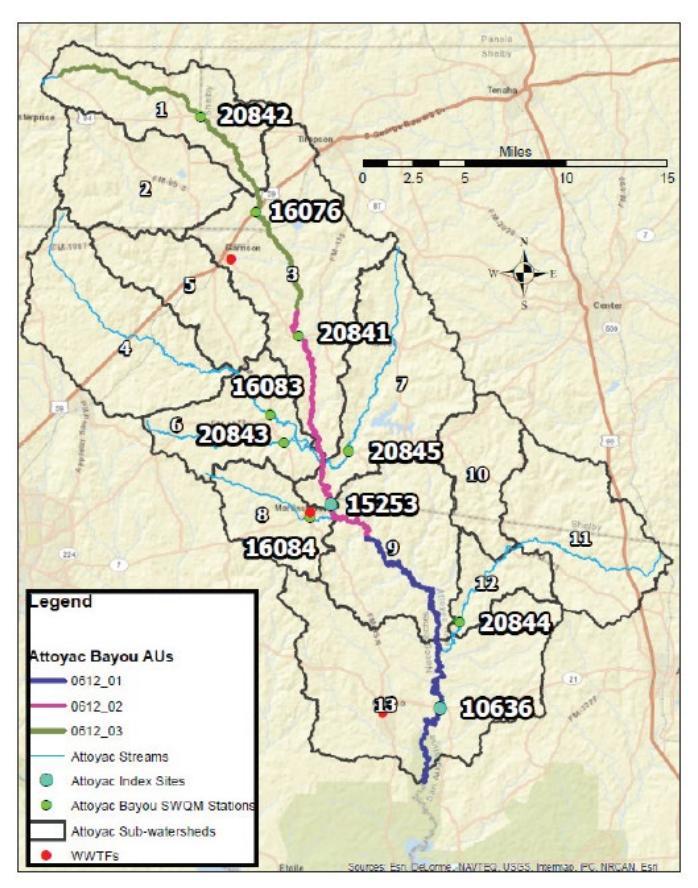
Figure 1 - Water quality monitoring sites within the watershed.

Five of the impaired stream segments were monitored in the Attoyac Basin monthly between March 2017 and August 2019 for a total of 31 monitoring events. These sites were the Attoyac Bayou at FM 138 (Station ID# 20841), Naconiche Creek at FM 95 (ID# 20843), Waffelow Creek at FM 95 (ID# 16083), Terrapin Creek at FM 95 (ID# 16084) and Big Iron Ore Creek at FM 354 (ID# 20844). Water quality parameters measured in-situ included stream discharge (when possible), dissolved oxygen, pH, temperature and specific conductance. Grab samples were transported to the ANRA laboratory for

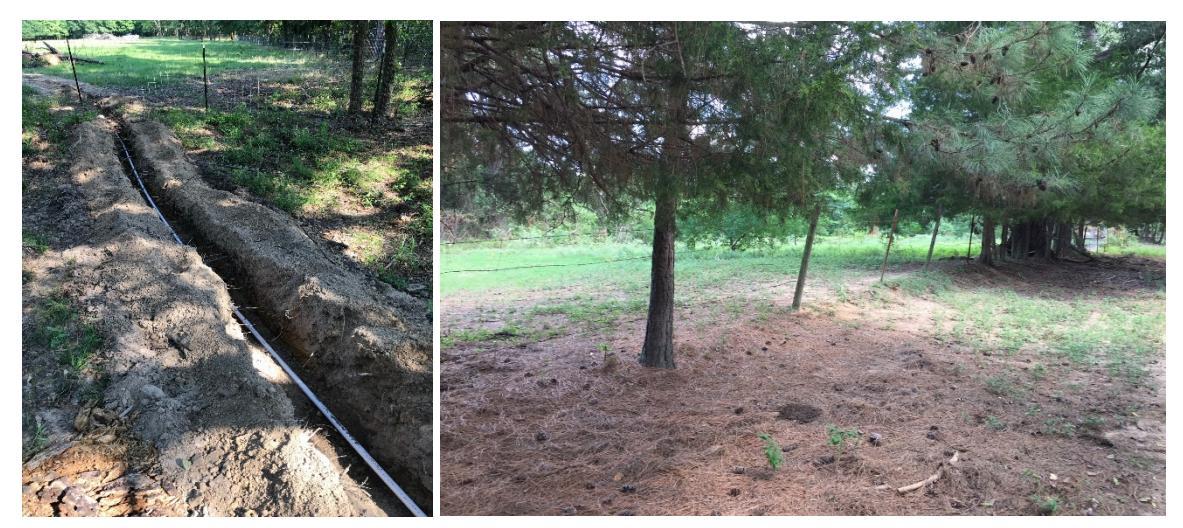
**Figure 4** - Livestock water pipeline and cross fences installed in the watershed as part of a WQMP. Photo by Chris Crenshaw, Nacogdoches SWCD 319 technician during the project period.

and are property specific. During the project performance period, the Attoyac Bayou technician wrote plans for eight sites over 1,967 acres. The practices implemented included livestock pipeline, watering facilities, cross fences and prescribed grazing.

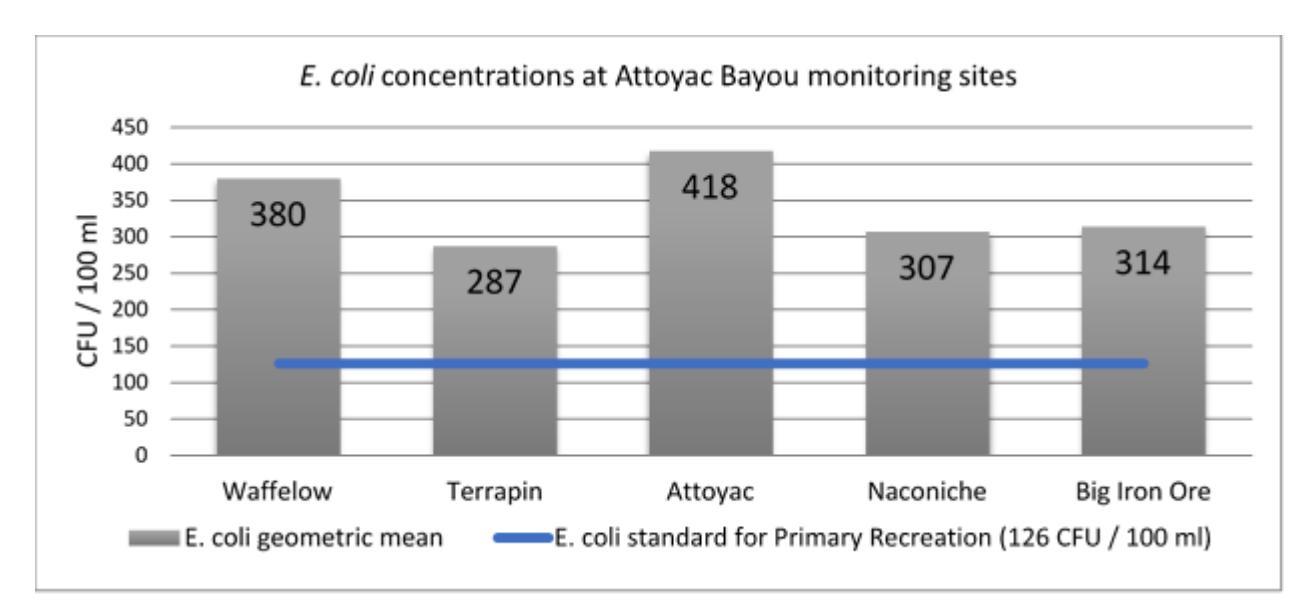
#### Figure 5 - E. coli concentrations geometric means by monitoring site from March 2017 through August 2019.

Based on preliminary analyses, geometric mean *E. coli* remains elevated above the primary contact recreation standard of 126 colony-forming units (CFU) per 100 milliliters (mL) at all five sites in the watershed. The lowest mean for the study period was at the Terrapin Creek station with 287 most probably number (MPN)/100 mL. Higher concentrations were measured during times of greater streamflow at all sites. Most of the samples taken at each site were higher than this standard. For the Attoyac segment, geometric mean *E. coli* concentrations have increased during the last nine years of monitoring, from 225 MPN/100 mL in the 2010-2012 period, to 281 MPN/100 mL for the 2014-15 cycle, and 418 MPN/100 mL from 2017-2019. However, mean concentrations are strongly affected by large flow events with concentrations greater than 2,400 MPN/100 mL during these times. Additional monitoring for bacteria is warranted based on these data, and as more data is collected with future monitoring efforts, more extensive statistical investigations will be completed.

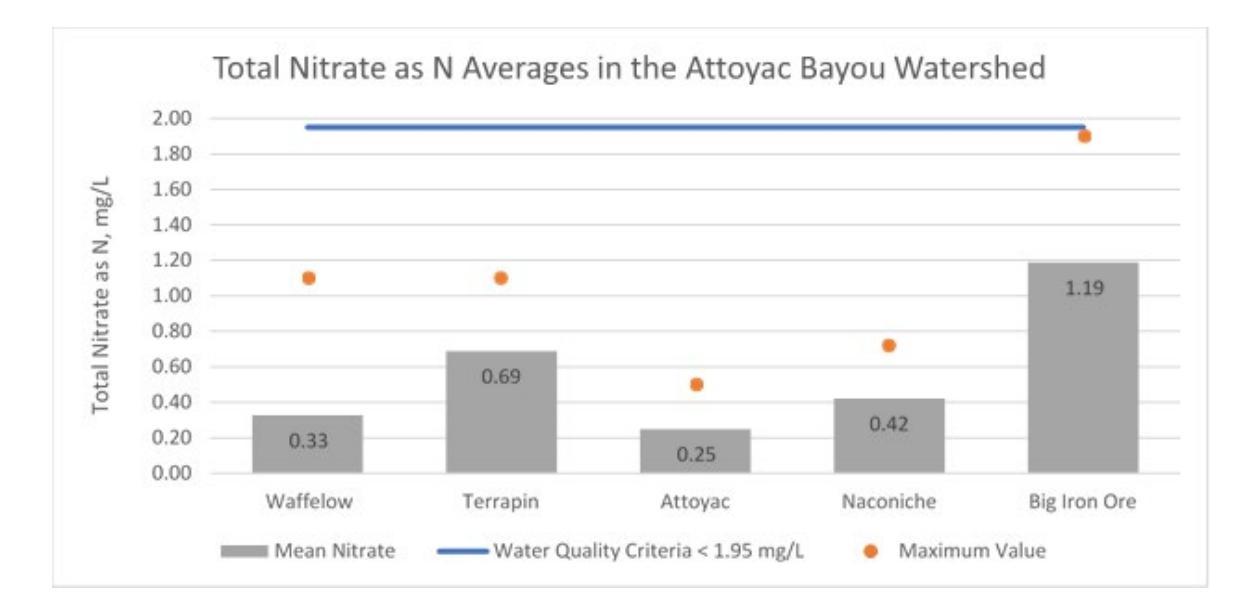
*Figure 6* - Total nitrate as N averages by monitoring site from March 2017 through August 2019.

For nitrate-nitrogen, mean concentrations were well below the threshold value of 1.95 milligrams (mg)/liter(L) across all sites during the monitoring period. No concentrations above 1.95 were measured during the period, indicating that nitrogen levels are not likely to be a significant concern. For ammonia

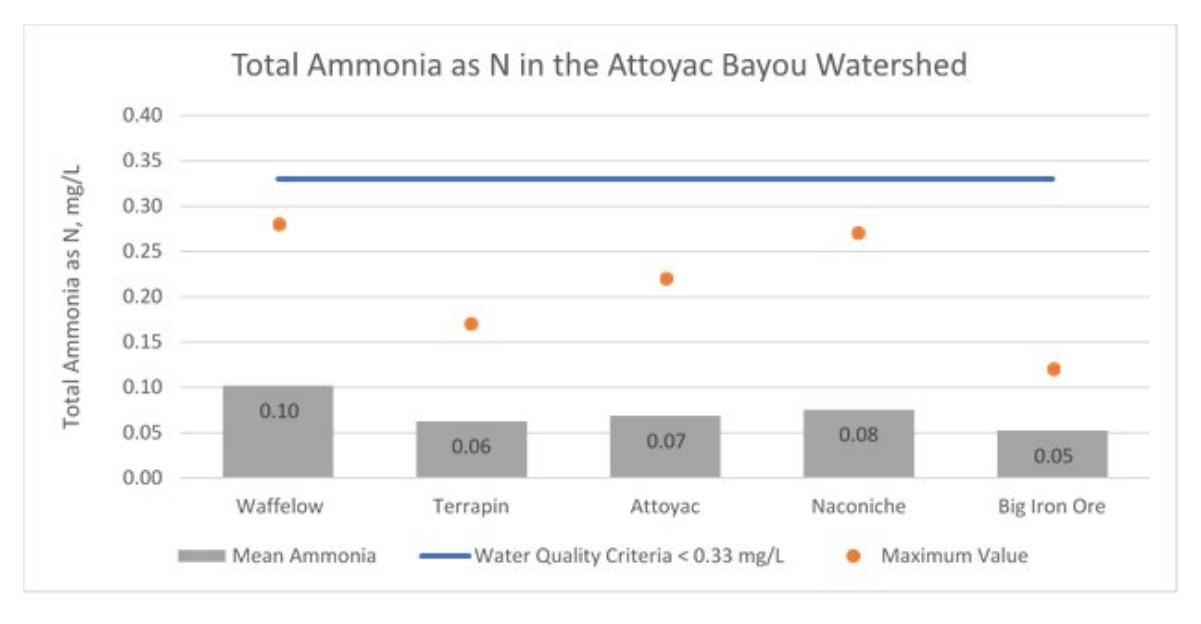
*Figure 7* - Total ammonia as N averages by monitoring site from March 2017 through August 2019.

nitrogen, means were well below the screening criteria of 0.33 mg/L with no observations above this concentration during the period. Total phosphorus concentrations were similarly below screening values and once again, the maximum value measured during the period was 0.44 mg/L, well below the screening criteria of 0.69 mg/L. None of the nutrient concentrations measured during this study period would support the conclusion that excess nutrients from nonpoint pollution sources are negatively impacting these streams.

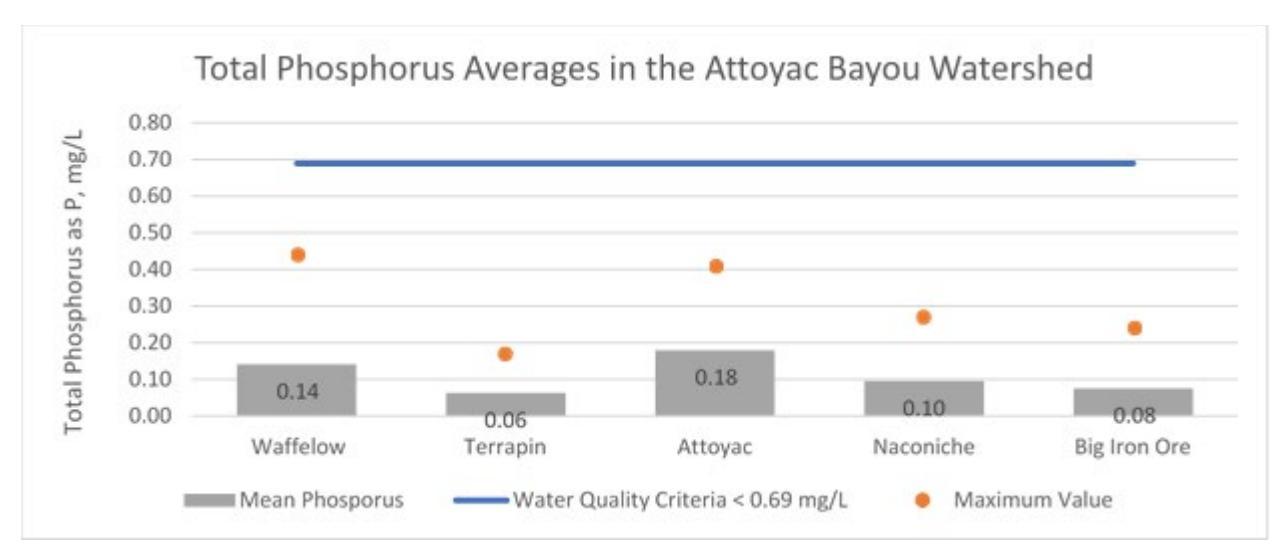
Figure 8 - Total phosphorus by monitoring site from March 2017 through August 2019.

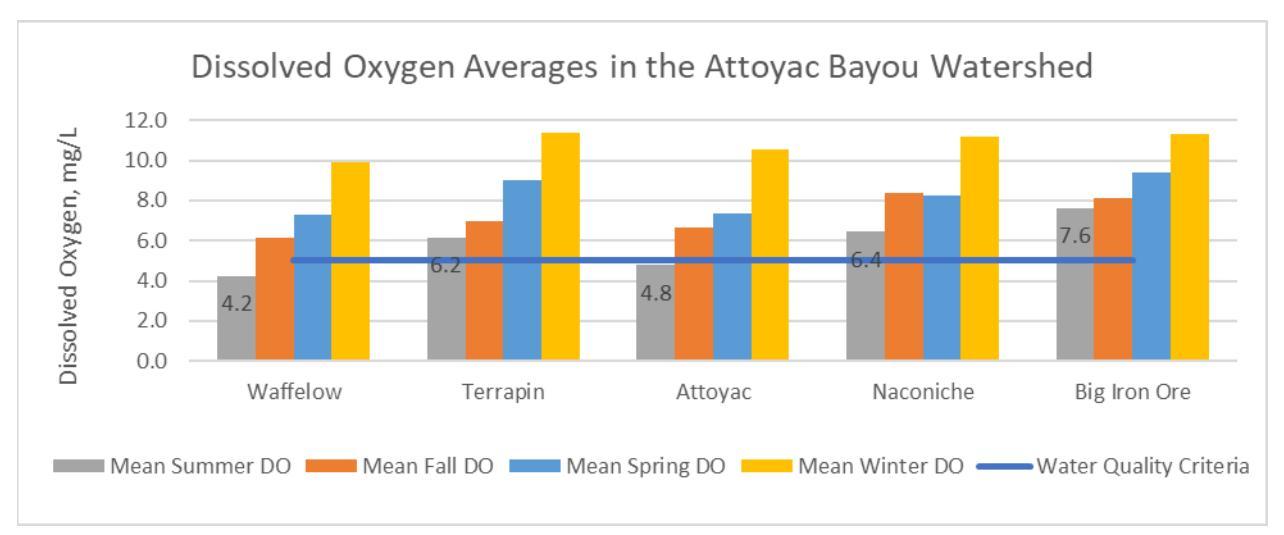
Figure 9 - Dissolved oxygen averages by monitoring site from March 2017 through August 2019.

Annual mean dissolved oxygen (DO) concentrations were above 5.0 mg/L, the water quality standard for DO, for all monitoring locations during the study period. Summer is the season when the lowest DO values are typically observed, especially on smaller stream systems when discharge is minimal. Mean summer DO concentrations were above 5.0 mg/L for the Big Iron Ore (7.6 mg/L), Naconiche (6.4 mg/L) and Terrapin (6.2 mg/L) stations. Mean summer DO was 4.2 mg/L for the Waffelow monitoring site and 4.8 mg/L for Attoyac site. About 31% of the samples measured at the Waffelow sampling location were below 5.0 mg/L, with almost all of these lower readings being observed during summer months. Stream discharge was minimal during these periods with DO measurements being made in a pool upstream of the SH 95 bridge. These relatively lower DO concentrations at the Waffelow Creek in summer are likely not a significant concern since they probably reflect the stream geomorphology and fluvial status rather than potential nonpoint sources of pollution. The relatively low levels of nitrogen and phosphorus measured at the Waffelow sampling site also reinforce this conclusion.

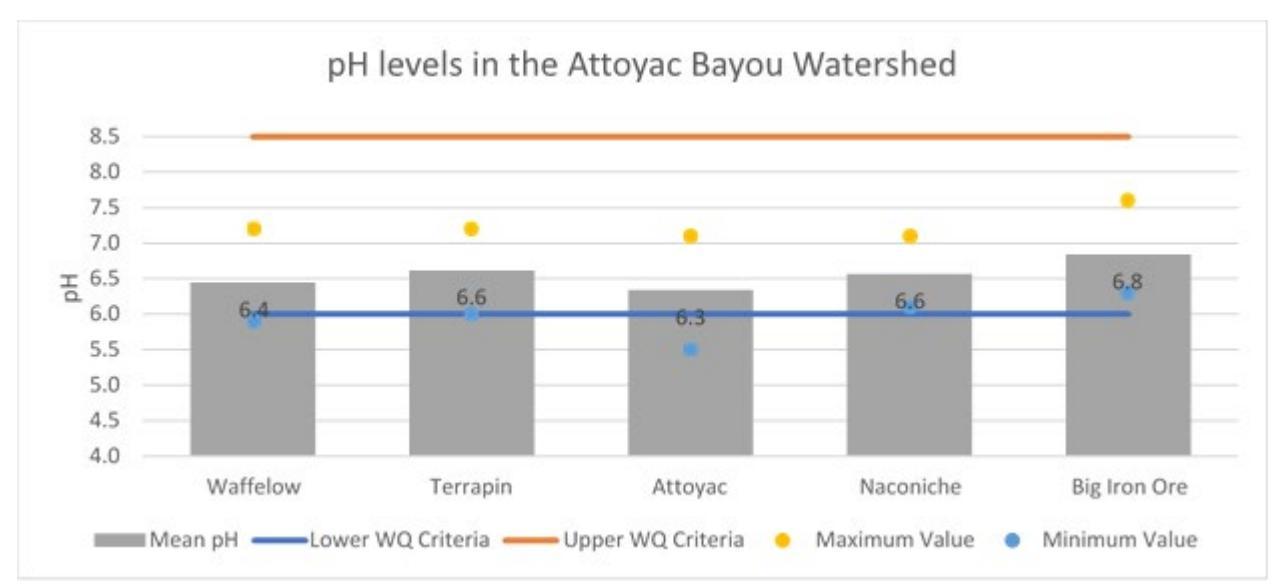
Figure 10 – Mean pH by site from March 2017 through August 2019.
