Mission and Aransas Rivers TMDL I-Plan Implementation Final Report

Texas Water Resources Institute TR-515
November 2019

Prepared for the Texas General Land Office

Texas Water Resources Institute Technical Report- 515
College Station, Texas
November 2019

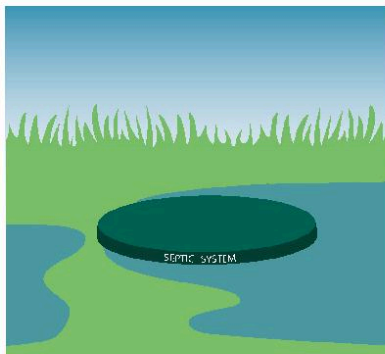
Standing water or damp spots near your septic tank or drainfield/sprayfield

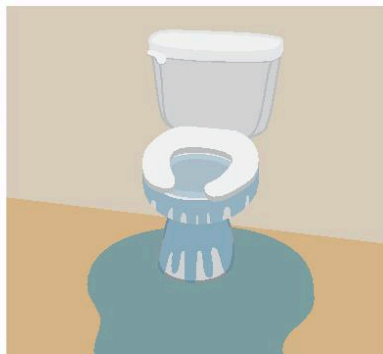
Water and sewage from toilets, drains and sinks are backing up into your home

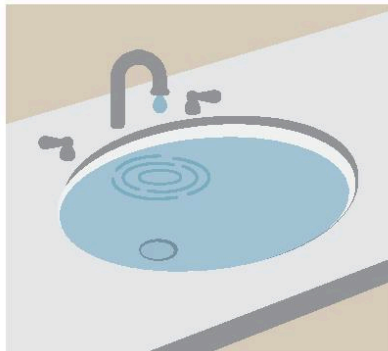
Your bathtubs, showers and sinks are draining slowly

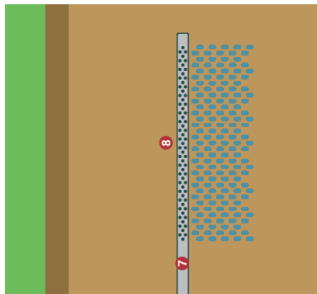
1. Inlet
2. Scum layer
3. Settling layer
4. Sludge layer
5. Access riser
6. Effluent screen
7. Outlet
8. Drainfield

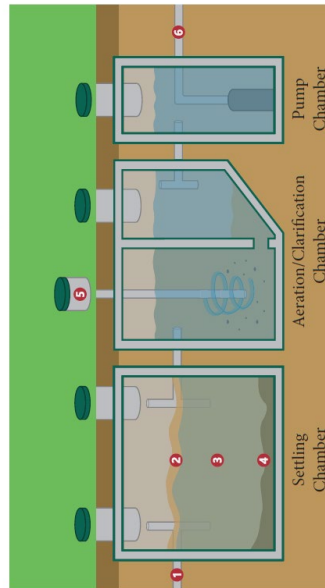
Aerobic Treatment System

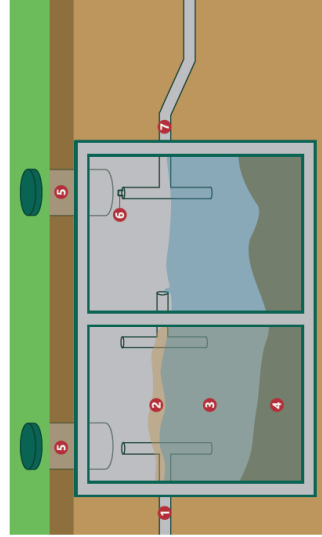
Conventional Septic System

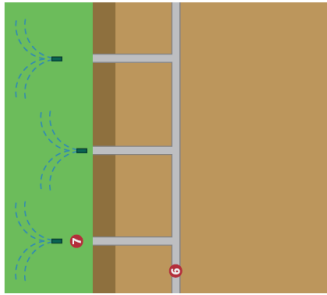
1. Inlet
2. Scum layer
3. Settling layer
4. Sludge layer
5. Access riser
6. Outlet
7. Sprayfield

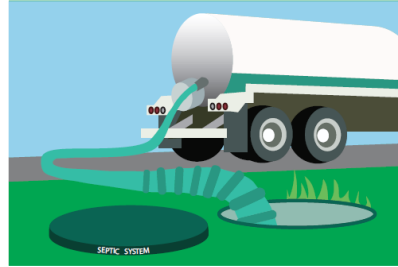
Regular Septic Tank Pumping

- Contact a septic service technician to measure the level of solids in your tank.
- Pump out septic tanks every 3-5 years or when total solids in the tank reach 25-33% of tank capacity.
- Make sure pumping is done during dry seasons to reduce the risk of tank flotation.

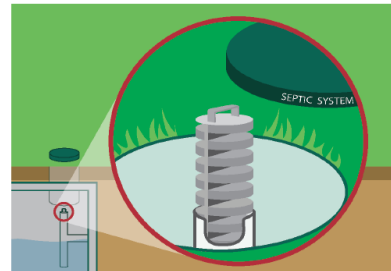
Clean Effluent Screens

- Conventional septic systems have effluent screens installed at the septic tank outlet to protect the drainfield by preventing solids from leaving the tank.
- Wash these screens directly over the inlet compartment of the septic tank every 1-2 years.

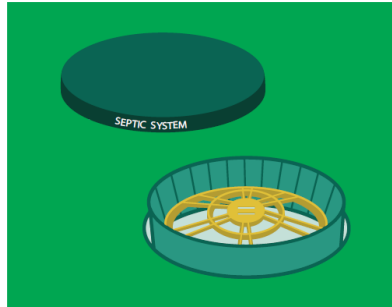
Tank Accessibility

- Having a readily accessible septic tank lid will make performing maintenance easier.
- Adding a septic tank riser can make locating, inspecting and pumping your septic tank more convenient.
- Lids and risers must be properly secured to prevent unwanted access by children and animals.
- Your septic tank access ports should be free of encroachment.

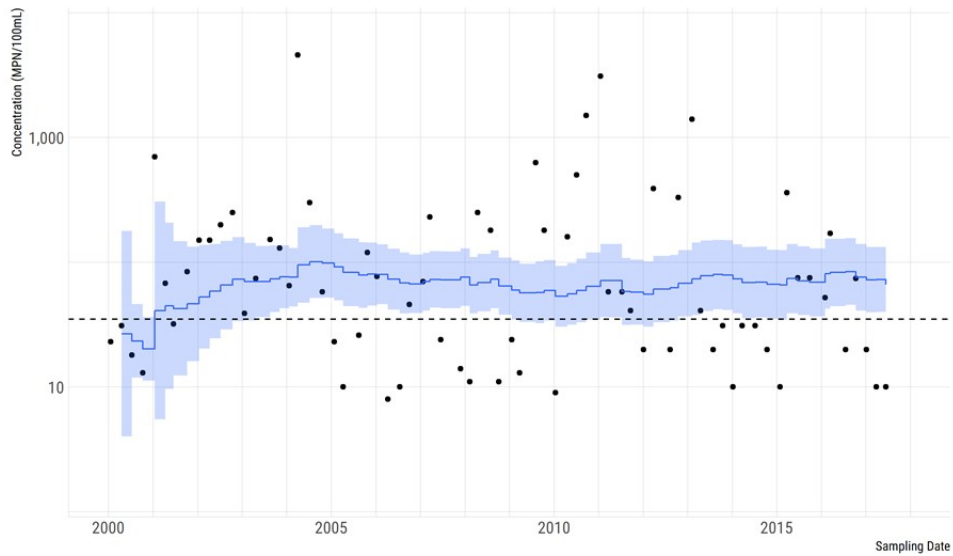
Enterococcus Bacteria Concentrations

2001_01 Mission River Tidal (January 2000 - December 2017)

Source: TCEQ CRP Data Tool
 Solid Blue Line == 7-yr Rolling Geometric Mean,
 Shaded Area == 95% Confidence Interval,
 Dotted Line == Water Quality Standard (35 MPN/100mL).

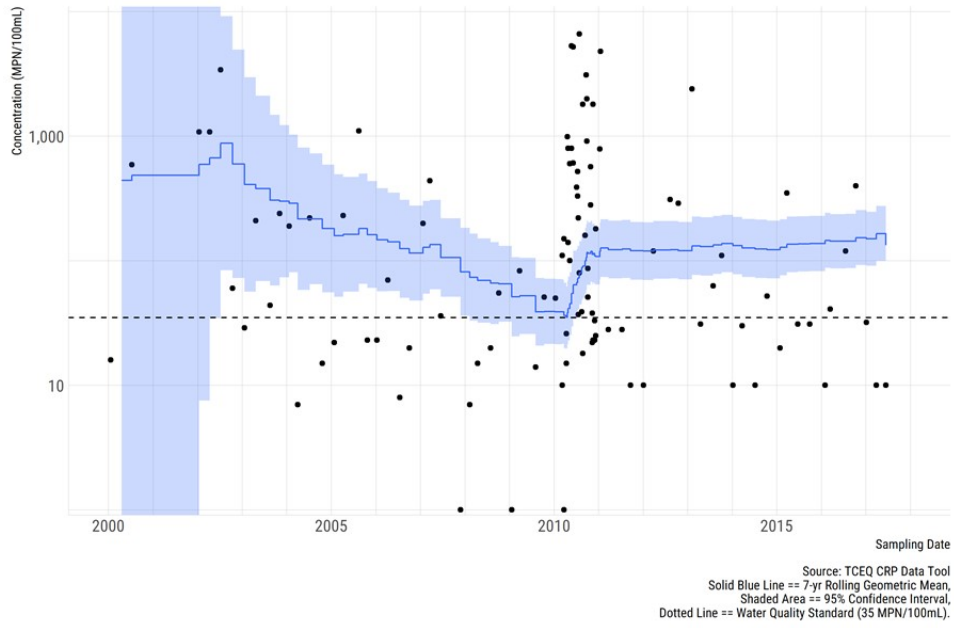
Enterococcus Bacteria Concentrations

2001_01 Aransas River Tidal (January 2000 - December 2017)

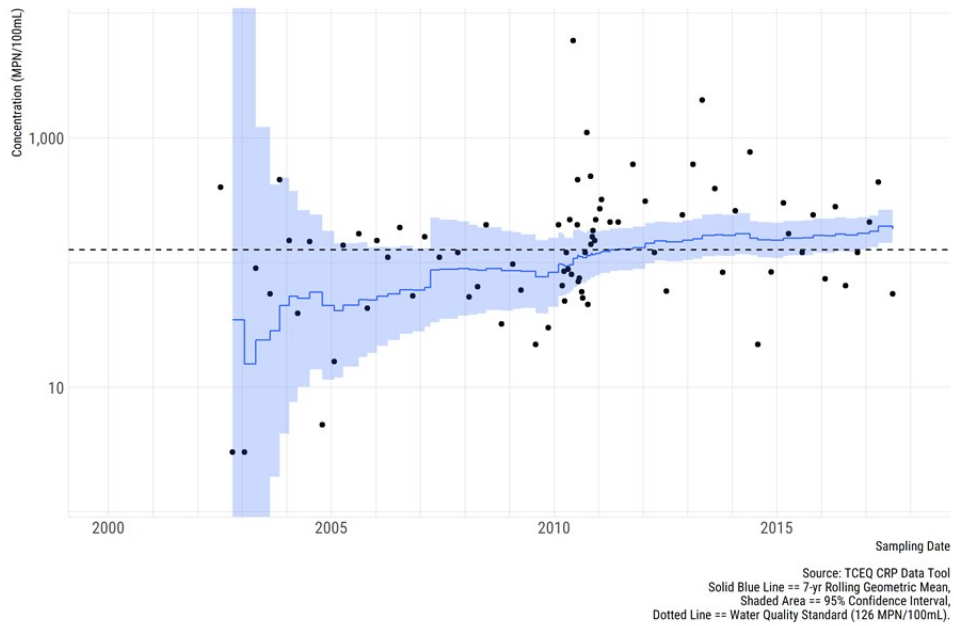
E. coli Bacteria Concentrations

2004_02 Aransas River Above Tidal (January 2000 - December 2017)

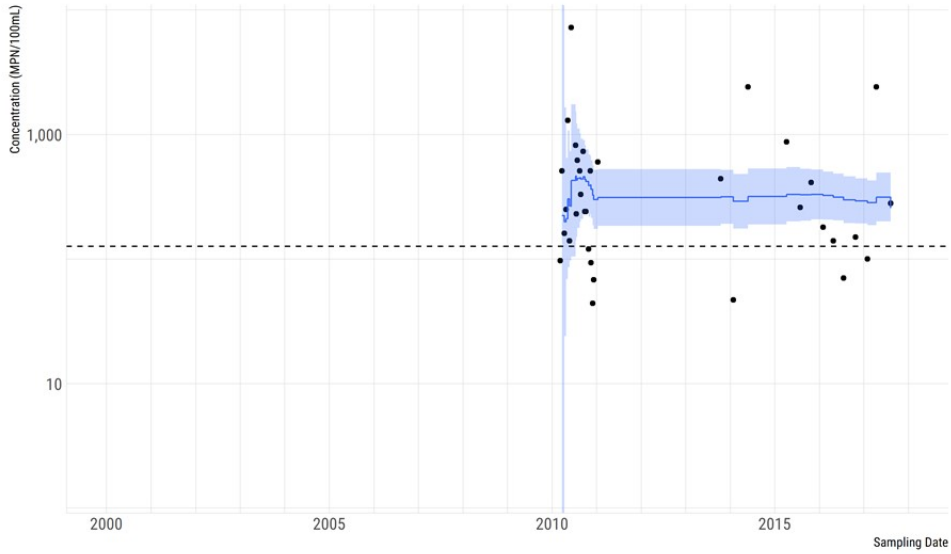
E. coli Bacteria Concentrations

2004B_02 Poesta Creek (January 2000 - December 2017)

Source: TCEQ CRP Data Tool
Solid Blue Line == 7-yr Rolling Geometric Mean,
Shaded Area == 95% Confidence Interval,
Dotted Line == Water Quality Standard (126 MPN/100mL).
